Executive Summary

Engineer's Foundation Evaluation

123 Main St, Your City, FL, 12345

0.0 - Background and Purpose

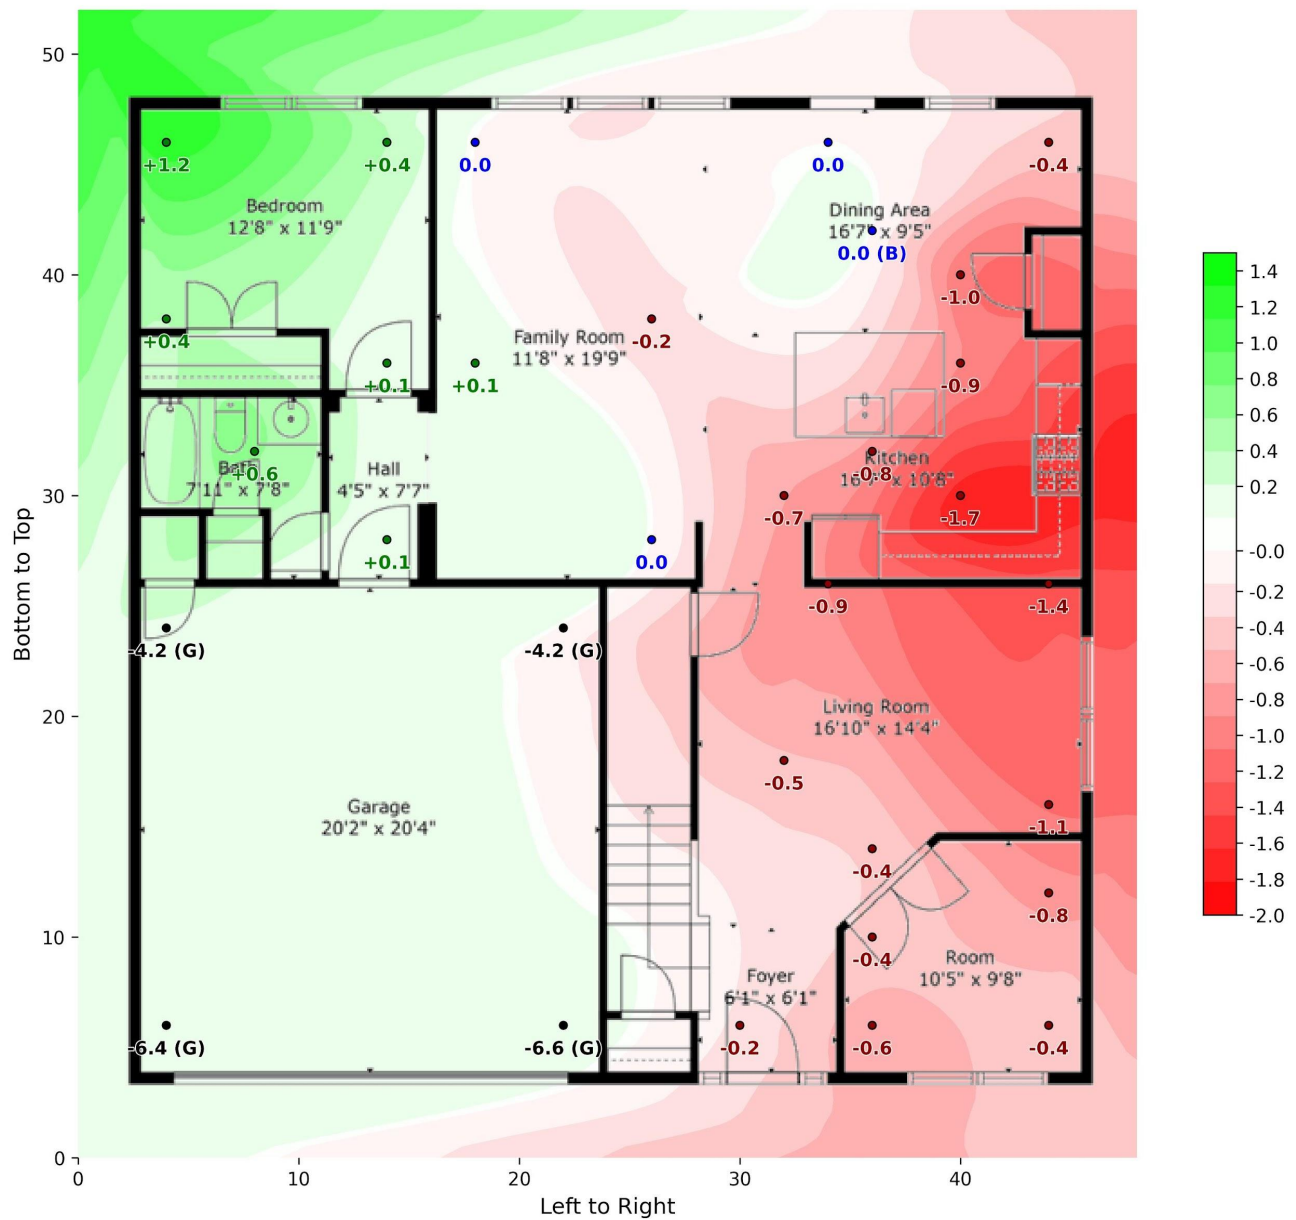
Elevation Plot Graphic (Figure A)

The elevation plot resulted in the graphic as depicted above in Figure A. The red-points and areas are elevation measurements that were lower than the base station elevation (0.0). The green-points and areas are elevation measurements that were higher than the base station elevation (0.0). The blue-points (and white areas) are equal to the base station elevation (0.0). The base station is depicted with a (B) symbol. The elevation plot takes into account differences in flooring thicknesses. The maximum elevation point was determined to be 1.2 inches and the minimum was -1.7 inches, resulting in an elevation difference of 2.9 inches of difference across the structure.

The elevation plot graphic above will show points labeled with a (G) symbol representing Garage. These elevation points were measured and plotted so they can be compared year-to-year, however, they are excluded from the foundation analysis. This is because garages can be non-monolithic and/or they are poured to purposefully slope toward the exterior garage door making any conclusions derived difficult to interpret.

Elevation differences across the structure are the first indicator that a foundation problem may or may-not exist. As documented above, the maximum elevation point of this structure was determined to be 1.2 inches and the minimum was -1.7 inches, resulting in an elevation difference of 2.9 inches of difference across the structure. The elevation plot takes into account differences in flooring thicknesses. The elevation deflection across an entire structure should, best-case-scenario, remain within 0.5 to 1-inch depending on the age of the structure. Measured differences approaching 2-inches are an initial sign of possible foundation fatigue. The maximum allowable elevation difference is subjective, depending on other factors such as the visual condition, size, and age of the structure (36 year(s) old) along with how the foundation performs when calculating deflection and tilt.

Based on observed elevations of the foundation from the elevation plot, the elevation differences do not fall within industry standards and tolerable limits. These findings indicate that the foundation does not have consistent and uniform elevation measurements. Note: elevation measurements alone is not the only indicator of foundation problems; see the deflection and tilt calculations (and the report's overall conclusion) for a complete understanding of foundation stabilization. If elevations fall outside of industry standard/tolerable limits, it is a first indicator that the foundation will fail in deflection and/or tilt.

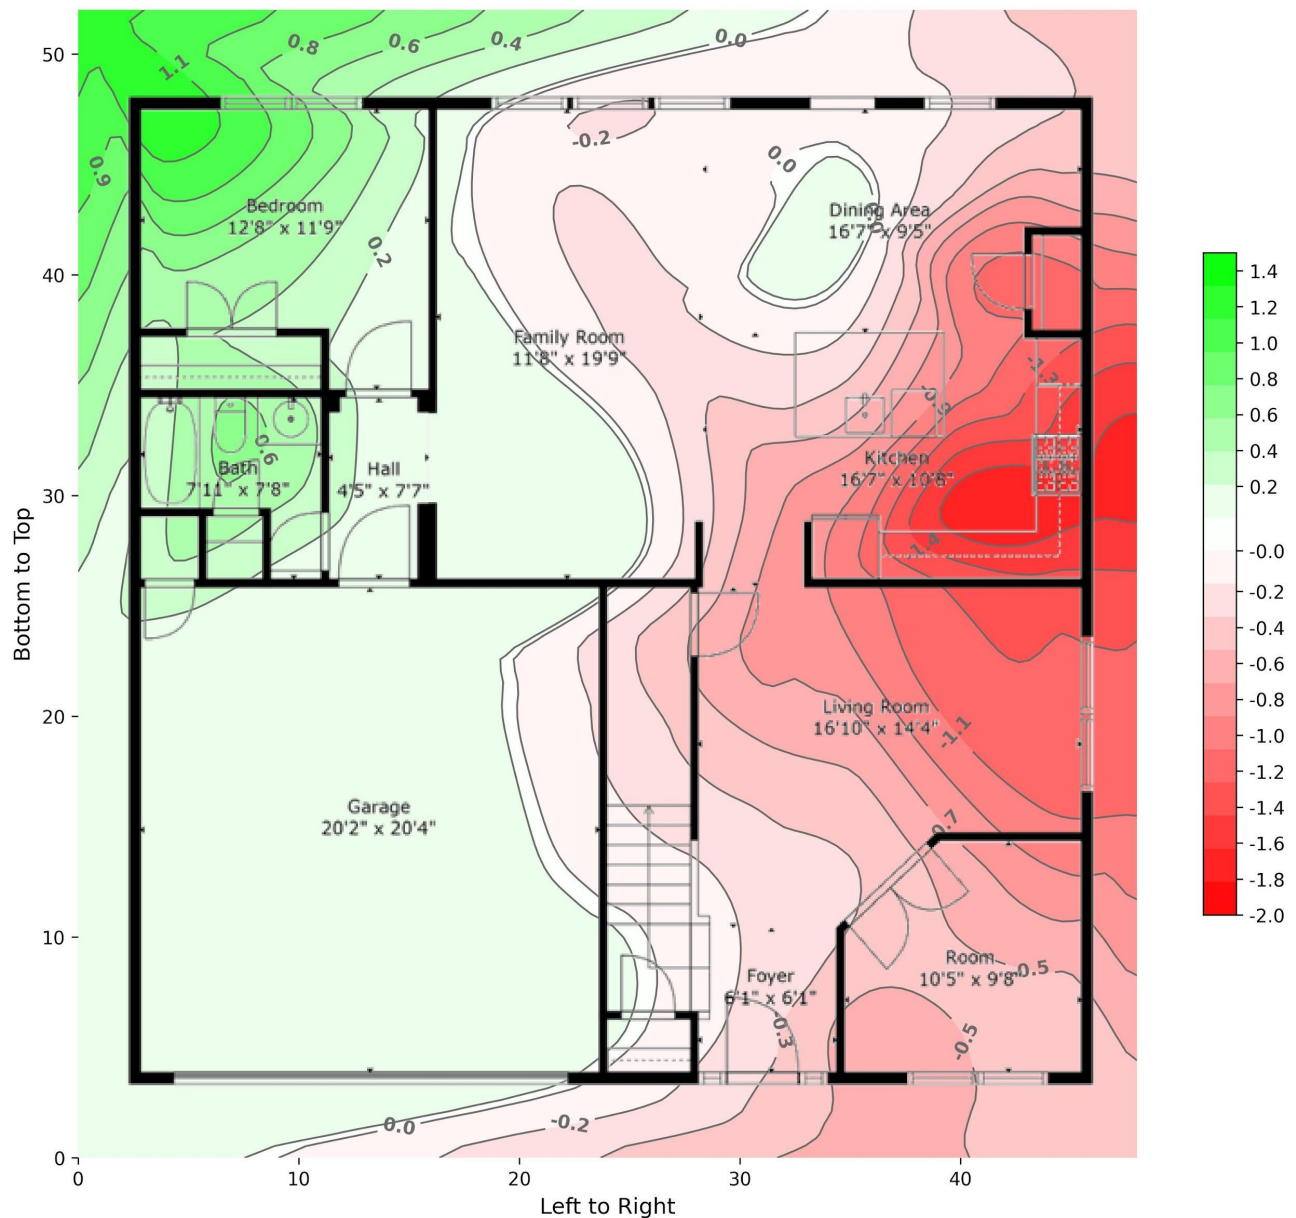
Mesh Contour Graphic (Figure B)

The mesh contours graphic depicted above in Figure B is similar to the elevation plot. The red, green, and white areas depict areas that are lower, higher, and equal to the base station elevation (0.0). The lines or contours (similar to map topography) are labeled at specific intervals.

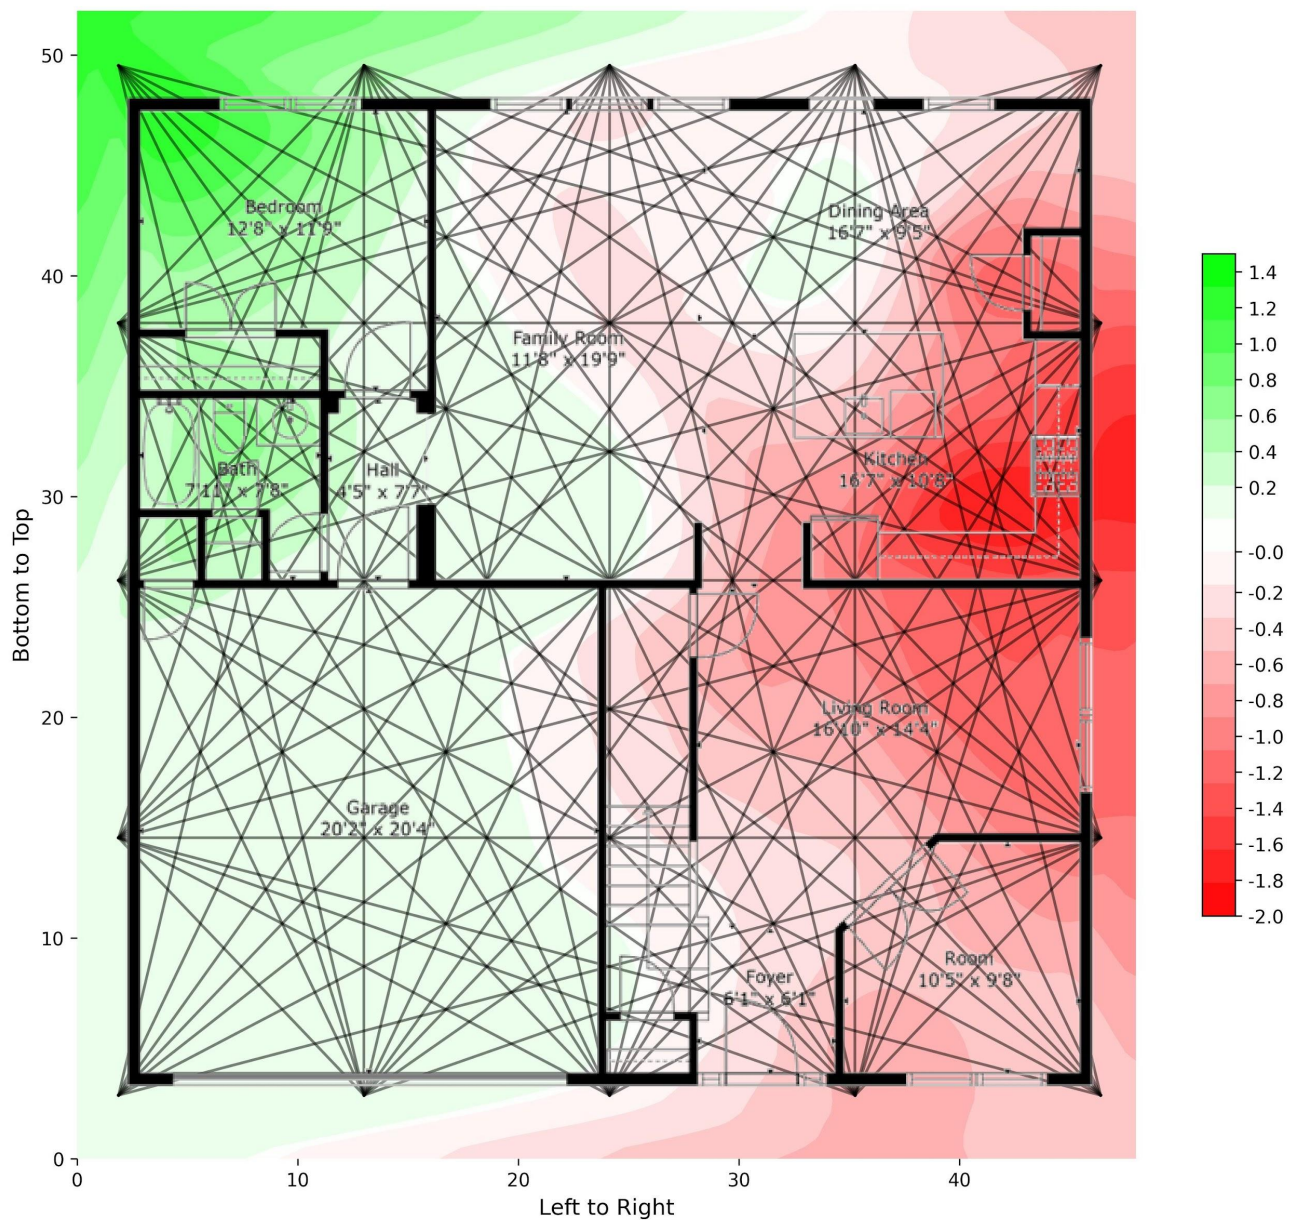
All Profiles Graphic (Figure C)

Below is a graphic that shows the locations of deflection and tilt profiles that were calculated. The total profiles calculated was 79 with a total usable profiles (above the effective length threshold) of 75.

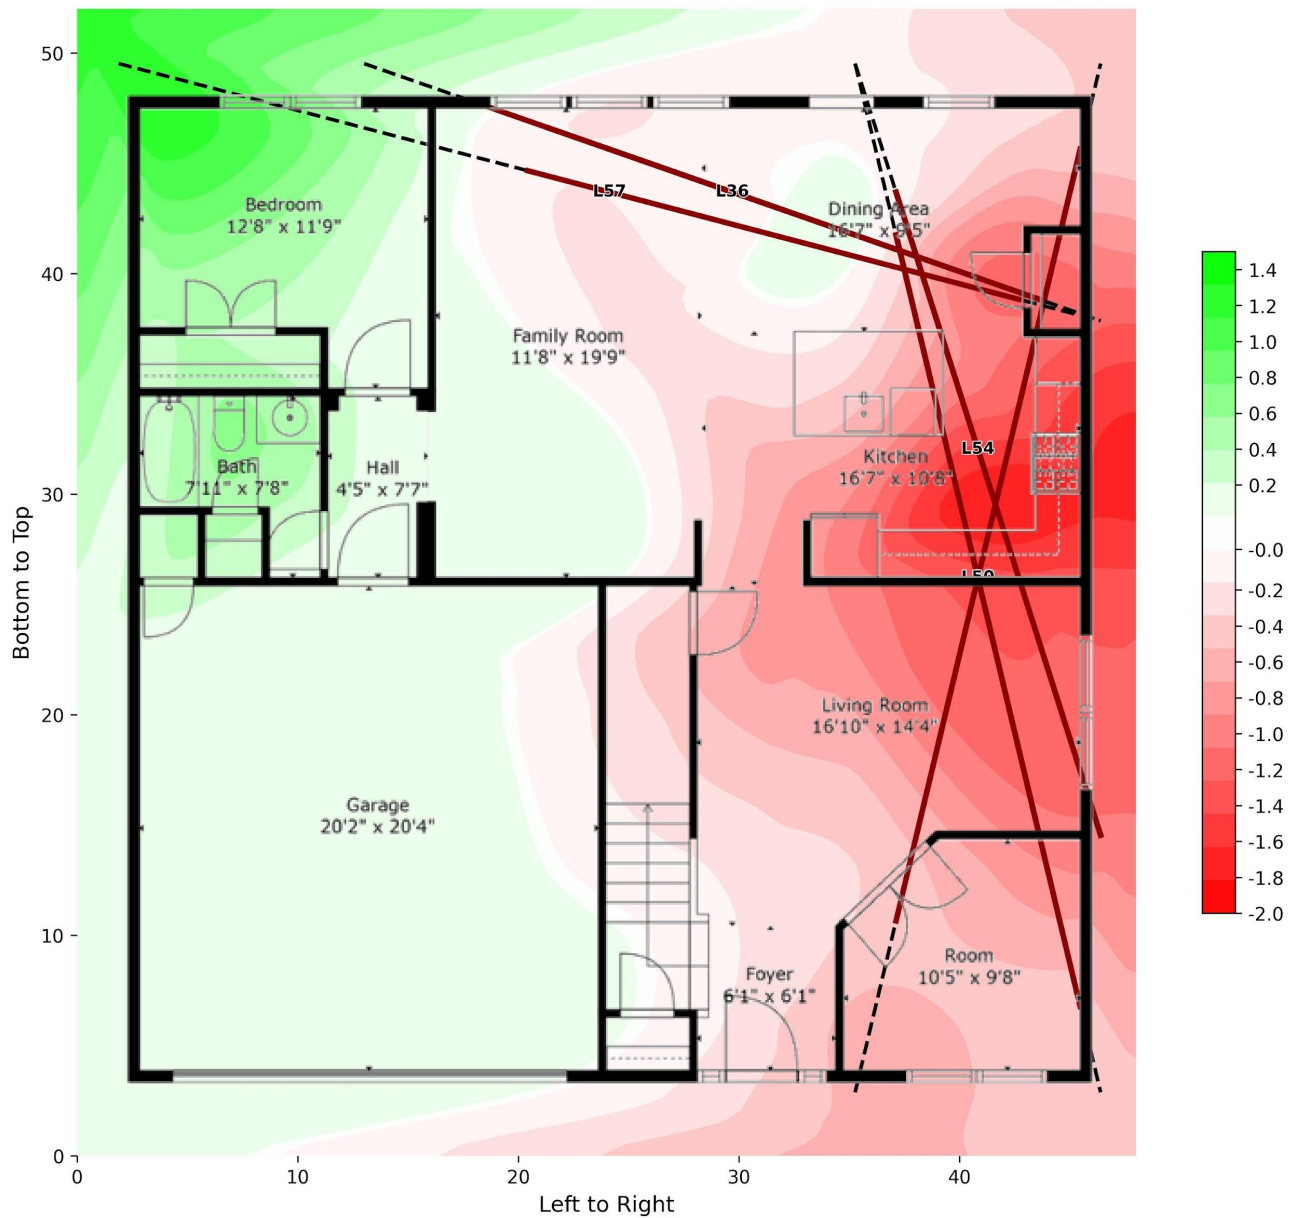
Deflection Failures Graphic (Figure D)

Below is a graphic that indicates the locations of the 5 deflection calculation failures.

The above Figure D shows deflection failures along the foundation. Deflection failures can be considered localized failures in (sometimes) isolated portions of the foundation. The profile lines that were calculated are represented by a dashed black line and the areas that the deflection failures occur are represented by a dark red line segment. Of the 75 deflection profiles calculated, 5 profile failures were identified.

Deflection failures can be considered localized failures of the foundation in (sometimes) isolated portions of the foundation. Of the 75 deflection profiles calculated, 5 failures were identified.

Deflection failures are above standard acceptable limits; they exceed industry-standard thresholds and the structure should be considered actively moving/settling in areas where deflection failures are occurring. See the report's overall conclusion for a complete understanding of the overall foundation stabilization issue.

To stabilize and lift the foundation, install and/or adjust perimeter and interior piles/piers as shown in the attached Exhibit A - Proposed Repair Plan. The underpinning may be concrete cylinders, steel pipe, helical screws, or drilled concrete piers – refer to Exhibits D, E, F, and G. Underpinning will not improve the performance of the foundation in non-underpinned areas. Note, any foundation movement, even corrective, can cause additional cosmetic distress. The contractor shall determine the amount of elevation correction needed based on the reaction of the structure during the adjustment in order to minimize stress and additional cosmetic damages.

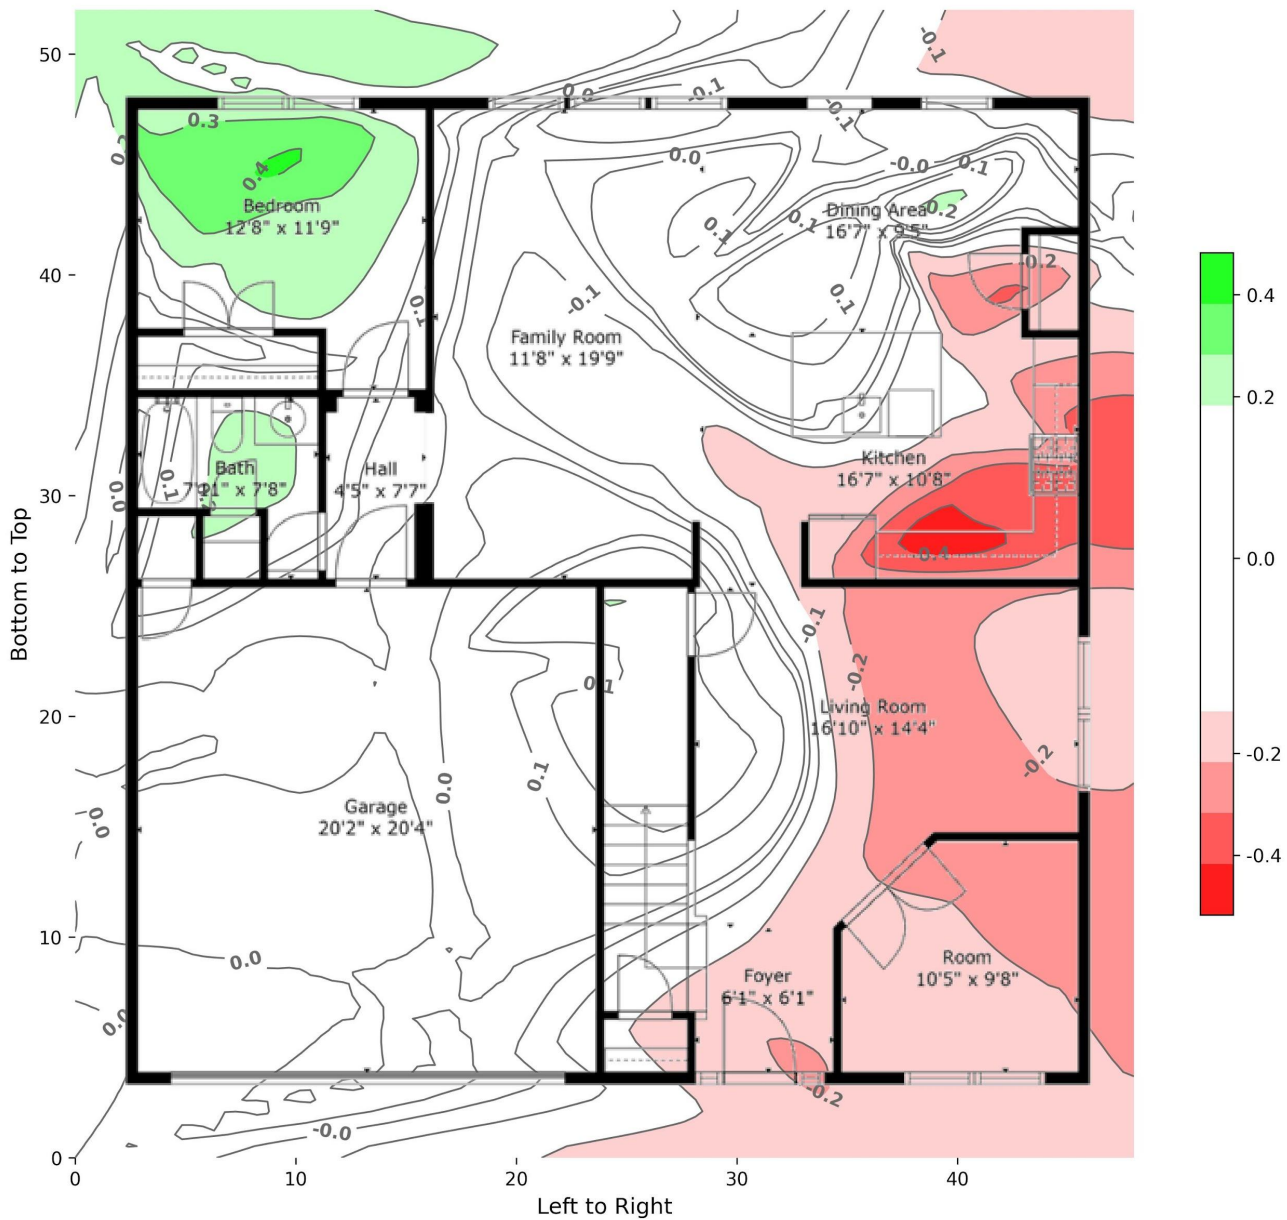
Elevation Plot Difference Graphic (Figure F)

A previous elevation plot completed in 2022 was available to use as a baseline of movement progression. Elevation differences are shown that show us the clear progression of movement from one date to another. As part of this evaluation, a contour mesh showing the elevation differences between the current contour mesh and the baseline was processed and is shown below.

The mesh contour graphic above in Figure F shows areas in red that are lower than the baseline elevation plot and areas of green that are higher than the baseline elevation plot (from the provided drawing completed in 2022). The darker the color (both red and green) the larger/smaller the elevation differences.
