Engineer's Damaged Truss/Timber Evaluation

On 11/12/2025 a Damaged Truss Evaluation (DTE) was performed at the property located at address 123 Main St, Your City, FL, 12345, which consists of a 2600 square-foot single family no garage structure built in 2007 with a truss roof framing.

Exhibit A - Damaged Area 1 (Damaged King Post)

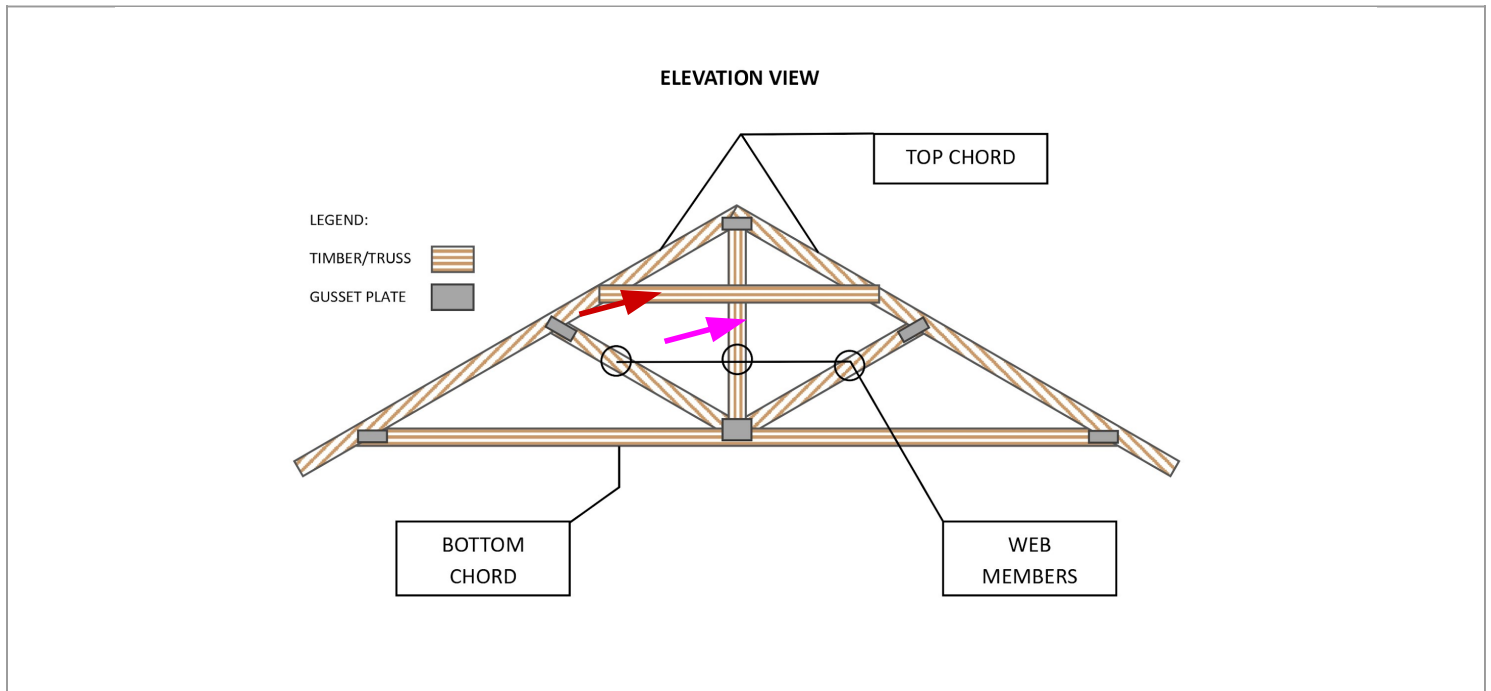
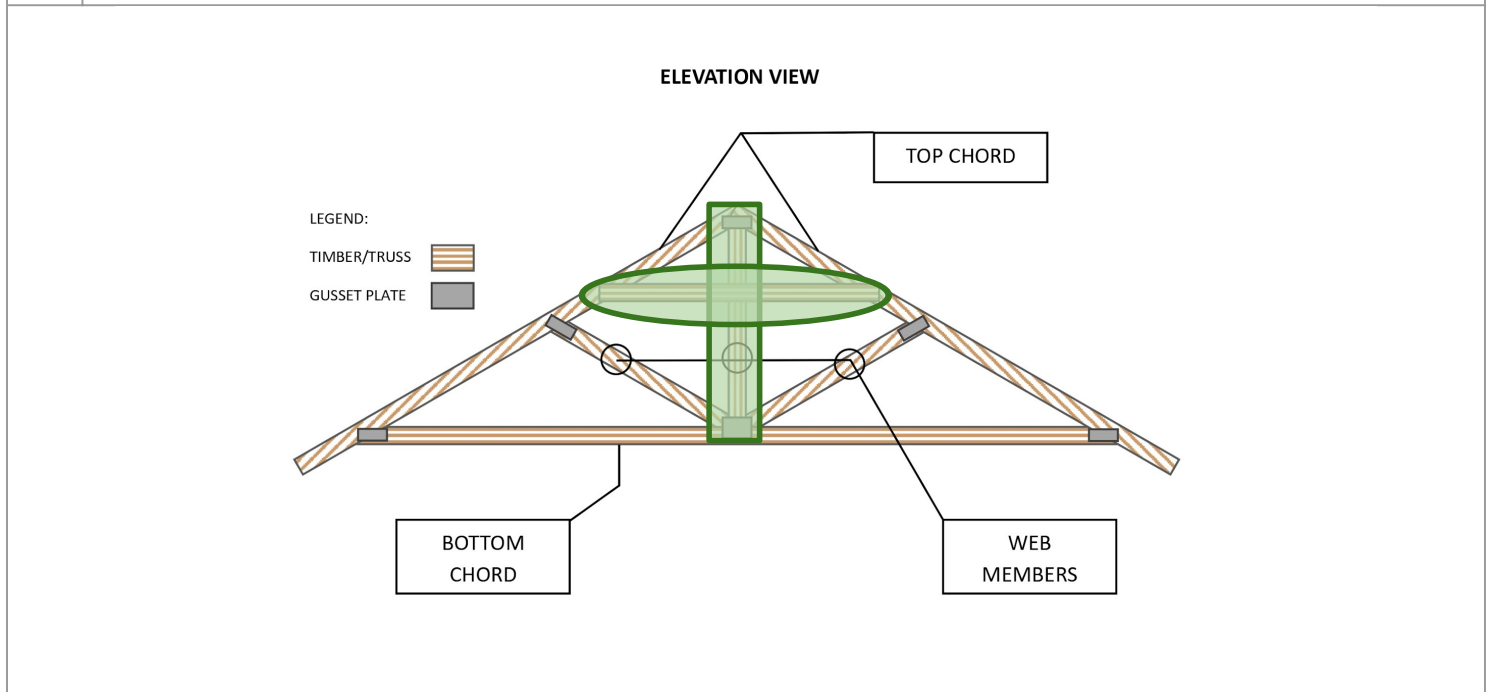
Member Deflecting/Bowing: We agree with the findings of the inspection report that the observed bowing of the king post of two truss members should be considered significant (See Exhibit A). The affected members exhibit noticeable bowing along their span, suggesting overstress, insufficient lateral restraint, or deformation due to sustained loading or moisture-related movement. The deflection indicates localized loss of stiffness and potential redistribution of loads within the truss system. While the overall roof structure remains generally intact, the bowed members may have a reduced capacity to maintain proper alignment and resist design loads.

Replacement of Member: For timber or truss member/s showing signs of deflection or bowing, remove the affected member/s and replace it with new dimensional lumber of the same grade and species, but constructed as a triple-laminated member (three 2x members fastened together) for increased capacity (see Exhibit B). Cut the replacement member/s to match the existing configuration and ensure tight bearing at connection points. Secure the new member/s using approved truss plates, gusset plates, or structural screws/bolts consistent with industry standards and truss repair guidelines. Verify that all connections are tight and properly aligned to maintain the original configuration and load path. Add collar ties as necessary, confirming proper connection to the king post, and fasten each collar tie using four (4) 10d common framing nails installed in a standard rectangular pattern, with two nails per row and two rows.
