# MERIT PROPERTY INSPECTIONS

## PROPERTY INSPECTION REPORT COPY

1234 Main St  
Tampa, FL 12345

06/11/2026

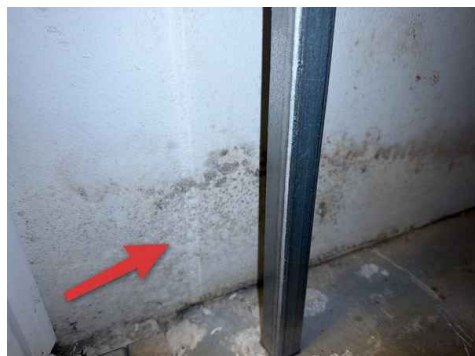
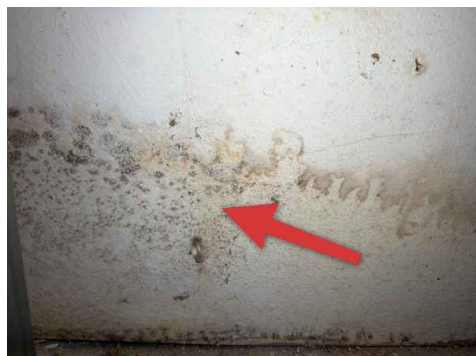
Observed signs of **suspected mold** (discoloration, mold odor, mold spots, etc.) in one or more areas of the wall. Recommend mold inspector identifying source of moisture intrusion and possibly sending samples to a lab for testing.

Contact a qualified mold inspection professional.

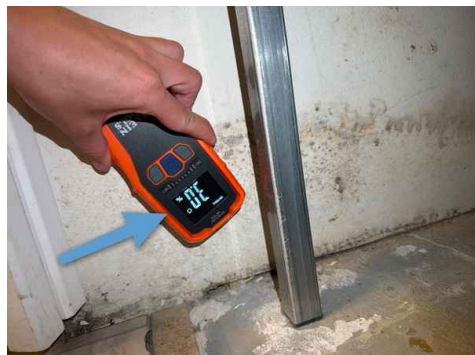
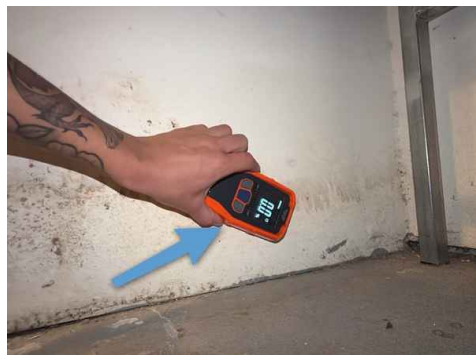
#### 2.5.2 E. Walls (Interior and Exterior)

### DRY WATER STAIN OBSERVED

A stain on the wall is present. This stain did not appear damp and could be from a previously resolved water leak. Recommend repainting and monitoring to address as necessary.

Contact a qualified painting contractor.

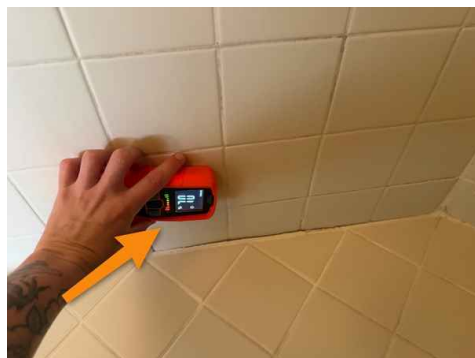
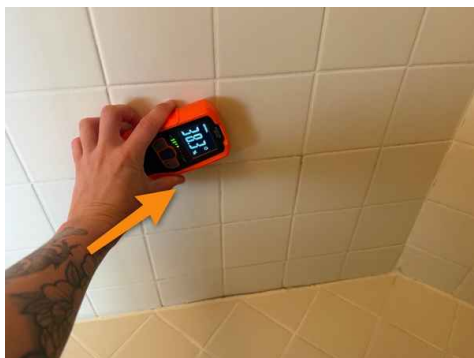
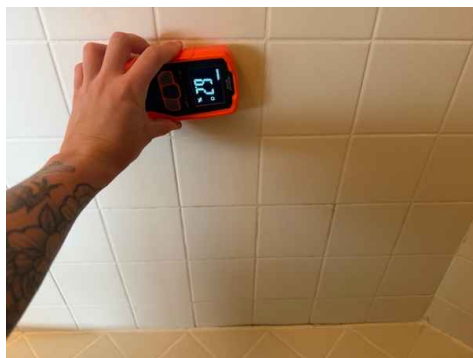
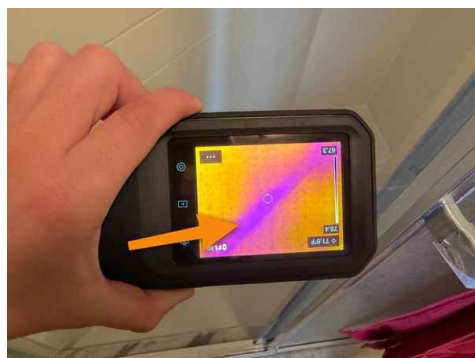
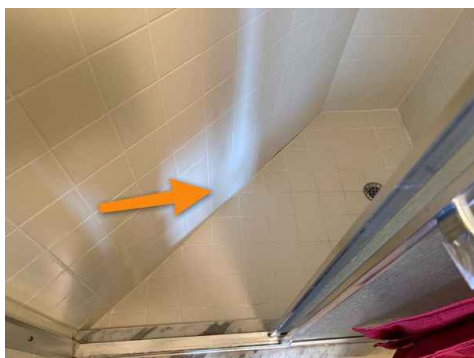
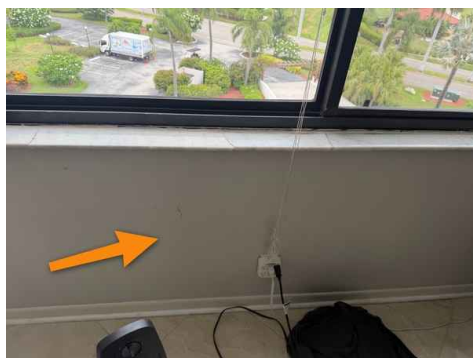
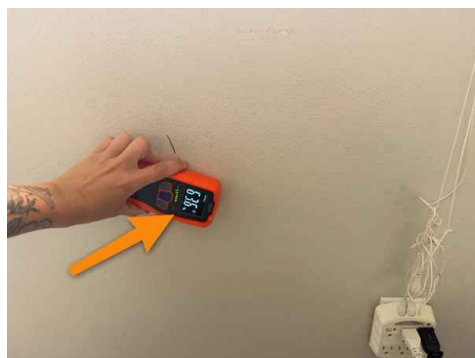
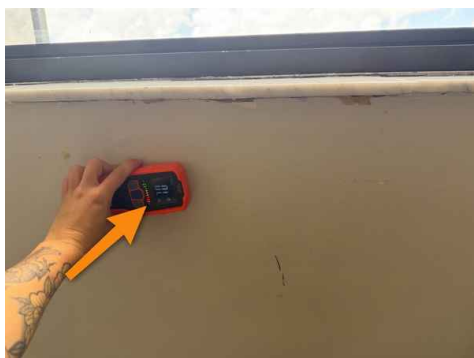
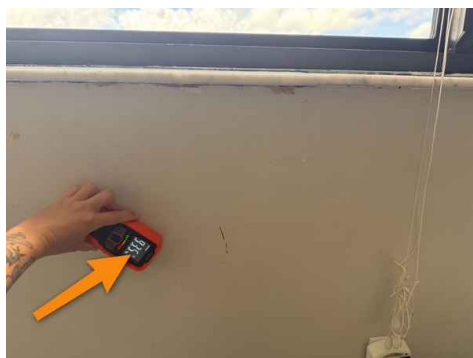
#### 2.5.3 E. Walls (Interior and Exterior)

### HIGH LEVELS OF MOISTURE PRESENT

**There are high level areas of moisture present on this wall.** This was identified by signs of water intrusion (separation of baseboards, cracks, or moisture staining).

While relative humidity can have some effect on moisture levels, drywall is considered to have an appropriate level of moisture if it has a moisture content of between 5% and 12%.

Moisture readings in this area are higher than normal indicating active or previous water intrusion. Prolonged moisture conditions can contribute to concealed damage and potential microbial growth. The source and full extent of the moisture intrusion could not be determined during this inspection. Recommend a qualified professional identifying the source of moisture intrusion, and a mold remediation be performed if mold is present.

Contact a qualified mold remediation contractor

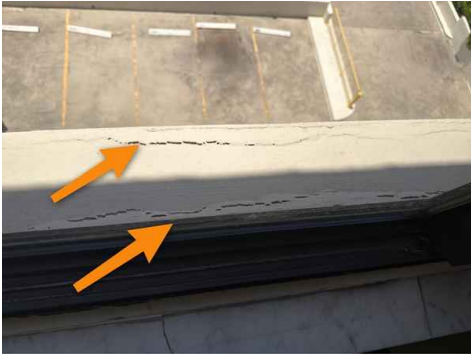
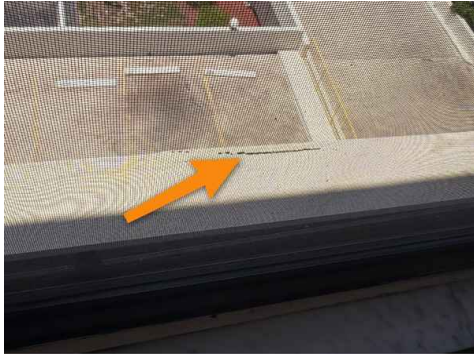
## 2.5.4 E. Walls (Interior and Exterior)

Significant cracking was observed in the exterior stucco wall covering. Elevated moisture readings were detected on the interior side of the affected wall, indicating possible moisture intrusion through the cracked exterior surface. Prolonged moisture exposure may result in deterioration of building materials and can create conditions conducive to microbial growth. The extent of any concealed damage could not be determined during the inspection. Recommend evaluation and repair by a qualified stucco contractor or building envelope specialist to address the cracking and moisture intrusion.

Contact a stucco repair contractor

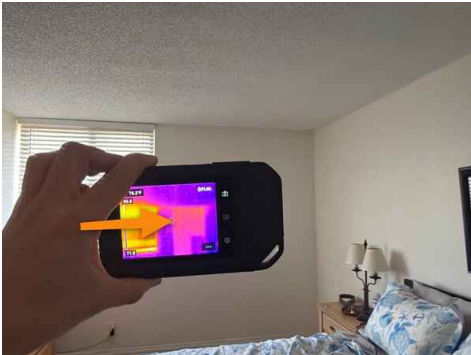
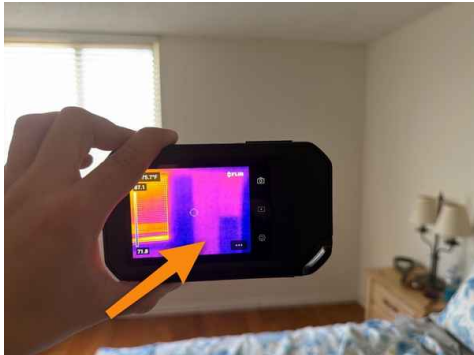
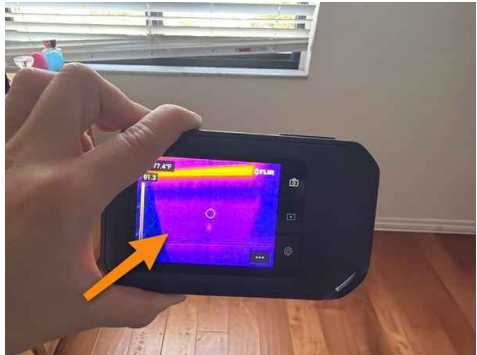
2.5.5 E. Walls (Interior and Exterior)

There is a hot or cold spot that is showing in the thermal imagery scan that was performed. This is typically caused by a lack of insulation in the walls. This can also be caused by a settling of blown-in or batt insulation in the walls of older structures. Wall areas missing insulation can be more difficult to remedy because of access limitations. Some spots may be permanent inefficiencies because of the cost/benefit in trying to remedy the issue. Recommend further investigation by an insulation contractor or an HVAC specialist.

Contact a qualified insulation contractor.

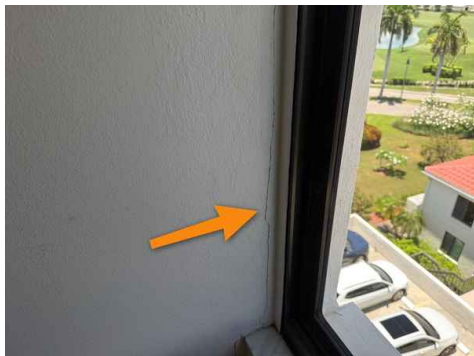
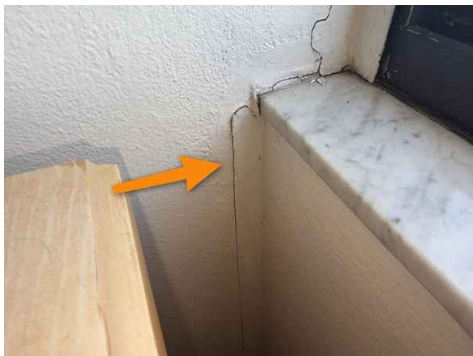
2.5.6 E. Walls (Interior and Exterior)

**MINOR INTERIOR CRACKS**

Minor cracks were observed in interior wall surfaces. These are commonly associated with normal settling or minor movement. Recommend monitoring for changes and repair as needed.

Contact a qualified drywall contractor.

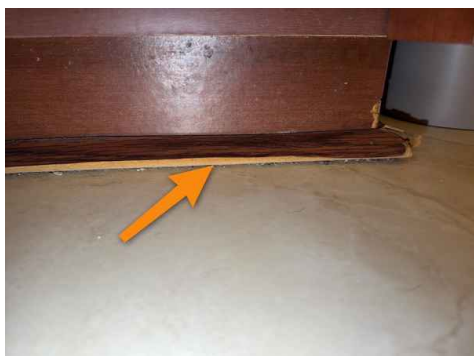
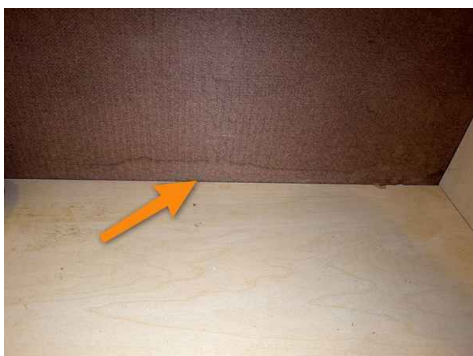
#### 2.5.7 E. Walls (Interior and Exterior)

### CABINET- EVIDENCE OF WATER DAMAGE

Evidence of water damage and staining was observed within the cabinet. The condition indicates moisture exposure and may be associated with leakage from plumbing fixtures or components. No leak observed at time of inspection. Recommend monitoring and repairing damaged materials as needed.

Contact a qualified cabinet contractor.

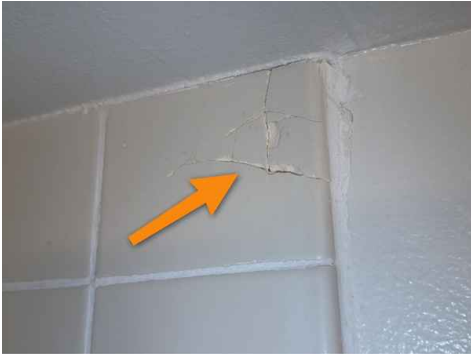
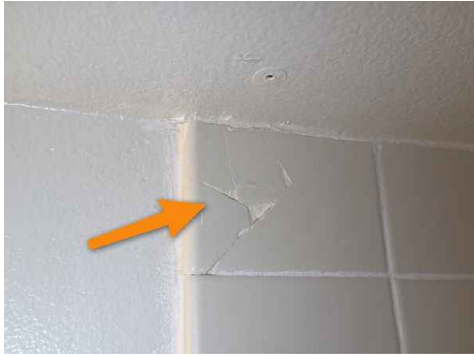
#### 2.5.8 E. Walls (Interior and Exterior)

### DAMAGED SHOWER WALL TILE

Damage was observed to the shower wall tile near the ceiling. Damaged tile surfaces may allow moisture to penetrate behind the finished wall covering, potentially leading to deterioration of underlying materials. Recommend repair or replacement of the affected tile by a qualified contractor to help prevent moisture intrusion.

Contact a qualified tile contractor

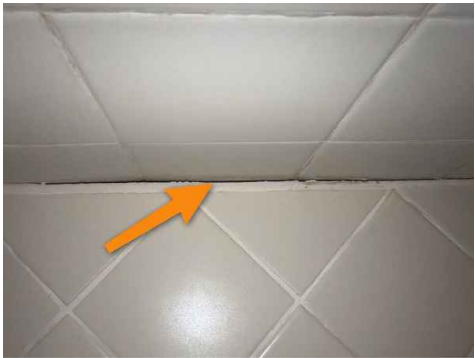
2.5.9 E. Walls (Interior and Exterior)

Separation and gaps were observed at the shower wall seam. This condition may allow water to penetrate behind the finished surfaces, resulting in moisture intrusion and wicking into adjacent wall materials. Prolonged moisture exposure can contribute to deterioration of building materials and create conditions conducive to microbial growth. The extent of any concealed damage could not be determined during the inspection. Recommend further evaluation of any moisture-related damage by a qualified professional and repairs as needed.

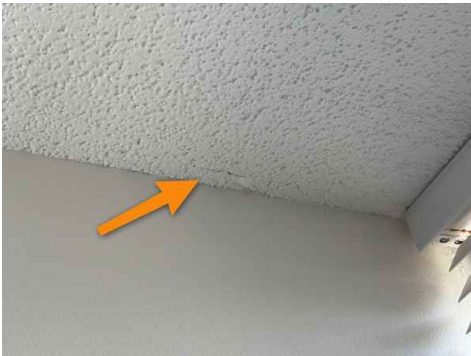
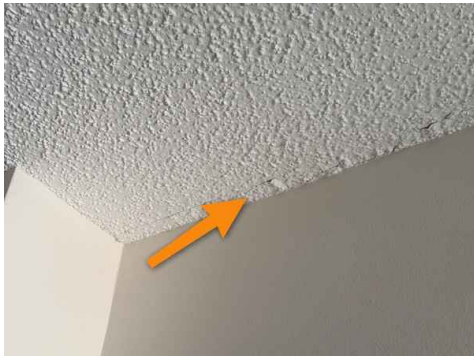
2.6.1 F. Ceilings and Floors

**CEILING - SHEETROCK CRACKS MINOR**

Minor sheetrock cracking was observed on the ceiling. This is common in structures this age and is often determined to be cosmetic, most often the separation of drywall tape joints. Recommend patching, repainting, monitoring these locations for further cracking.

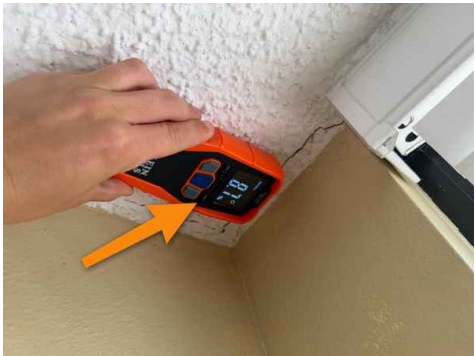
Dining- no elevated levels of moisture

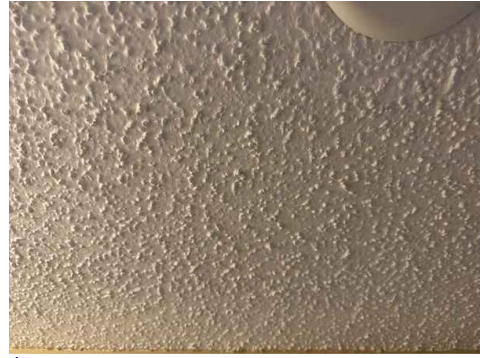
Areas of the structure have popcorn textured ceilings. This texture most likely contains asbestos. Asbestos was the material of choice for popcorn ceilings until the substance was banned as a health hazard in 1978. Manufacturers switched to paper fiber that year, but suppliers continued to sell existing stores of asbestos-laced material. That means that popcorn ceilings installed as late as the mid-'80s could contain asbestos.

The ceiling will not endanger your health as long as it remains completely undisturbed or properly encapsulated with paint. Popcorn ceiling can be tested for asbestos by carefully scraping a small sample into a plastic bag and having it tested at an EPA-accredited lab.

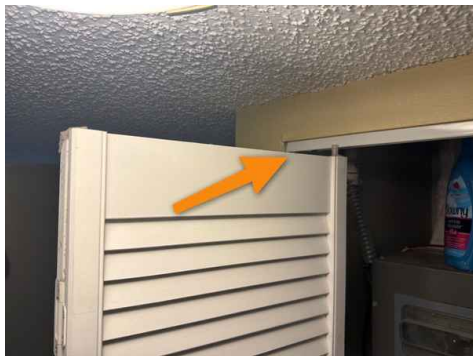
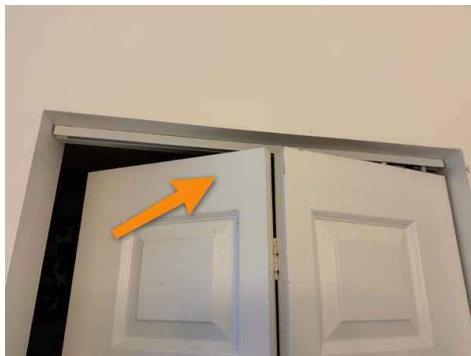
The door is not sliding on it's tracks / rails correctly or is off the tracks completely. Recommend a contractor evaluate and reinstall correctly.

Contact a qualified door repair/installation contractor.

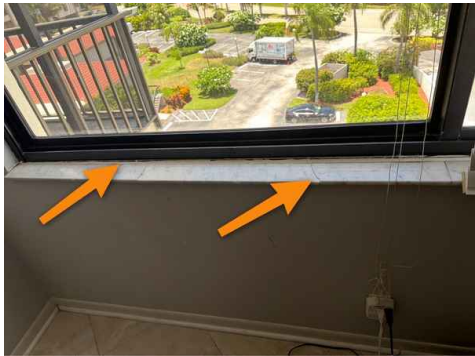
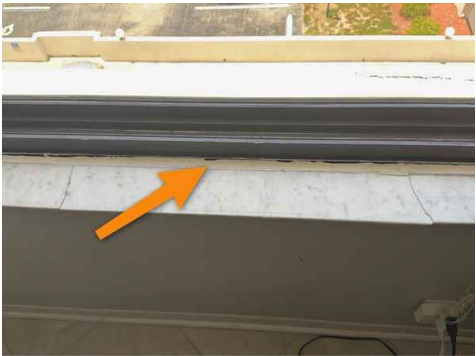
### 2.9.1 H. Windows

#### WINDOW SILL CRACKING / SEPARATION

Cracking and separation were observed at the window sill and adjacent finishes. The condition appears consistent with movement of the building materials and/or differential movement between the window assembly and surrounding wall surfaces. These openings may permit moisture intrusion and can worsen over time. Recommend repair of the affected areas by a qualified contractor and monitoring.

Contact a qualified general contractor.

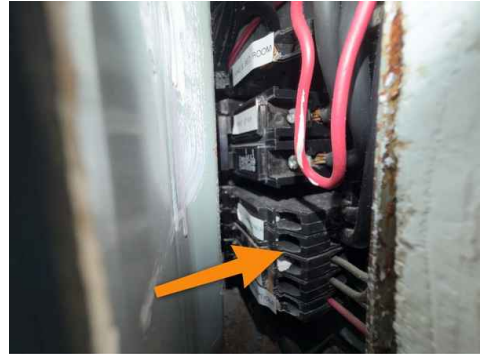
**PANEL MISSING AFCI BREAKERS**

AFCI (Arc-Fault Circuit Interrupter) protection was not installed at applicable branch circuits. Modern safety standards recommend AFCI protection to reduce the risk of electrical fires caused by arc faults. Homes constructed prior to adoption of the 2008 NEC AFCI requirements may not be required to have this protection and are generally considered grandfathered under the standards in place at the time of construction. Upgrades can improve safety and should be discussed with a qualified electrician.

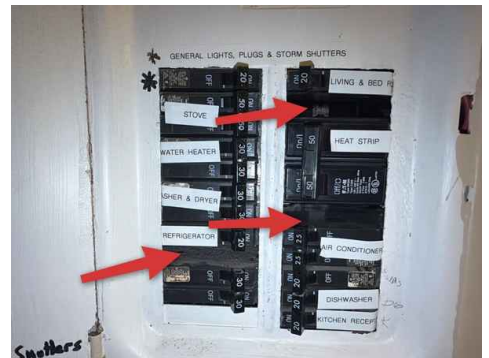
## 3.1.2 A. Service Entrance and Panels

**MISSING BREAKER FILLER PLATES**

Breaker filler plates are missing from the breaker panel. Without filler plates, fingers can fit through the slit creating a safety hazard.

Recommend installing the filler plates or contacting an electrician who can install them.

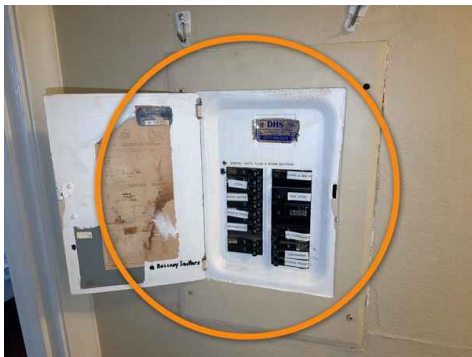
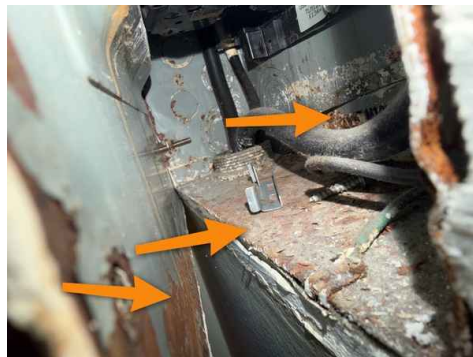
## 3.1.3 A. Service Entrance and Panels

The electrical panel appears to be nearing the end of its typical service lifespan based on observed age and condition. Corrosion observed. While functional at the time of inspection, older electrical panels may become less reliable over time and could benefit from further evaluation, maintenance, or replacement by a qualified electrician.

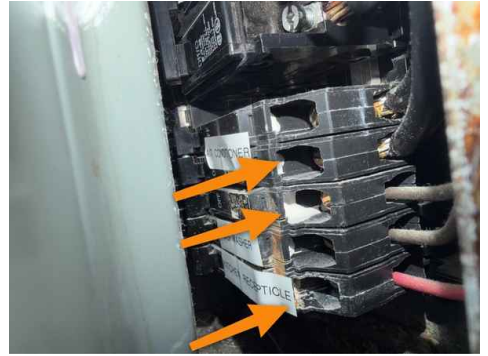
## 3.1.4 A. Service Entrance and Panels

**MINERAL DEPOSITS OBSERVED IN ELECTRICAL PANEL**

White mineral deposits were observed near the circuit breakers, suggesting possible past or ongoing moisture intrusion. Recommend evaluation by a qualified licensed electrician and correction as needed.

Contact a qualified electrical contractor.

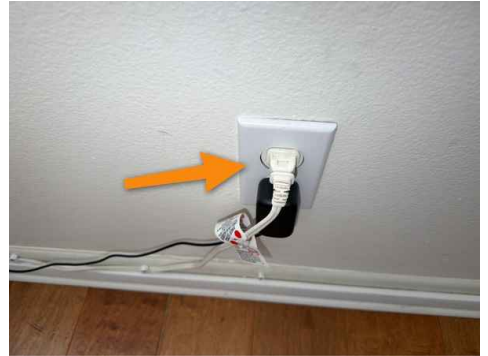
## 3.2.1 B. Branch Circuits, Connected Devices, and Fixtures

**OUTLET - LOOSE AND NOT SECURE**

An outlet is loose and not securely fastened to the gang-box and/or the structure behind the sheetrock. Loose outlets will become worse over time as contact points start to wear down and wires bend back and forth. Loose outlets can eventually lead to broken wires, dead circuits, flickering lights, or other electrical problems (including electrical fire). Recommend an electrical contractor tighten the outlet so it does not move.

Contact a qualified electrical contractor.

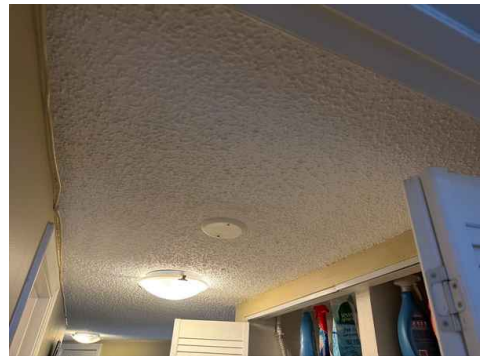
## 3.3.1 C. Low Voltage &amp; Other

**SMOKE ALARM - MISSING**

Smoke alarm/detector is missing. It is recommended that smoke alarms be installed inside each bedroom, outside each sleeping area and on every level of the structure. On levels without bedrooms, it is recommended that alarms be installed in the living room (or den or family room) or near the stairway to the upper level, or in both locations. Recommend installation of fire alarm.

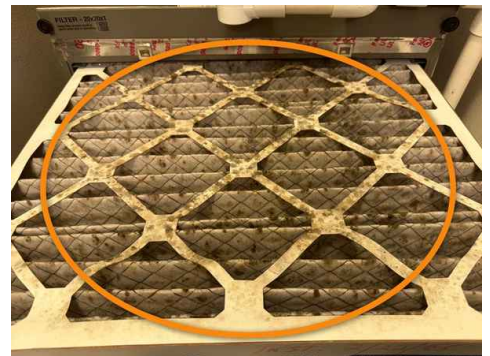
**FILTER REQUIRES REPLACEMENT**

The HVAC filter appears to be beyond its expected lifespan. Recommend replacement. Do it yourself or hire an HVAC/Handyman Contractor.

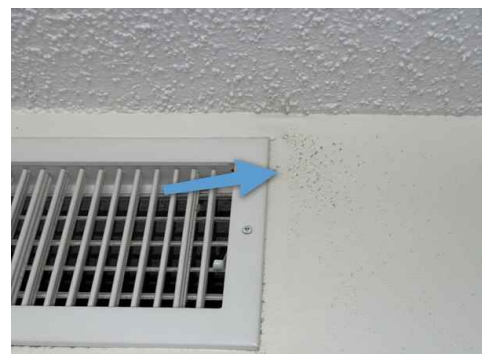
## 4.3.2 C. Duct Systems, Chases, and Vents

**DUCT CLEANING IS RECOMMENDED**

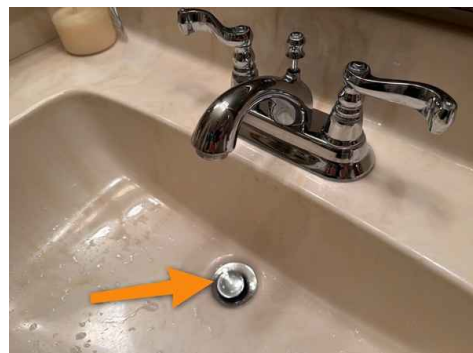
The faucet drain pull is not functioning properly and is jammed. Recommend plumbing contractor to resolve issue.

Contact a qualified plumbing contractor.

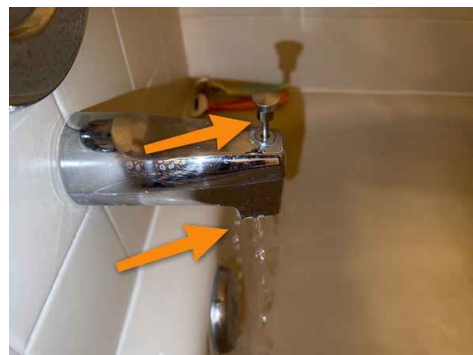
### 5.1.2 A. Plumbing Supply, Distribution Systems, and Fixtures

The tub spout divert is not fully diverting water to the shower. A leaking and/or broken shower diverter wastes water and creates a lower-pressure shower experience. Recommend consulting a plumbing contractor.

Contact a qualified plumbing contractor.

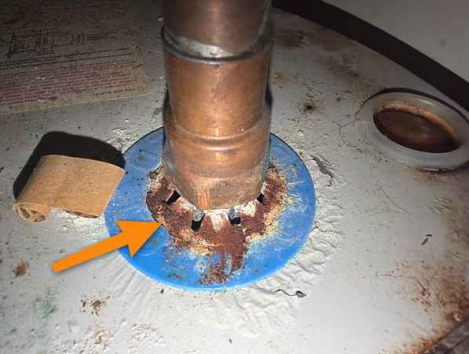
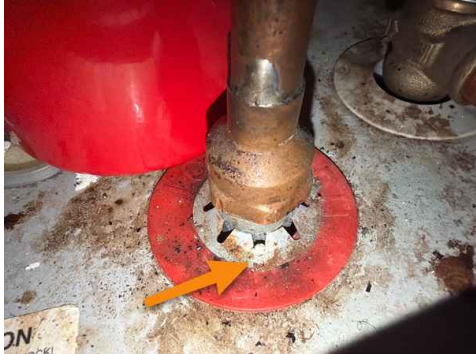
### 5.3.1 C. Water Heating Equipment

#### CORROSION AT PIPE CONNECTORS

Corrosion and mineral deposits were observed at the water heater plumbing connection. This condition is typically associated with past or ongoing moisture exposure and may indicate leakage at the connection. Continued deterioration can lead to water damage and premature failure of the affected components. Recommend evaluation and repair by a qualified plumbing contractor, with replacement of deteriorated components as necessary.

Contact a qualified plumbing contractor.

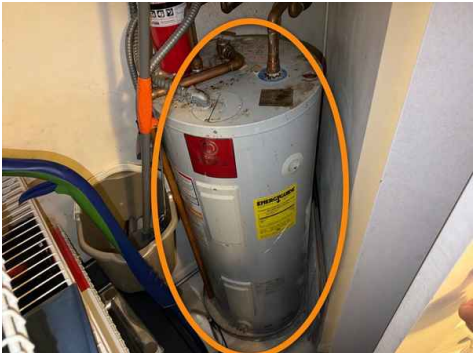
5.3.2 C. Water Heating Equipment

The water heater has reached the end of its expected useful life based on age. Typical residential water heaters have a service life of approximately 8 to 12 years, and this unit appears to be at or beyond that range. The current age warrants consideration of replacement in the near term and/or budgeting for replacement.

Contact a qualified plumbing contractor.

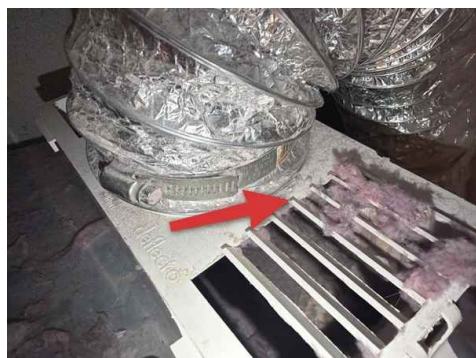
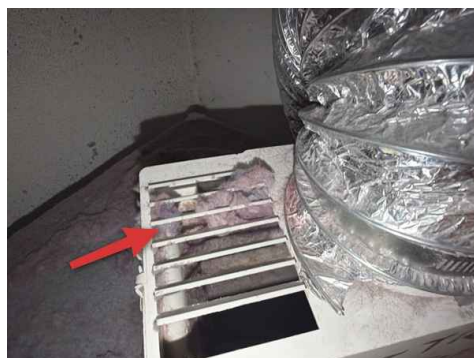
The dryer vent is dirty and may be partially clogged. Consider cleaning the vent prior to use to prevent the buildup of debris and possible fire hazard.
