## SUMMARY

1234 Main Street Tampa FL 33611

Buyer Name  
06/13/2026 9:00AM

Abby Bullock  
Professional Home Inspector  
Merit Property Inspections  
(813)-485-4335  
[info@meritinspects.com](mailto:info@meritinspects.com)

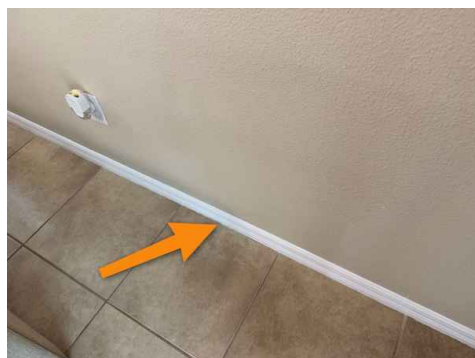
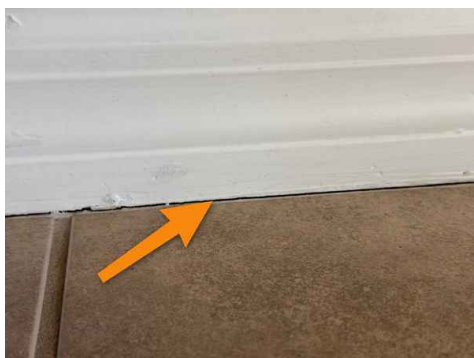
#### AREAS OF TRIM/BASEBOARDS ARE SEPARATING

Areas in the structure are showing separation. Separation of trim/baseboards are primarily considered cosmetic and can be resolved by sanding, recaulking, and/or re-painting. That said, these finish areas are some of the most sensitive areas of the home and susceptible to small changes in movement of the foundation and framing. These types of separations are the first signs of foundation issues and should be monitored. The best way to monitor for future separation is to fix these problems professionally and monitor the areas for reappearing.

Contact a qualified carpenter.

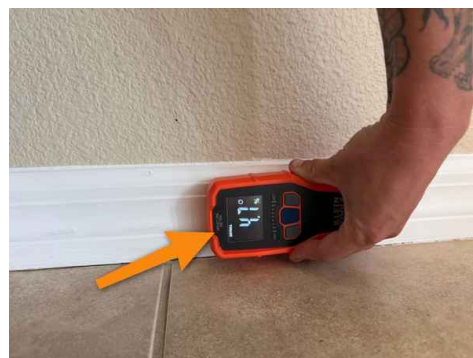
No elevated levels of moisture present

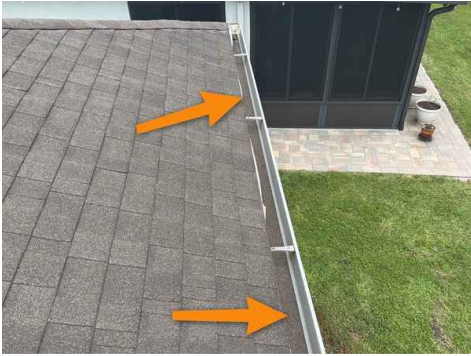
Back

#### GUTTERS ARE FULL

The gutters are full of debris. Recommend removal for functional use of gutters.

Contact a handyman or DIY project

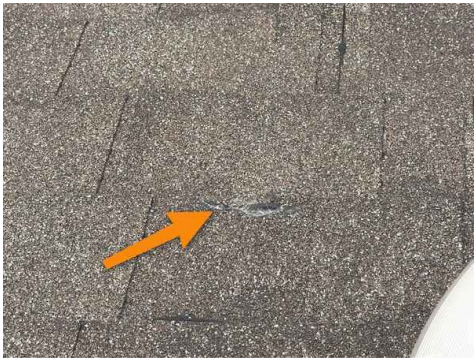
Left

2.3.1 C. Roof Covering Materials  
**DAMAGED COVERINGS/SCUFFING**

Roof coverings exhibited general damage and/or scuffing that could affect performance. Recommend a qualified roofer evaluate and repair.

Recommendation  
Contact a qualified roofing professional.

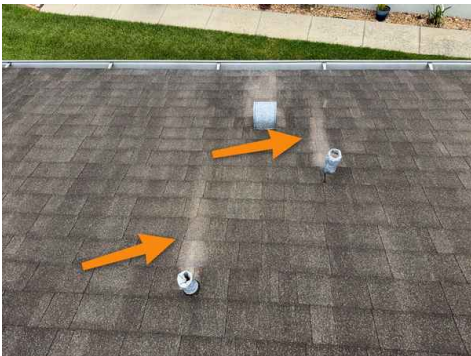
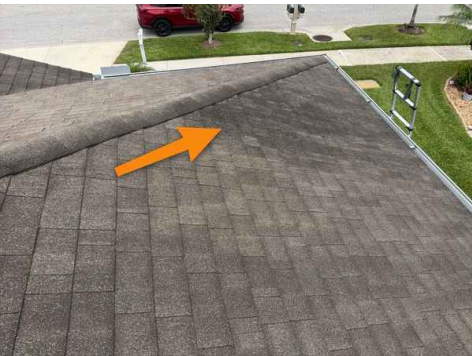
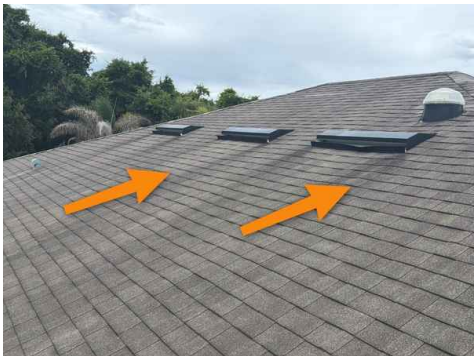
2.3.2 C. Roof Covering Materials  
**DISCOLORATION**

Roof coverings were discolored, which can be caused by moisture or weathering. Recommend a qualified roofing contractor evaluate and remedy with a roof cleaning or repair.

Recommendation  
Contact a qualified roofing professional.

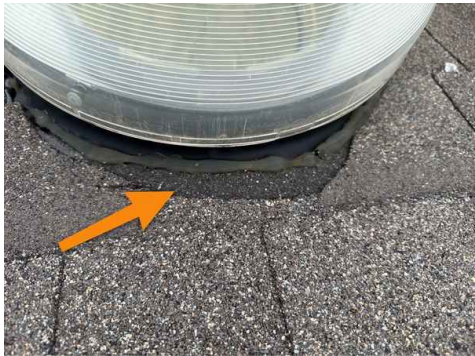
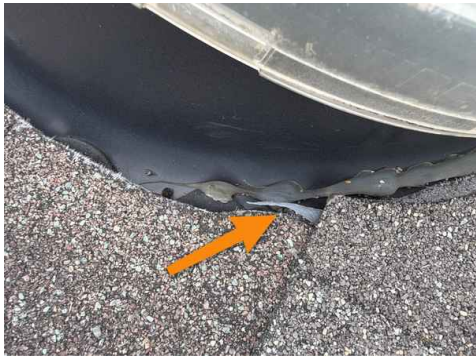
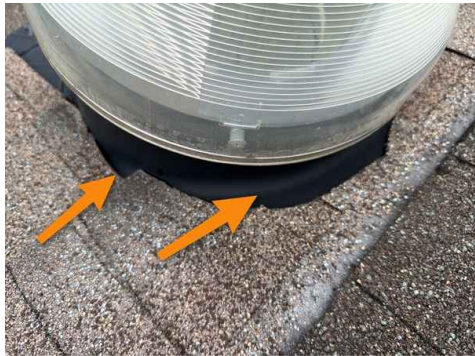
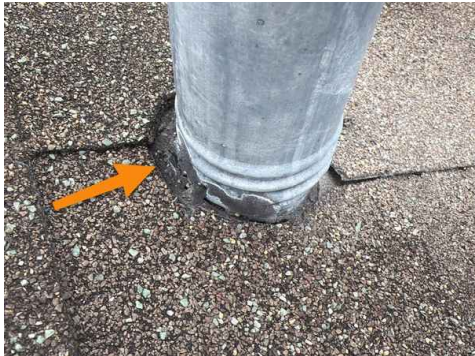
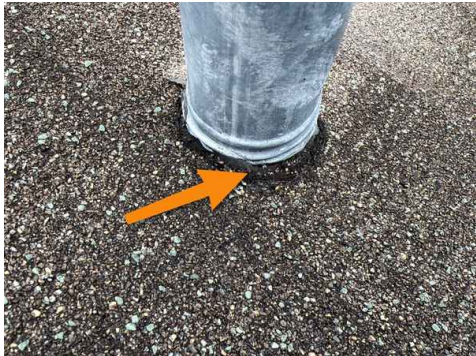
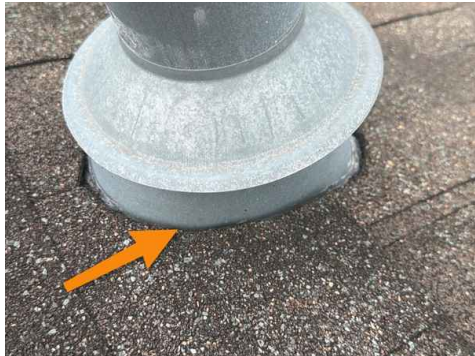
2.3.3 C. Roof Covering Materials  
**INSUFFICIENT COVERINGS / SEALING AT ROOF PENETRATIONS**

Observed areas that appeared to be missing sufficient coverings and sealant at roof penetrations. Recommend qualified roofing contractor evaluate & repair.

Recommendation  
Contact a qualified roofing professional.

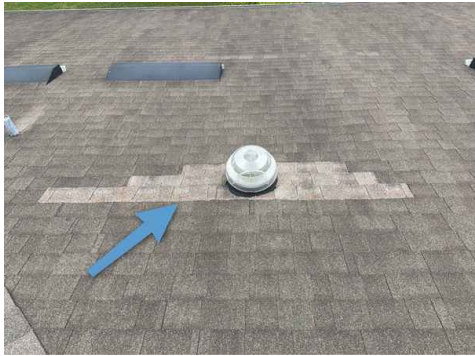
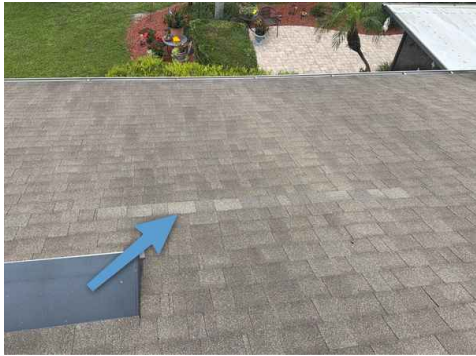
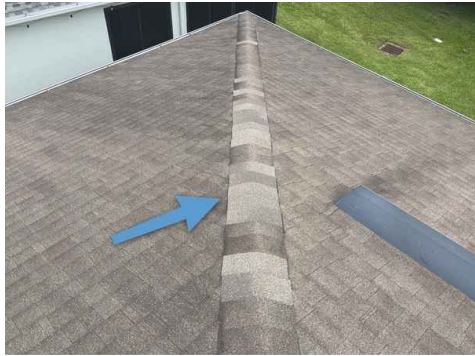
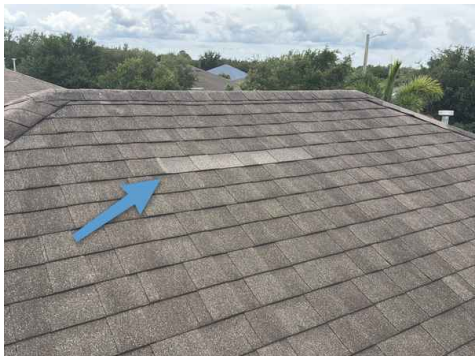
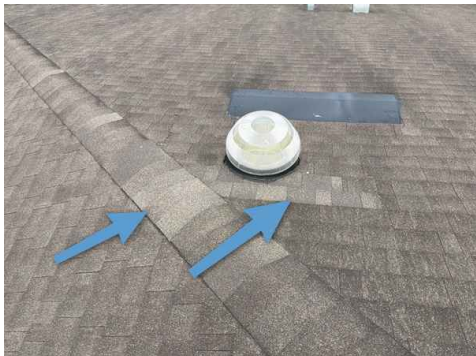
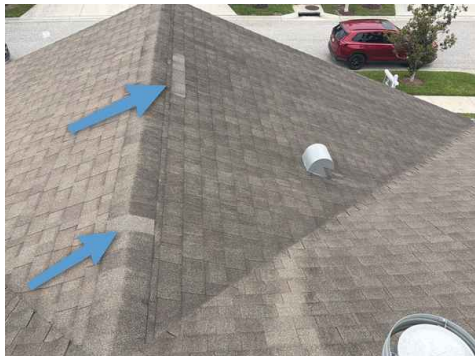
**ROOF PATCH**

A roof patch was discovered and should be monitored for future leaks.

Recommendation  
Recommend monitoring.

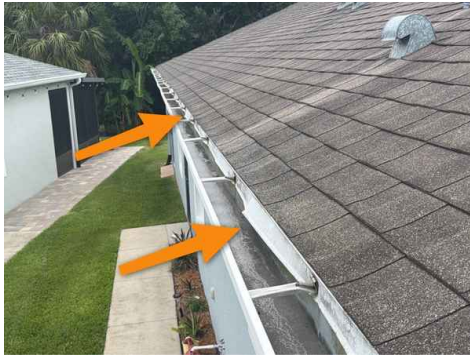
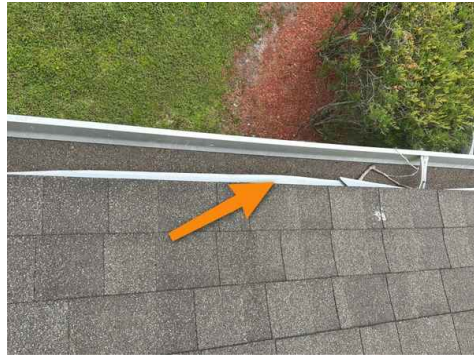
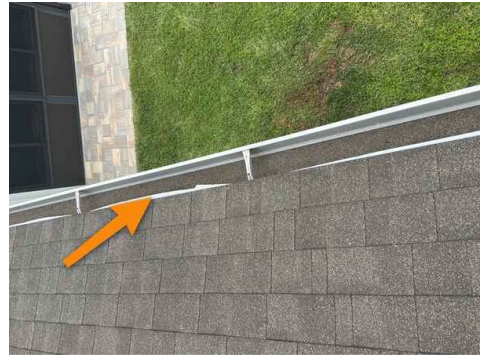
**LIFTED / SEPARATED FLASHING**

Areas of the roof show lifted or separated flashing areas. These areas will not seal with the lower shingle areas or siding and can allow for water intrusion. Recommend a roofing contractor to replace.

Contact a qualified roofing professional.

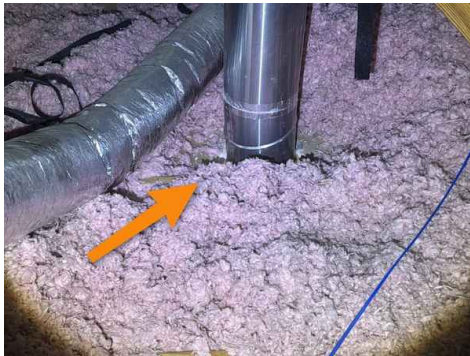
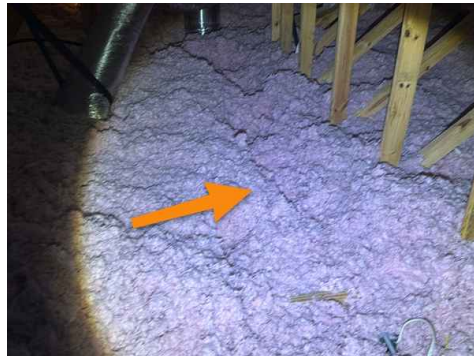
**INSULATION IS UNEVENLY DISTRIBUTED**

Insulation in the attic unevenly distributed and not smooth / even across the attic surface. This is common in older structures where attic insulation has been moved for repairs and installations. Insulation that is not smooth and even across the attic surface will be less efficient and will be unable to create a thermal barrier as intended. Recommend a insulation contractor smooth the insulation and/or install new insulation in areas of the attic, as necessary.

Contact a qualified insulation contractor.

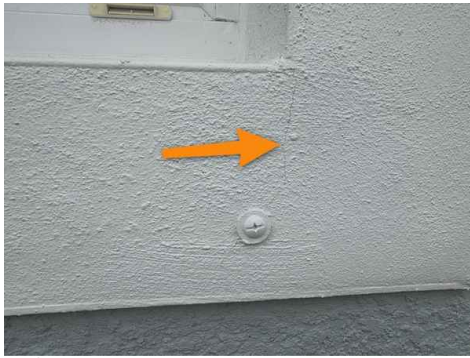
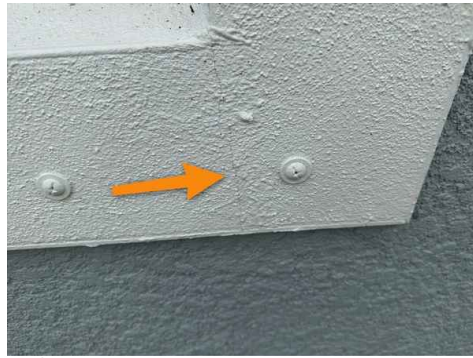
**MINOR STUCCO CRACKS**

Cracks were observed in the exterior stucco. **These openings can allow for moisture intrusion** and should be sealed with a compatible elastomeric sealant and repainted as needed. Recommend repair by a qualified stucco contractor to help prevent damage.

Contact a stucco repair contractor

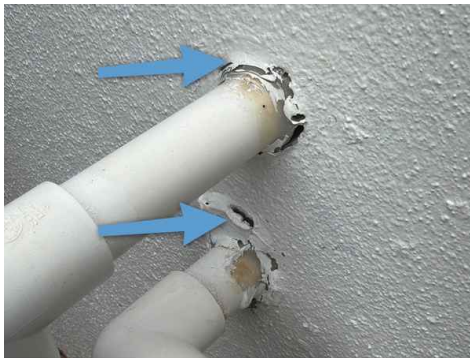
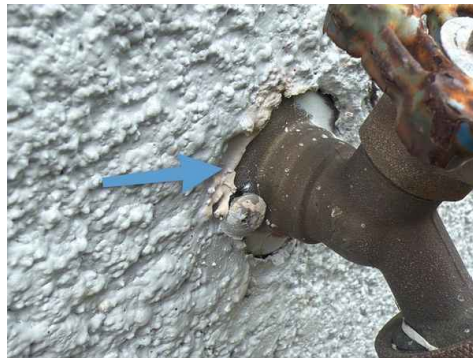
#### CAULKING DETERIORATED AND/OR MISSING

Caulking is necessary to seal gaps less than 1/2-inch. Caulking that is missing can provide for water penetration and allow insect access into the structure.

Contact a qualified general contractor.

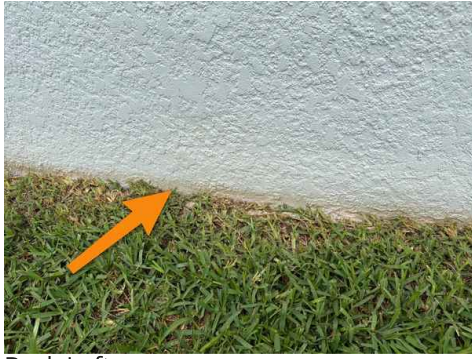
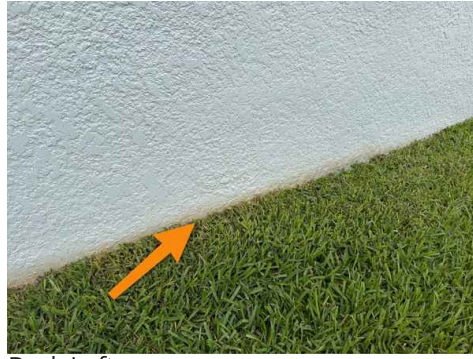
#### DISCOLORATION AT STUCCO EXTERIOR

Discoloration was observed at the exterior stucco wall covering near grade level. The discoloration is consistent with moisture exposure, organic growth, or accumulation of dirt and debris. While the full extent and cause could not be determined during the inspection, prolonged moisture exposure may contribute to deterioration of exterior finishes over time. Recommend monitoring and further evaluation if conditions worsen or moisture intrusion is suspected.

Contact a stucco repair contractor

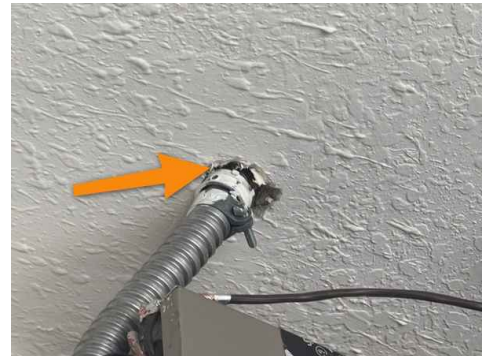
Garage

#### CEILING - UNSEALED PENETRATION POINT

The garage ceiling was observed without fire-rated sealant at the ceiling penetration. Openings in the garage ceiling can allow smoke and fire to spread into the living space above and reduce the effectiveness of the fire separation. Recommend sealing the penetration with approved fire-rated sealant by a qualified contractor.

Contact a qualified fire suppression contractor.

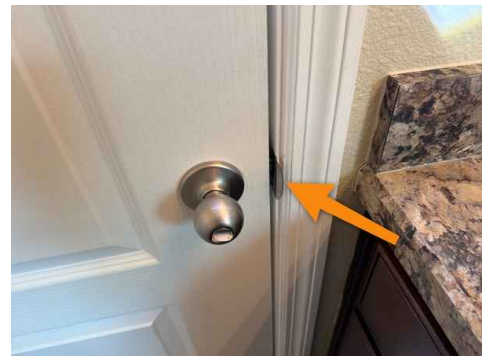
Hall Bathroom

#### DOOR DOESN'T LATCH TO CLOSE

Door doesn't latch to close properly. Recommend handyman repair door, latch, frame, and/or strike plate.

Contact a qualified handyman.

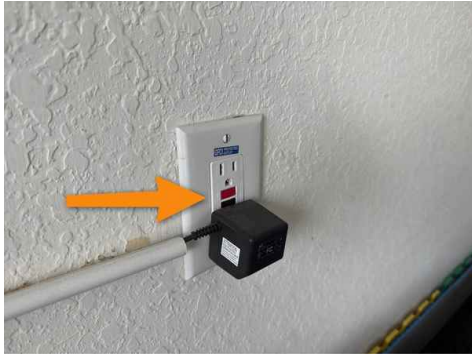
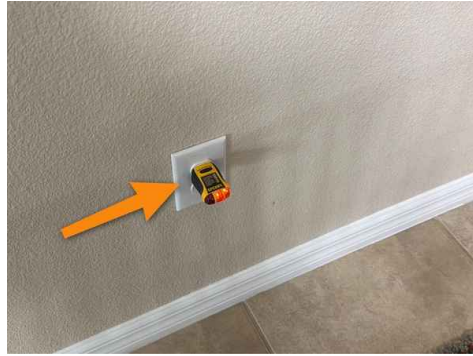
#### OUTLET - LOOSE AND NOT SECURE

An outlet is loose and not securely fastened to the gang-box and/or the structure behind the sheetrock. Loose outlets will become worse over time as contact points start to wear down and wires bend back and forth. Loose outlets can eventually lead to broken wires, dead circuits, flickering lights, or other electrical problems (including electrical fire). Recommend an electrical contractor tighten the outlet so it does not move.

Contact a qualified electrical contractor.

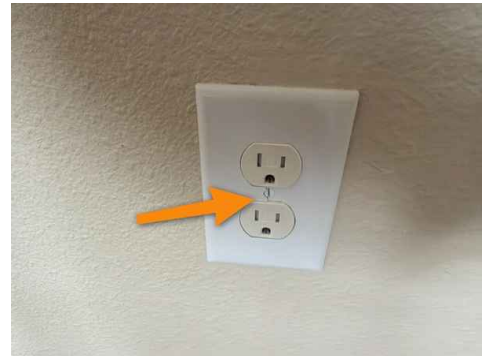
1st Bedroom

#### COVER PLATE IS DAMAGED

Electrical receptacle plate is damaged. This may cause short and shock risk over time. Recommend replacement of the damaged or missing cover plate.

Contact a qualified electrical contractor.

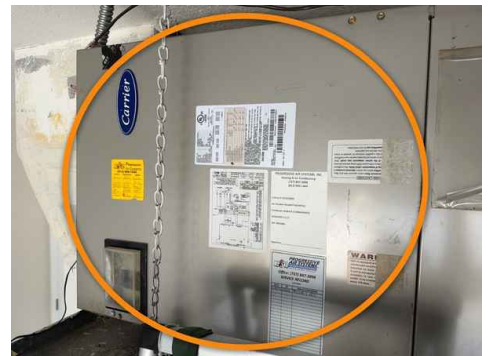
Garage

#### HEATING EQUIPMENT NEARING END OF ITS USEFUL LIFE

The heating equipment is nearing the end of its expected service life. It is anticipated that the equipment will need to be replaced within the next five (5) years.

Contact a qualified HVAC professional.

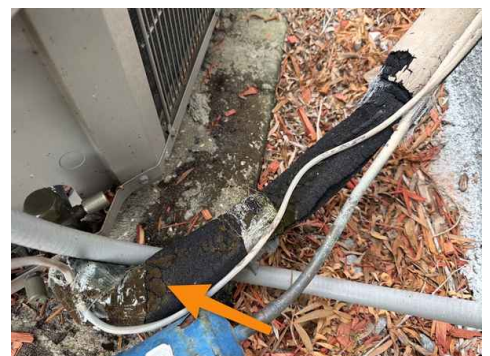
Back

#### CONDENSER - FREON INSULATION MISSING OR DAMAGED

Missing or damaged insulation on the refrigerant line can cause energy loss and condensation. Recommend contacting an HVAC professional to replace the missing or damaged insulation.

Contact a qualified HVAC professional.

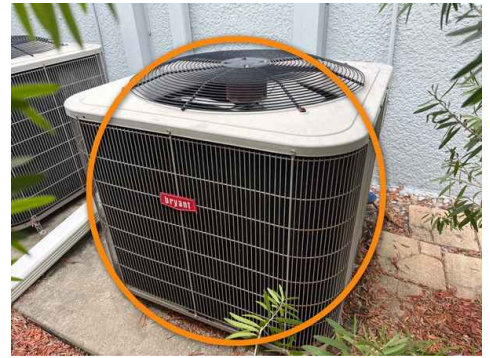
Back

**CONDENSER - COOLING SYSTEM  
NEARING END OF ITS USEFUL LIFE**

The condenser (outdoor unit) cooling equipment is nearing the end of its expected service life. It is anticipated that the equipment will need to be replaced within the next five (5) years.

Contact a qualified HVAC professional.

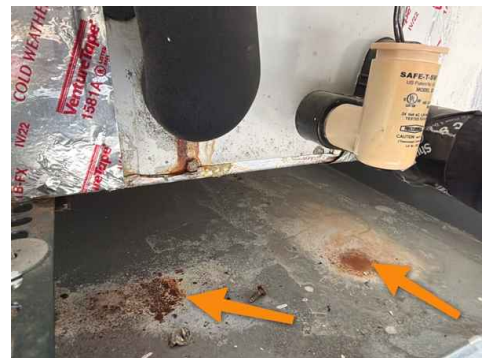
Garage

**EVAPORATOR - RUST PRESENT IN PAN**

Rust is present in the cooling system emergency overflow pan under the AC evaporator (inside unit). This could be caused by malfunctioning with consistent overflows and may not be an active issue. No active condensation leak into the pan is observed. Recommend careful monitoring.

Contact a qualified HVAC professional.

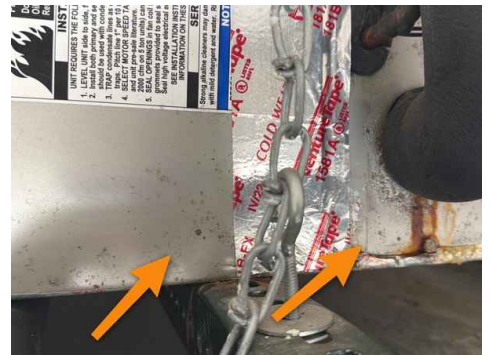
Garage

**EVAPORATOR - MILDEW IS PRESENT**

Mildew (or black mildew-like substance) is present in areas of HVAC evaporator. Areas that have mildew are often higher in moisture content and will need to be cleaned more frequently. Recommend cleaning areas with a antimicrobial and possibly testing for the presence of mold.

Recommended DIY Project

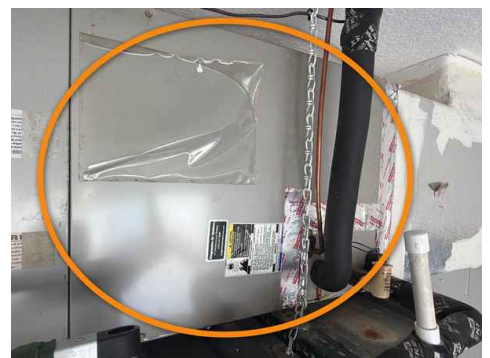
Garage

**EVAPORATOR - COOLING EQUIPMENT  
NEARING END OF ITS USEFUL LIFE**

The evaporator (inside unit) cooling equipment is nearing the end of its expected service life. It is anticipated that the equipment will need to be replaced within the next five (5) years.

Contact a qualified HVAC professional.

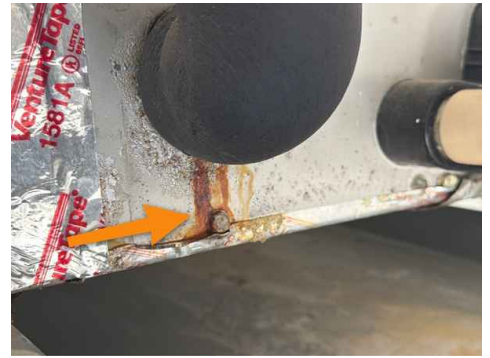
Garage

**EVAPORATOR- CORROSION**

Corrosion was observed at the evaporator coil cabinet. The presence of rust and corrosion may indicate past or ongoing moisture exposure or elevated humidity levels within the system. Continued deterioration could affect the service life of the equipment and surrounding components. Recommend evaluation and repair by a qualified HVAC contractor as needed.

Contact a qualified HVAC professional.

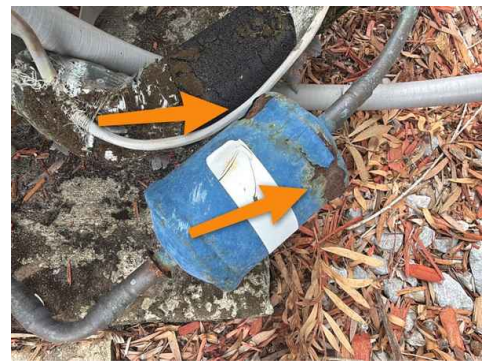
Back

**FILTER DRIER CORROSION**

Corrosion was observed on the HVAC refrigerant filter drier. Corrosion can contribute to deterioration of the component and may indicate prolonged exposure to moisture or environmental conditions. While the system was operational at the time of inspection, recommend evaluation by a qualified HVAC contractor and replacement as needed to help ensure continued system reliability.

Contact a qualified HVAC professional.

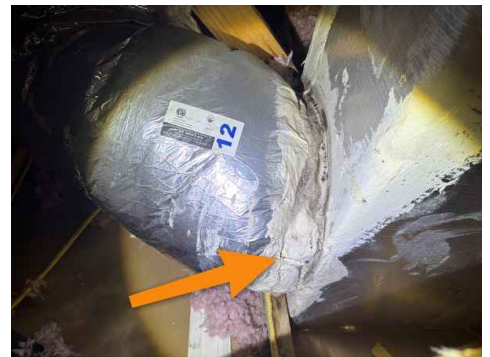
Front Attic

**DUCT NOT PROPERLY SEALED**

Ductwork was observed not properly sealed. Insufficiently sealed ducts can allow air leakage, reducing system efficiency and potentially introducing contaminants into the system. Recommend sealing by a qualified HVAC contractor.

Contact a qualified HVAC professional.

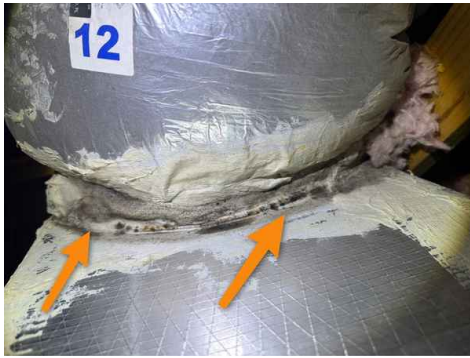
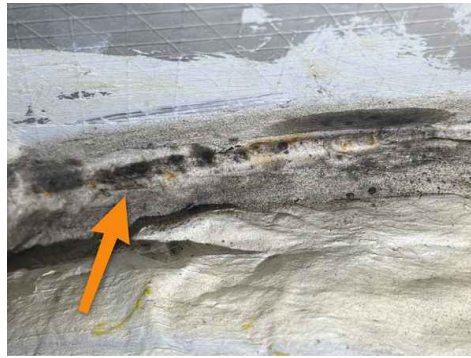
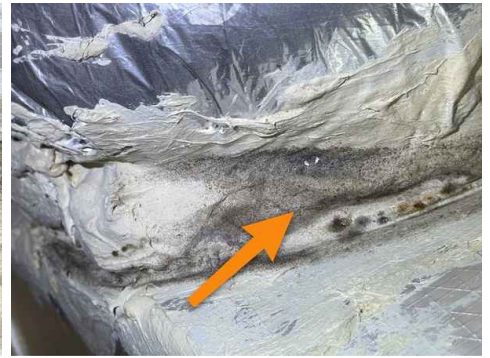
**MOLD-LIKE SUBSTANCE ON DUCTING**

A mold-like substance was observed on HVAC ducting. The substance was not tested for mold identification. Recommend further evaluation and cleaning by a qualified HVAC contractor or mold remediation specialist as needed.

Contact a qualified mold inspection professional.

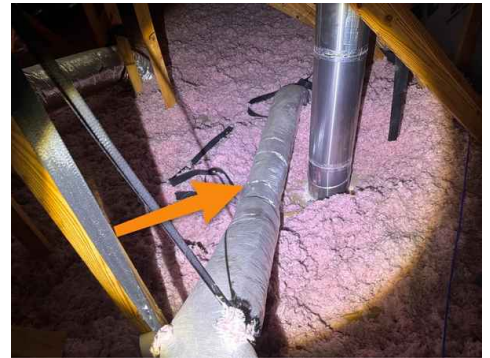
Back Attic

#### 4.3.3 C. Duct Systems, Chases, and Vents **DUCT IS IMPROPERLY SUPPORTED**

Section of HVAC ductwork were observed sagging/improperly supported. Condition may restrict airflow, reduce system efficiency, and place stress on duct connections. Recommend repair and proper support by a qualified HVAC contractor.

Contact a qualified HVAC professional.

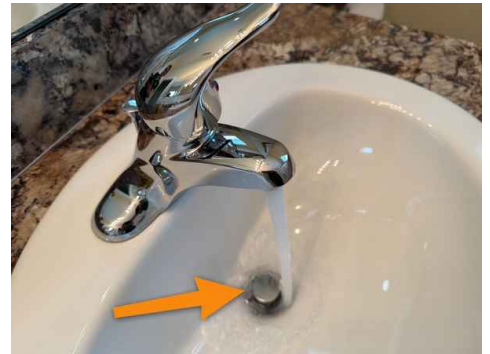
Hall Bathroom

##### **FAUCET / SPIGOT DRAIN PULL ISSUE**

The faucet / spigot drain pull is not functioning properly. Recommend plumbing contractor to resolve issue.

Contact a qualified plumbing contractor.

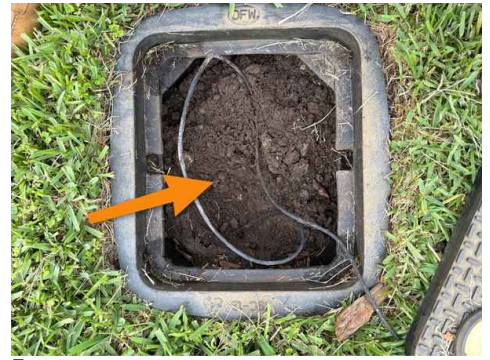
Front

**DEBRIS IN WATER METER BOX**

Debris / dirt was observed inside the water meter box. Accumulated debris may interfere with access to the meter or valve components. Recommend clearing the debris to maintain proper access and functionality. This condition can typically be addressed by a general handyman.

Contact a qualified handyman.

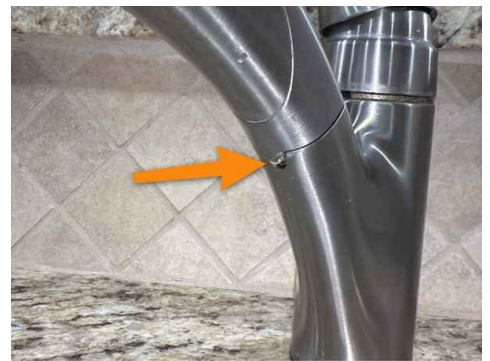
Kitchen

**GENERAL DAMAGE TO FAUCET**

General damage was observed at the faucet fixture. The damaged condition may affect normal operation, appearance, or service life. Recommend repair or replacement as needed.

Contact a qualified plumbing contractor.

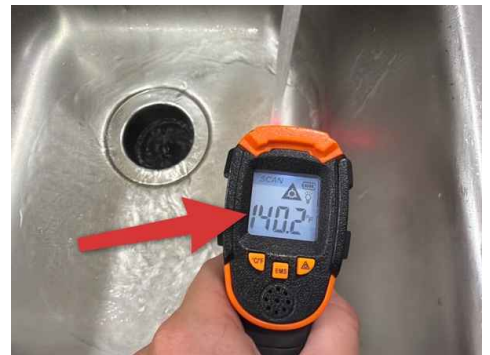
**HOT - WATER HEATER TOO HOT**

The water heater temperature is too hot. Generally accepted safe and comfortable water temperature is one-hundred twenty (120) degrees Fahrenheit from a hot water faucet.

A temperature above one-hundred thirty (130) degrees Fahrenheit is general considered to be unsafe. Recommend a plumbing contractor evaluate why the water heater is producing water that is considered too hot.

140°F

Contact a qualified plumbing contractor.

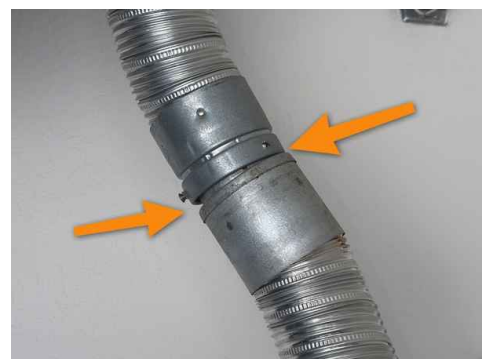
Garage

**VENT CONNECTOR JOINT IS OFFSET**

Vent connector joint at the gas water heater was not fully seated. Recommend evaluation and correction by a qualified contractor.

Contact a qualified HVAC professional.

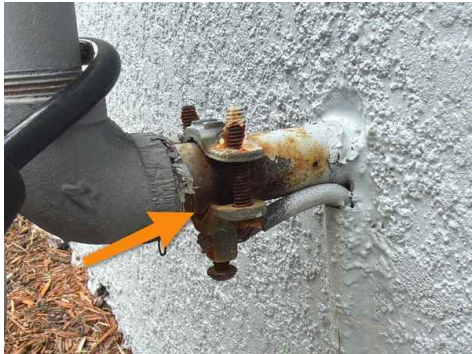
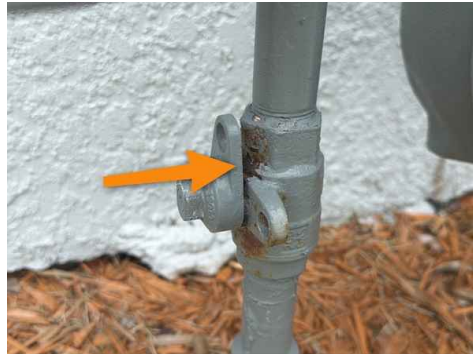
**CORROSION AND DETERIORATION OBSERVED**

Exterior gas piping shows corrosion and deterioration at fittings and vertical sections. Recommend evaluation and repair by a qualified contractor.

Contact a qualified plumbing contractor.

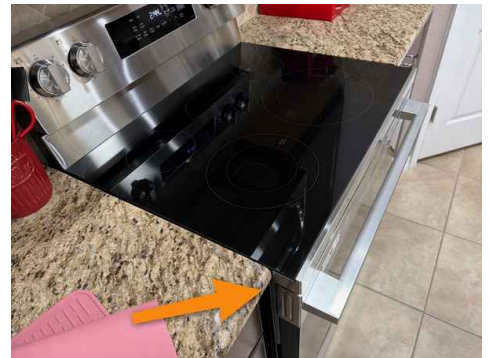
Kitchen

**RANGE IS NOT FLUSH WITH THE WALL**

The range is not flush with the wall. This usually means that there is something behind the range preventing the range from sliding to the back of the wall (such as a gas line, electric plug, or backsplash issue).

Contact a qualified professional.

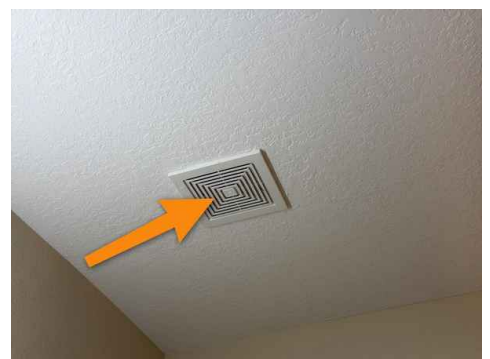
Primary Bathroom

**VENT FAN IS NOISY**

The vent fan is unusually noisy when powered on. Recommend further investigation to determine the cause of the problem.

Contact a qualified electrical contractor.
