## PROPERTY INSPECTION REPORT

1234 Main St  
Tampa, FL 33607

07/09/2025

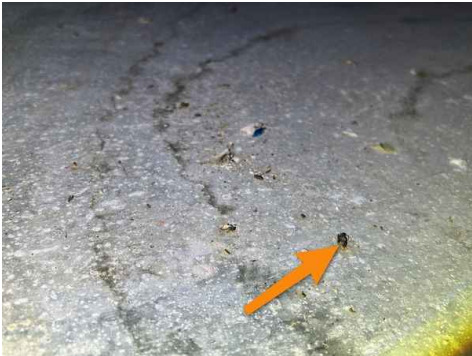
Bedroom Attic

Rodent droppings, chew marks, travel paths, nests, dead rodents, and/or other signs of an active rodent infestation were present. Recommend a rodent control specialist to further evaluate and provide recommendations. Rodent control services my be warranted.

Contact a qualified pest control specialist.

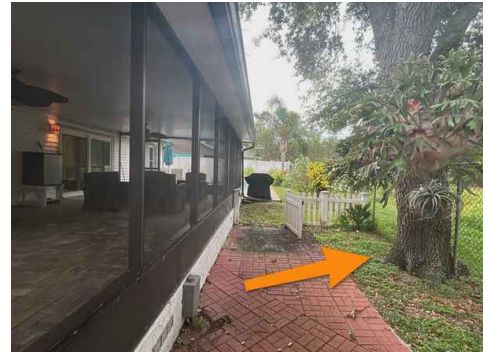
Back

## 2.1.1 A. Foundations

Trees growing near the structure may effect future performance of the foundation. Evaluate, remove, monitor, and/or address as necessary.

Recommended DIY Project

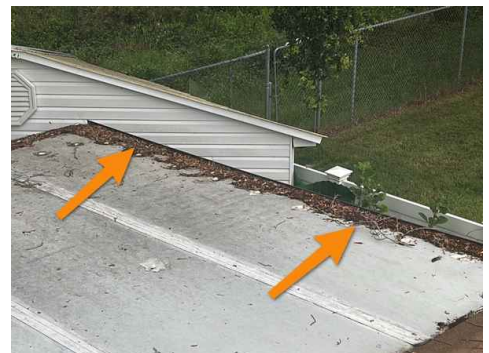
Back

## 2.2.1 B. Grading and Drainage

The gutters are full of leaves and debris. Recommend removal for functional use of gutters.

Contact a handyman or DIY project

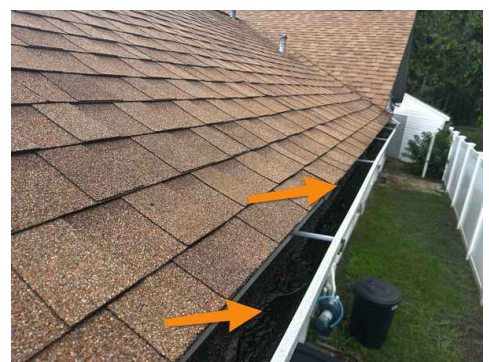
Right

## 2.2.2 B. Grading and Drainage

Gutter is holding water. Gutters holding water are often sagging or clogged; They will hold debris, leak at joints, and/or will too heavy for the fascia. Recommend a gutter contractor to correct the issue.

Contact a handyman or DIY project

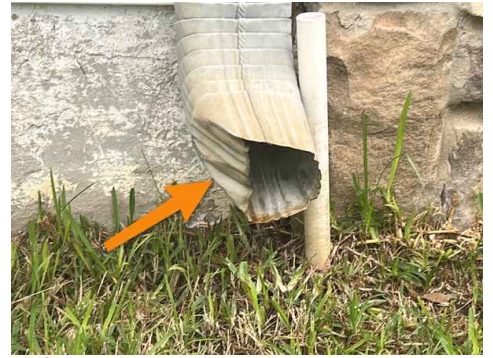
Left

## 2.2.3 B. Grading and Drainage

A downspout gutter is crushed. This can cause flow restrictions and debris buildup in the gutter system that could lead to an overflow. Recommend replacing the crushed portion of the gutter as necessary.

Contact a handyman or DIY project

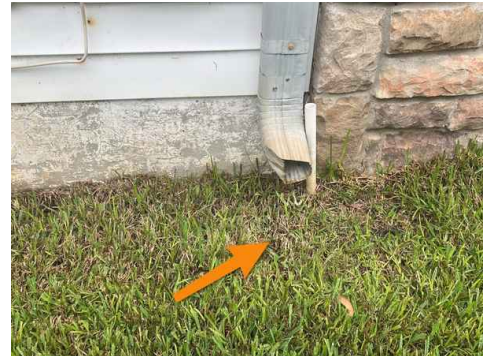
Left

##### **GUTTER MISSING SPLASHBLOCK**

Some or all of the gutter downspouts are missing splash blocks. Splash blocks help disperse the water away from the foundation and prevent the erosion of soils. Recommend installing splash blocks at all necessary locations.

Contact a handyman or DIY project

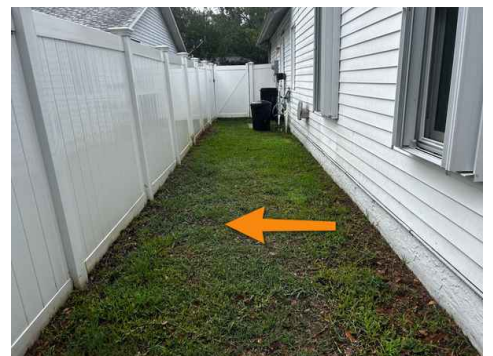
Right

#### 2.2.5 B. Grading and Drainage

The grading around the structure is relatively level (flat). This may not allow for property water drainage away from the foundation. Ideally, the structure should be the highest point on the property to promote good drainage and water run off away from the structure. Evaluate and address as necessary.

Contact a qualified landscaping contractor

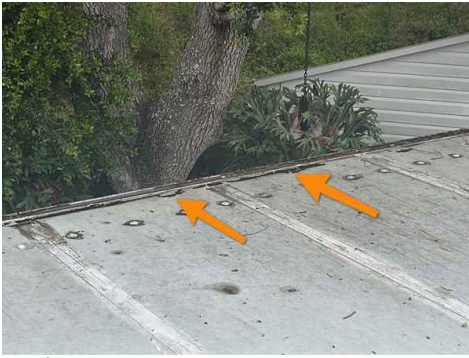
Back

#### 2.3.1 C. Roof Covering Materials

The roof exhibited scuff marks in localized areas. While the damage is currently superficial and does not appear to affect the overall integrity of the roof or had an active leak, continued wear in these areas could lead to premature deterioration. Monitoring is recommended, and repairs should be considered if the condition worsens to prevent potential water intrusion or further degradation.

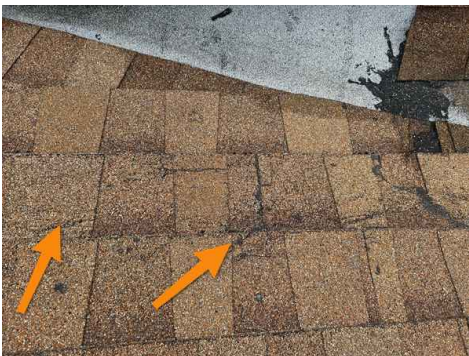
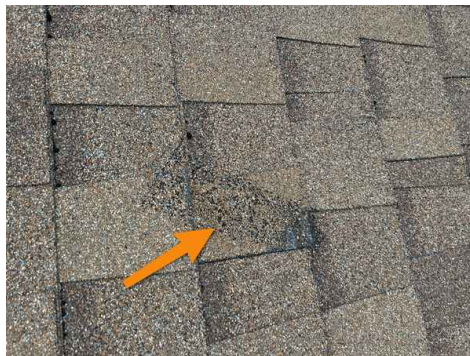
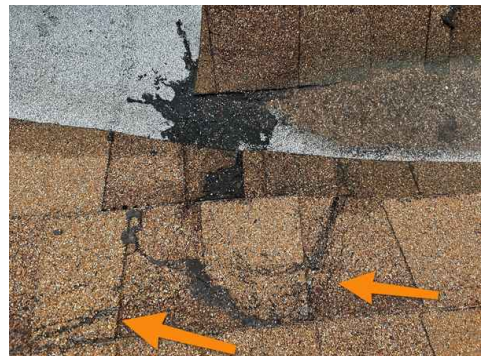
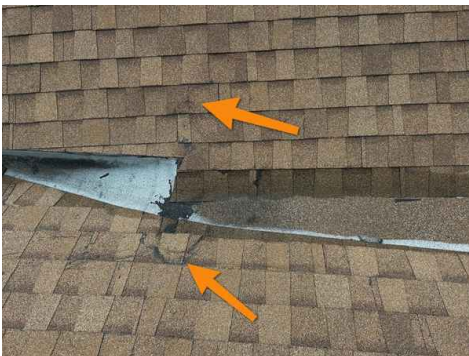
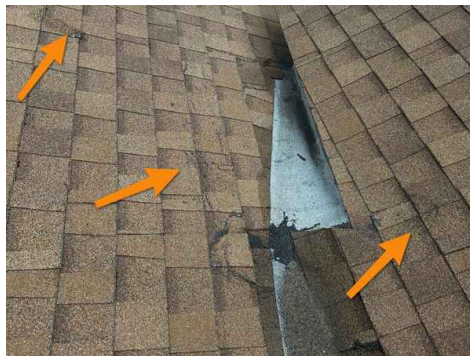
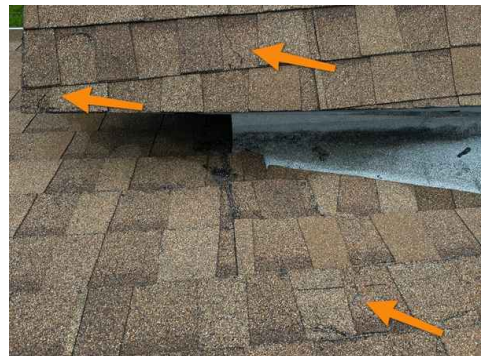
#### **DAMAGED COVERINGS/SCUFFING**

Roof coverings exhibited general damage and/or scuffing that could affect performance. Recommend a qualified roofer evaluate and repair.

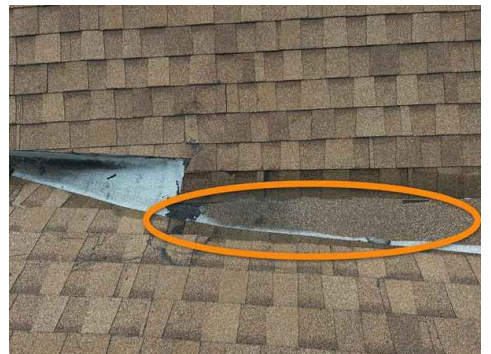
### 2.3.3 C. Roof Covering Materials

#### **INSUFFICIENT WATER SHEDDING**

Areas of the roof have insufficient water shed and ponding. Ponding can lead to accelerated erosion and deterioration. It may lead to leaks. Recommend a qualified roofer evaluate and repair.

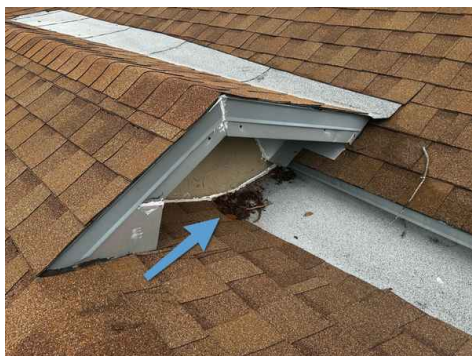
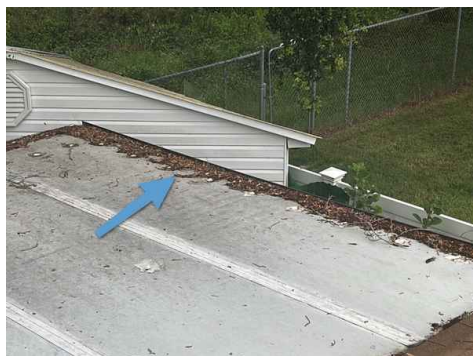
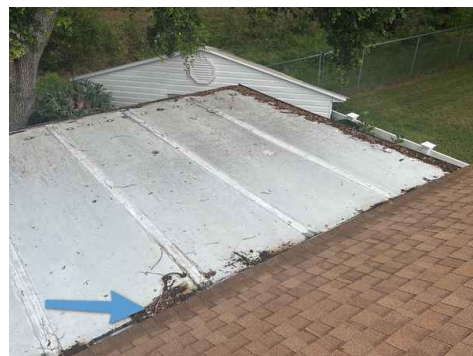
## 2.3.4 C. Roof Covering Materials

**DEBRIS PRESENT**

Excessive debris can cause the ponding of water and the leaking of a roof. It can also cause the deterioration of shingles. Recommend removal.

Recommended DIY Project

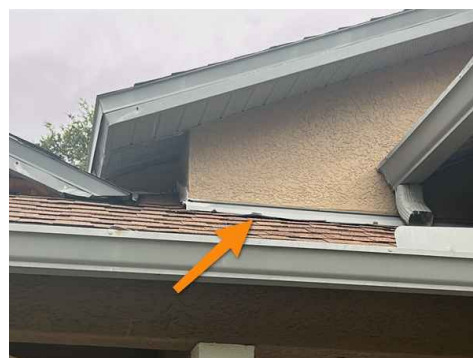
Front

**LIFTED SHINGLES**

Areas of the roof show lifted shingles. This is typically caused by high gusts of wind. Lifted shingles will not seal with the lower shingles and allow for water intrusion. Recommend a roofing contractor to replace.

Contact a qualified roofing professional.

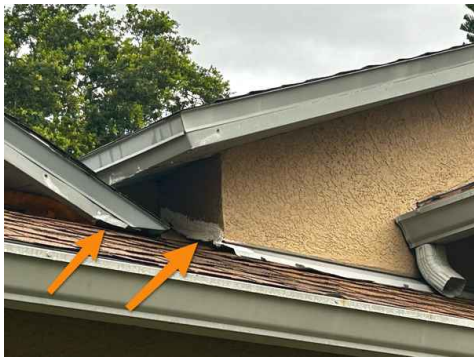
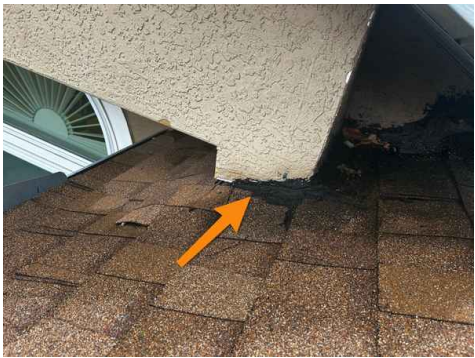
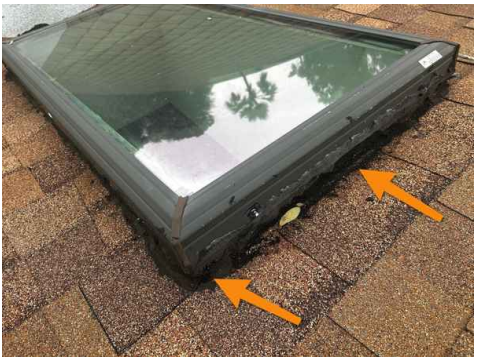
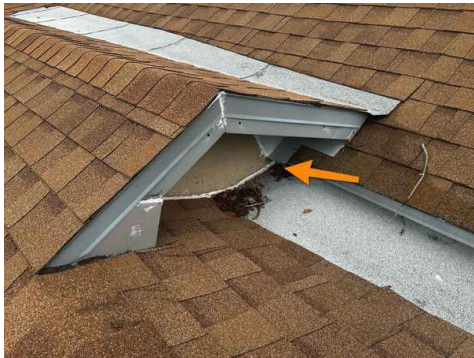
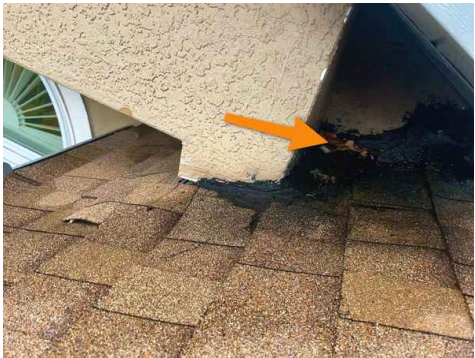
Front

**IMPROPER/ INSUFFICIENT FLASHING**

Flashing is improperly installed and insufficient in multiple areas. Wall/ skylight is missing proper step flashing and/or counter flashing. Missing and/or incorrectly installed flashing can cause water penetration / rot and eventually structural damage. Recommend replacement of the flashing by correct installation method.

Contact a qualified roofing professional.

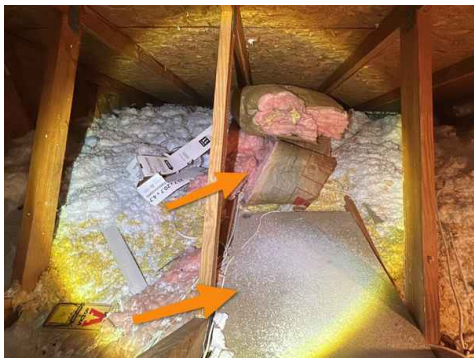
Bedroom Attic

**DAMAGED INSULATION**

Insulation appears to have been pulled out and/or damaged by contractors and/or pests. Recommend a qualified insulation contractor evaluate and repair.

Contact a qualified insulation contractor.

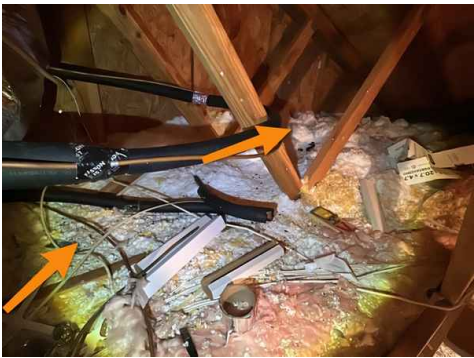
Bedroom Attic

Insulation in the attic unevenly distributed and not smooth / even across the attic surface. This is common in older structures where attic insulation has been moved for repairs and installations. Insulation that is not smooth and even across the attic surface will be less efficient and will be unable to create a thermal barrier as intended. Recommend a insulation contractor smooth the insulation and/or install new insulation in areas of the attic, as necessary.

Recommendation  
Contact a qualified insulation contractor.

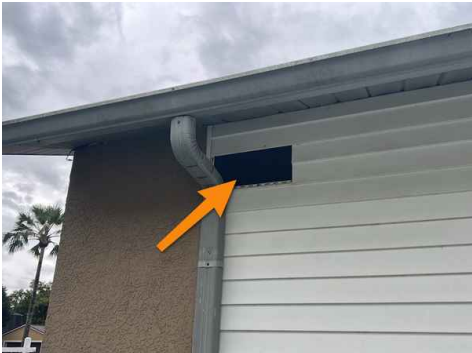
Right

**SIDING IS DAMAGED OR MISSING**

The siding is damaged or missing in these areas. Recommend a general contractor to resolve, as necessary.

Recommendation  
Contact a qualified general contractor.

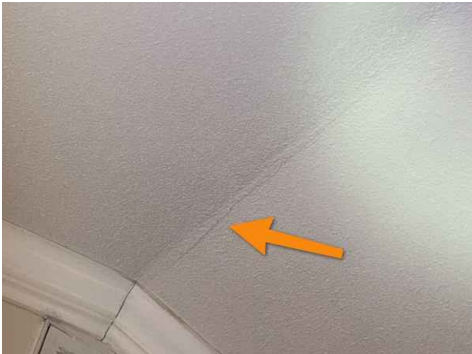
Living

**CEILING - SHEETROCK CRACKS MINOR**

Minor sheetrock cracking was observed on the ceiling. This is common in structures this age and is often determined to be cosmetic, most often the separation of drywall tape joints. Recommend patching, repainting, monitoring these locations for further cracking.

Recommendation  
Contact a qualified painting contractor.

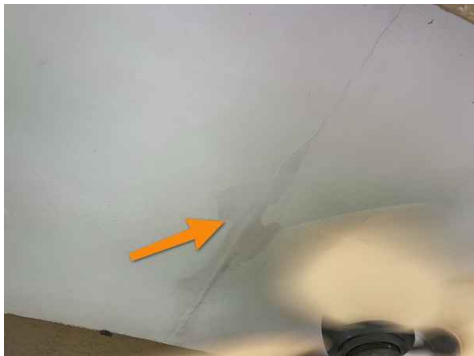
Front

**CEILING - WATER STAIN OBSERVED**

A stain on the ceiling is present. This stain did not visually appear damp and could be from a previously resolved water leak. No moisture was detected. Recommend repainting, monitoring, and addressing as necessary.

Contact a qualified painting contractor.

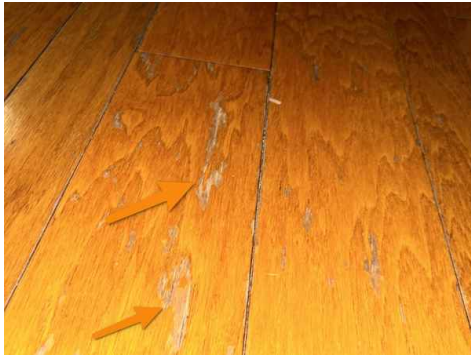
Across structure

**FLOORING - DAMAGED**

The flooring had general moderate damage visible at the time of the inspection. Damaged flooring may be primarily cosmetic and should be resolved as necessary. Recommend evaluation by a qualified flooring contractor.

Contact a qualified flooring contractor

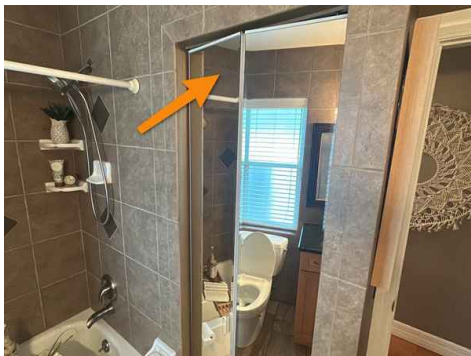
Primary Bathroom

Door sticks, rubs the frame, and is tough or impossible to open and/or close. The door is not aligning with the frame. Recommend hiring a door repair and installation contractor to realign the door.

Contact a qualified door repair/installation contractor.

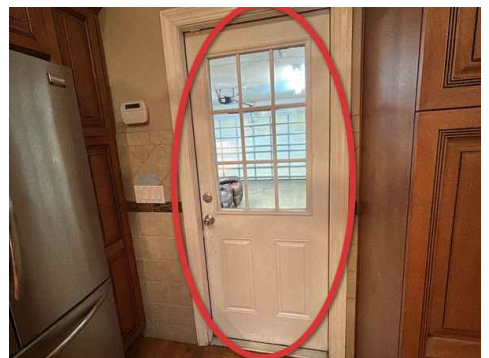
Kitchen/ Garage

The door does not appear to be fire-rated and lacks compliance indication with fire safety standards. This may compromise fire safety by failing to slow the spread of fire and smoke, which is especially critical in locations like garage-to-home entries. It is recommended to consult a licensed contractor or fire safety specialist to replace the door with one meeting the required fire-rating standards and ensure proper installation to maintain its fire-resistant integrity.

Contact a qualified door repair/installation contractor.

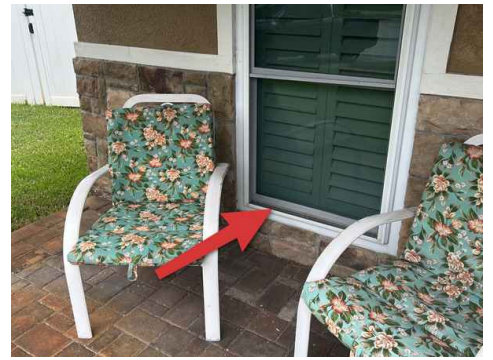
Front

## 2.9.1 H. Windows

Window fails to meet the minimum safety measurement requirements. Windows should be constructed with a sill that is higher than 24 inches. A bar lock in place is necessary for windows that have a sill less than 24 inches. Recommend installing a bar lock or moving/replacing window.

Contact a qualified window repair/installation contractor.

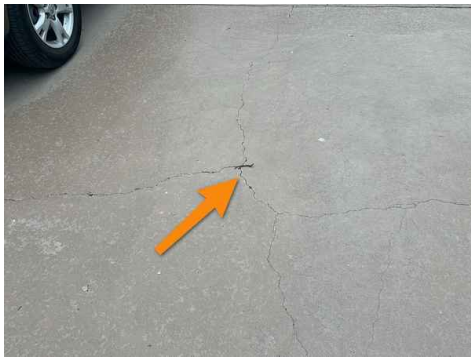
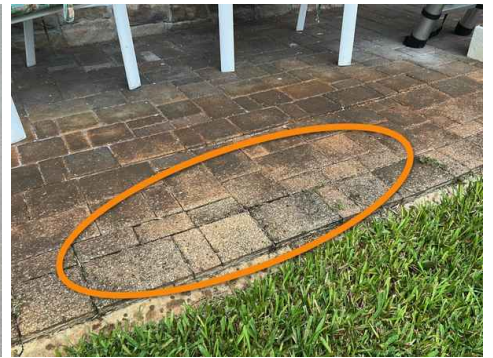
Front

**CRACKS, SEPARATION, OR HEAVING**

The porch show signs of aged cracking, separation, heaving, and/or deterioration. Compromised concrete will continue to exhibit decay, failure, collapse, and uplift if not remediated. Recommend caulking larger cracks and applying a concrete sealer. Cracking can also be a safety tripping hazard for pedestrians.

Recommend monitoring.

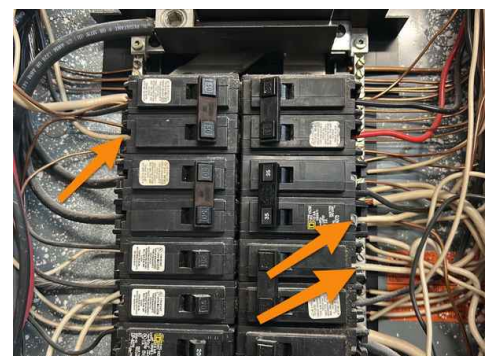
Garage

**Observations****3.1.1 A. Service Entrance and Panels****WHITE HOT WIRE NOT TAPED BLACK**

A white wire is connected directly to a breaker without black electrical tape, which would indicate that it is a hot conductor. This white wire is being used as a phase or hot conductor rather than neutral, which in-itself is not an issue, but should be denoted as such with black electrical tape wrapped around a portion of it. This will allow an electrician servicing the panel to better understand how the electrical wires are routed. Recommend denoting the white wire as a hot conductor by wrapping it with black electrical tape.

Contact a qualified electrical contractor.

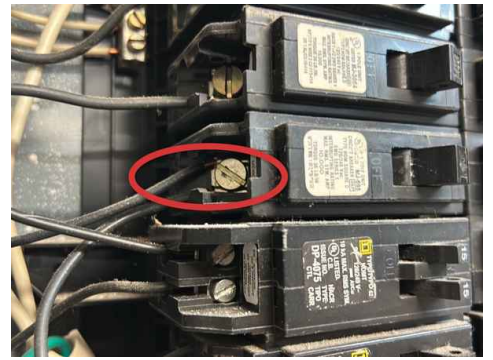
Garage

## 3.1.2 A. Service Entrance and Panels

Contact a qualified electrical contractor.

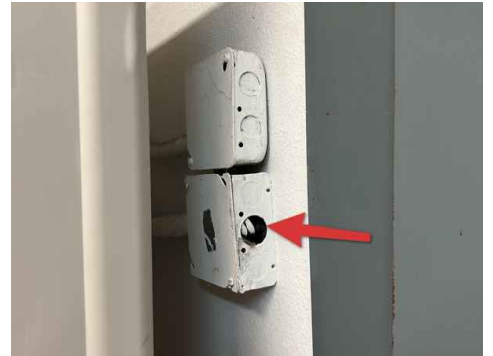
Garage

**MISSING KNOCKOUT PLATE FILLER**

Contact a qualified electrical contractor.

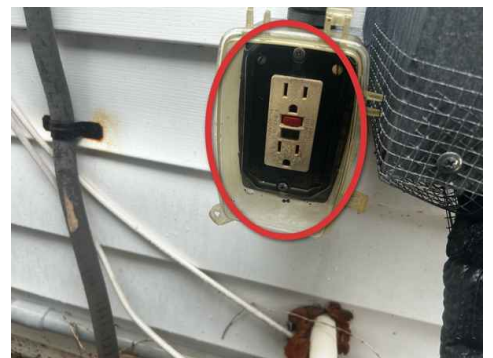
Left

## 3.2.1 B. Branch Circuits, Connected Devices, and Fixtures

Contact a qualified electrical contractor.

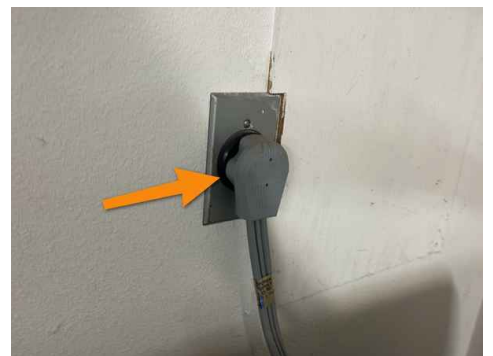
Garage

## 3.2.2 B. Branch Circuits, Connected Devices, and Fixtures

Laundry plug is a 3-prong style. The ground and neutral wires on 3-pronged outlets are grouped, creating the potential for an electrical shock. Electric dryers more recently contain 4-prong dryer cords that feature two hot wires, a neutral wire and a dedicated ground wire. This eliminates the possibility for a ground current traveling to the machine and considered safer.

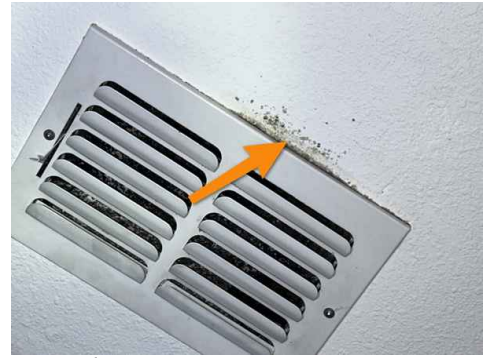
1st Bedroom

4.3.2 C. Duct Systems, Chases, and Vents

Contact a qualified mold inspection professional.

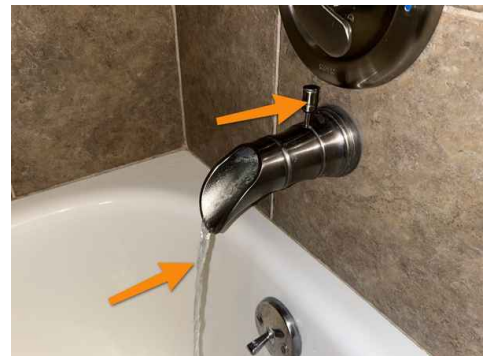
Primary Bathroom

## 5.1.2 A. Plumbing Supply, Distribution Systems, and Fixtures

Contact a qualified plumbing contractor.

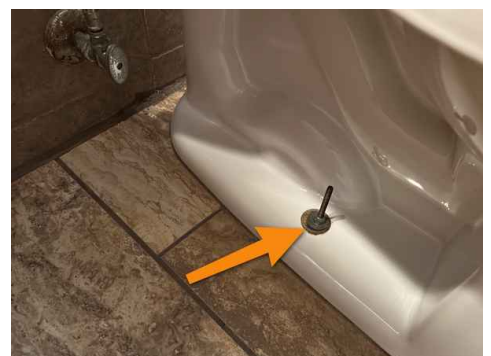
Primary Bathroom

## 5.1.3 A. Plumbing Supply, Distribution Systems, and Fixtures

Contact a qualified plumbing contractor.

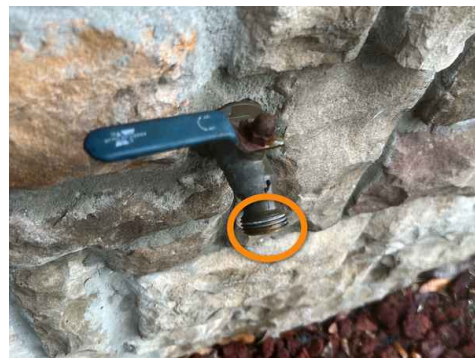
Front

5.1.4 A. Plumbing Supply, Distribution Systems, and Fixtures

Recommended DIY Project

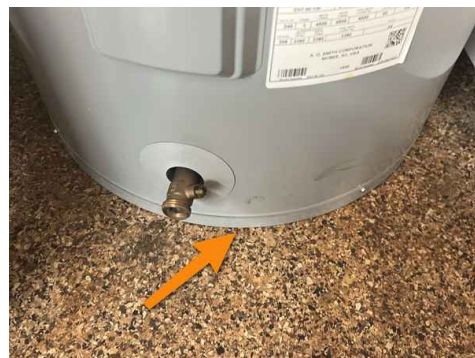
Garage

5.3.1 C. Water Heating Equipment

Contact a qualified plumbing contractor.

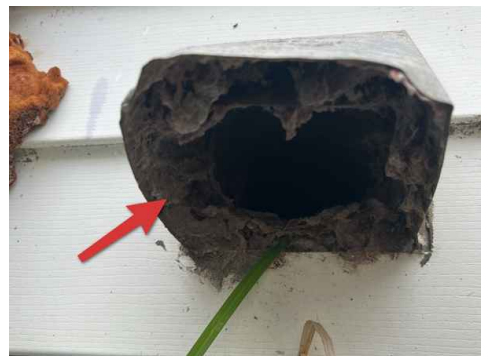
Right

### 6.8.1 H. Dryer Exhaust Systems
