# MERIT PROPERTY INSPECTIONS

## PROPERTY INSPECTION REPORT COPY

1234 Main Street  
St. Petersburg, FL 33716

06/13/2026 9:00AM

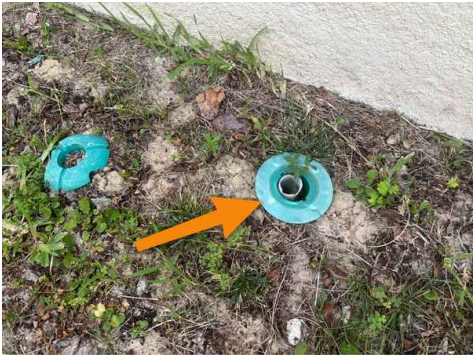
Multiple areas

**DAMAGE TO SUBTERRANEAN  
TERMITE BAIT STATIONS**

One or more subterranean termite bait stations were observed to be damaged. Damaged stations may reduce the effectiveness of the termite monitoring and treatment system. Recommend evaluation and repair or replacement by a qualified pest control professional.

Contact a qualified pest control specialist.

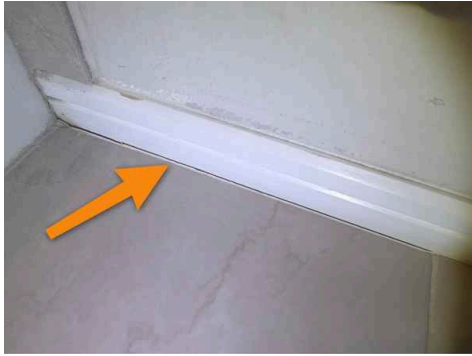
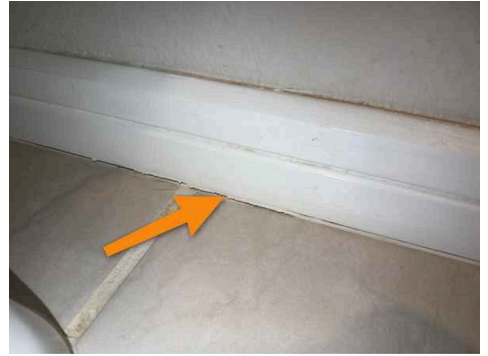
2nd Floor Hall Bathroom

Areas in the structure are showing separation. Separation of trim/cabinets/baseboards are primarily considered cosmetic and can be resolved by sanding, recaulking, and/or re-painting. That said, these finish areas are some of the most sensitive areas of the home and susceptible to small changes in movement of the foundation and framing. These types of separations are the first signs of foundation issues and should be monitored. The best way to monitor for future separation is to fix these problems professionally and monitor the areas for reappearing.

Contact a qualified carpenter.

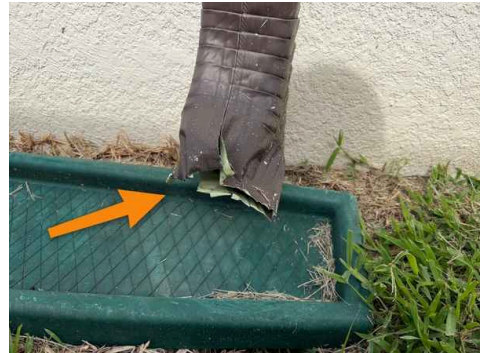
Left

A downspout gutter is crushed. This can cause flow restrictions and debris buildup in the gutter system that could lead to an overflow. Recommend replacing the crushed portion of the gutter as necessary.

Contact a handyman or DIY project

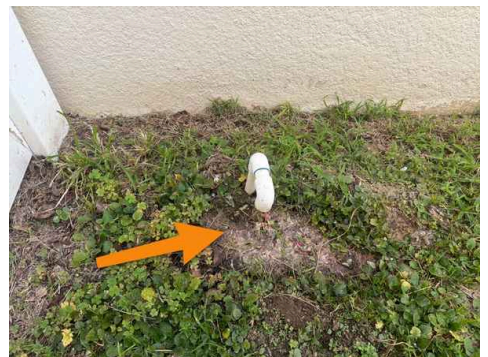
Right

The primary HVAC condensate discharge was observed terminating at the ground without a splash block. This can allow water to concentrate near the foundation and contribute to soil erosion or moisture accumulation. Recommend installing a splash block or an extension to direct water away from the structure.

Contact a handyman or DIY project

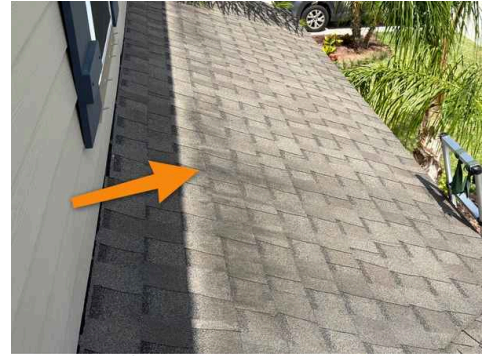
Front Roof

Roof coverings were discolored, which can be caused by moisture or sun exposure. Recommend a qualified roofing contractor evaluate and remedy with a roof cleaning or repair.

Contact a qualified roofing professional.

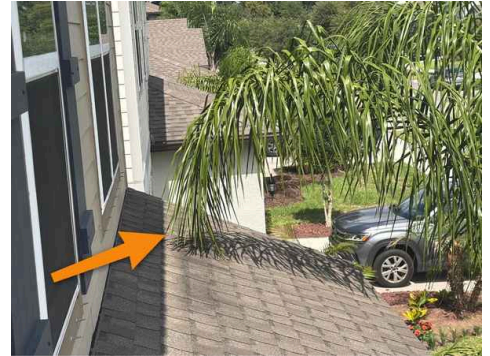
Front

Tree limbs are touching the roof. Tree limbs can drag the roof creating rapid delamination, damages to the roof shingles, or even holes in the roof. Recommend removing all limbs that are touching the roof by 5-feet or more (to account for wind movement and future growth).

Contact a qualified tree service company.

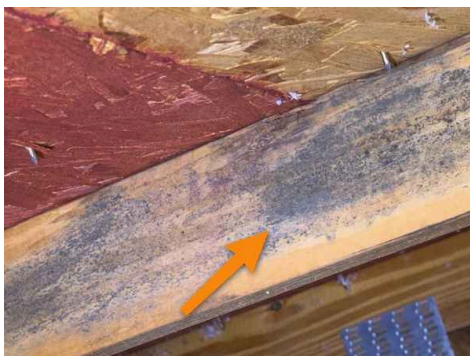
2nd Floor Attic

#### **POSSIBLE ORGANIC GROWTH OBSERVED**

Areas of mold-like discoloration were observed on the attic rafters and/or roof sheathing. This type of staining is typically associated with elevated moisture or inadequate attic ventilation. The inspection does not include testing to confirm whether the substance is mold. Recommend further evaluation and cleaning/treatment by a licensed mold remediation or indoor air quality specialist, and correction of any underlying moisture or ventilation issues as necessary.

Contact a qualified mold inspection professional.

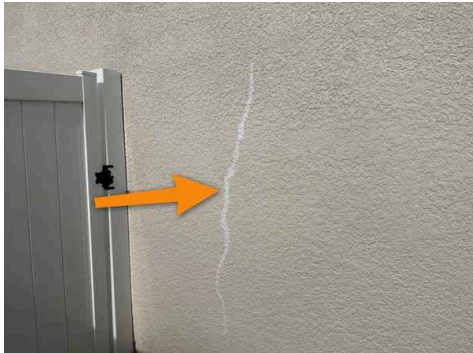
Left

#### **MINOR STUCCO CRACKS**

Cracks were observed in the exterior stucco. **These openings can allow for moisture intrusion** and should be sealed with a compatible elastomeric sealant and repainted as needed. Recommend repair by a qualified stucco contractor to help prevent damage.

Recommendation  
Contact a stucco repair contractor

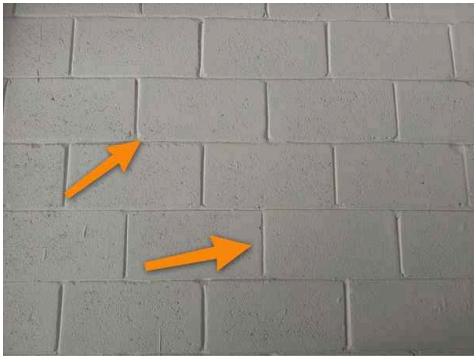
Garage

2.5.2 E. Walls (Interior and Exterior)  
**MINOR STAIR-STEP CRACKS**

Minor stair-step cracking was observed on the exterior wall in one or more areas. This type of cracking often results from normal settlement or minor foundation movement but should be sealed to prevent moisture intrusion and monitored for changes over time. Recommend evaluation and repair by a qualified structural contractor if cracking widens or worsens.

Recommendation  
Contact a stucco repair contractor

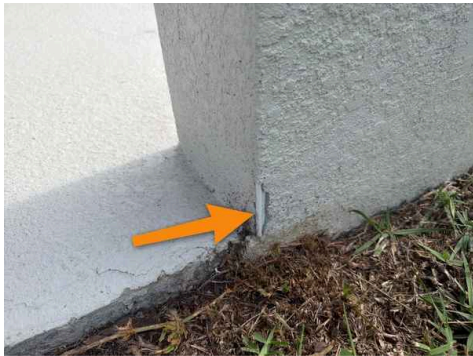
Back

2.5.3 E. Walls (Interior and Exterior)  
**SIDING IS DAMAGED OR MISSING**

The siding is damaged or missing in these areas. This may allow for moisture / pest intrusion. Recommend a general contractor to resolve, as necessary.

Recommendation  
Contact a qualified general contractor.

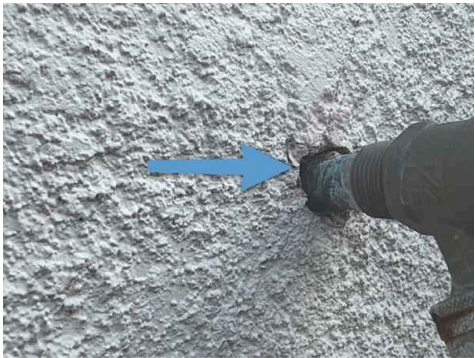
Back

**CAULKING DETERIORATED AND/OR MISSING**

Caulking is necessary to seal gaps less than 1/2-inch. Caulking that is missing can provide for water penetration and allow insect access into the structure.

Contact a qualified general contractor.

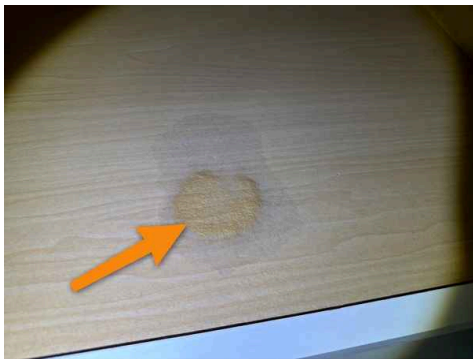
Primary Bathroom

**CABINET - WATER DAMAGE**

One or more areas of the cabinet show signs of water damage. Particularly in older structures, signs of water damage under the sink cabinets including stains, warping, and sagging flooring could be from previous leaks and are common discoveries. Recommend monitoring for future leaking, repainting, mold testing, and replacement depending on clients opinion and severity.

Recommend monitoring.

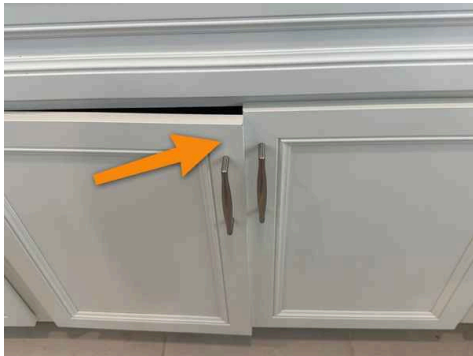
Kitchen

Cabinet door and/or drawer misaligned and not closing properly.

Recommendation  
Contact a qualified cabinet contractor.

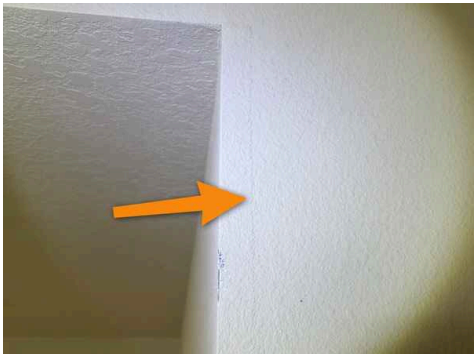
Staircase

**MINOR INTERIOR CRACKS**

Minor cracks were observed in interior wall surfaces. These are commonly associated with normal settling or minor movement. Recommend monitoring for changes and repair as needed.

Recommendation  
Contact a qualified drywall contractor.

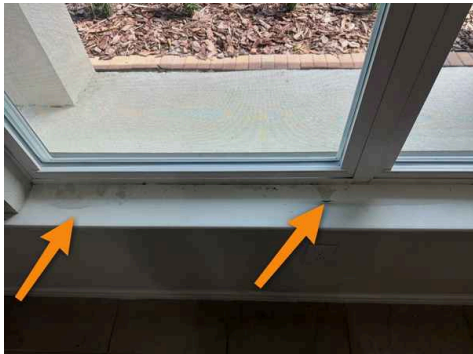
Office

**MOISTURE INTRUSION**

A window was observed in a partially open position, with evidence of moisture intrusion noted in the surrounding area. Prolonged exposure to moisture may contribute to deterioration of adjacent materials and finishes. Recommend closing and securing the window and repairing any resulting damage as needed.

Recommendation  
Recommend monitoring.

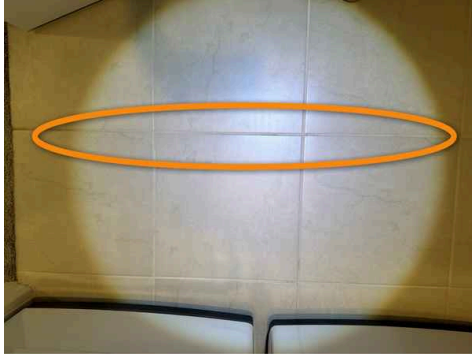
Laundry

**FLOORING - GROUT CRACKS**

Cracking was observed in the grout lines between floor tiles. This condition may result from normal settlement, minor subfloor movement, or age-related wear. Recommend repair and regrouting by a qualified flooring professional, and monitor for any further cracking that could suggest underlying substrate issues.

Contact a qualified flooring contractor

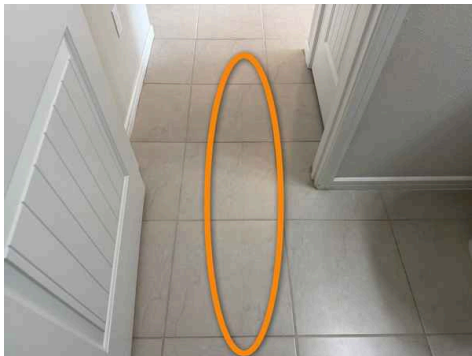
1st Hall Bathroom Hall

**FLOORING - TILES CRACKED**

Tiles that are cracking was observed. This is possibly due to structural foundation issues and is considered evidence of a structural deficiency. Recommend a qualified foundation repair company / contractor evaluate and advise on course of action prior to repair of the flooring.

Contact a qualified flooring contractor

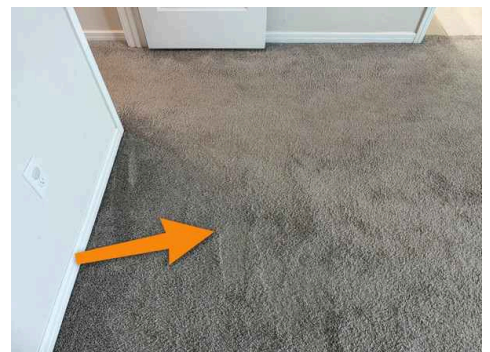
## Primary Bedroom

The flooring is spongy, moves, and/or squeaks as weight is distributed across it. This is typically a sign of weakness in the underlying joists, rotting subfloor, or separation of the flooring from the subfloor. A flooring contractor is recommended for further evaluation.

Contact a qualified flooring contractor

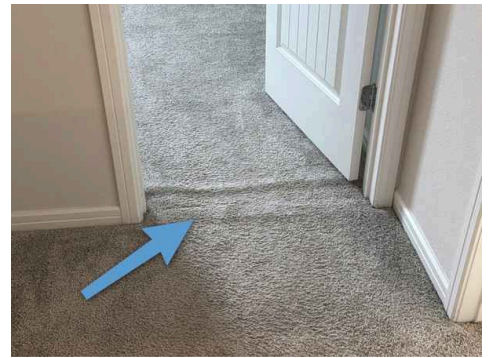
2nd Floor Hall

Carpet wrinkling was present at the time of inspection. Although carpet wrinkling (both in the carpet itself or underlying carpet pad) is generally considered a cosmetic defect, this can indicate areas of leakage, high moisture, and/or structural defects. Additionally carpet wrinkling is considered a safety tripping hazard to pedestrians. Recommend hiring a carpet installer to re-stretch the carpet and determine the problem.

Contact a qualified flooring contractor

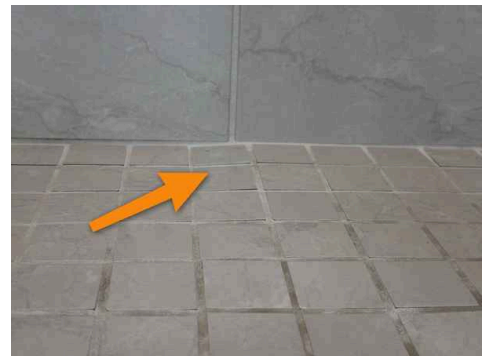
Primary Bathroom

Uneven tile surfaces were observed at the shower floor. Uneven tiles may create areas where water can collect, affect drainage, and present a potential tripping hazard. The cause of the unevenness could not be determined during the inspection. Recommend evaluation and repair by a qualified tile contractor as needed.

Contact a qualified tile contractor

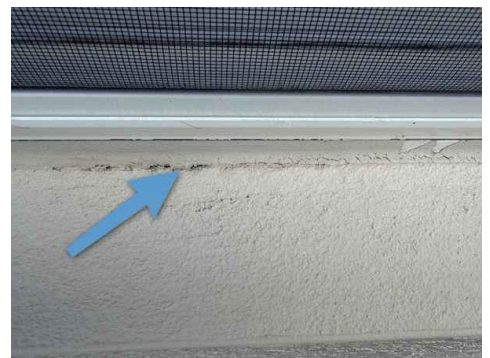
Back

Noticeable gaps and/or deteriorating caulking present around the windows. This can lead to water penetration and insect intrusion. Windows should be recaulked with a silicone based sealant.

Contact a qualified window repair/installation contractor.

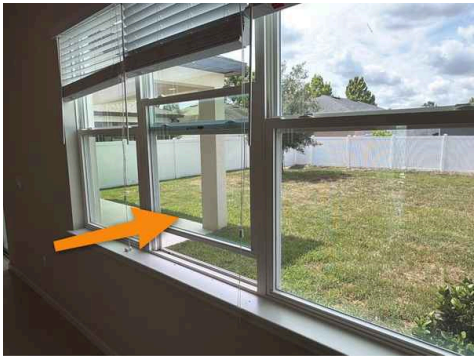
Living

One or more windows are difficult to open. This could be caused by a number of reasons, including structural deficiencies that apply force to the frame, windows have broken springs, or windows that are off their track(s). Recommend windows be restored to functional use by a window repair and installation contractor.

Recommendation  
Contact a qualified window repair/installation contractor.

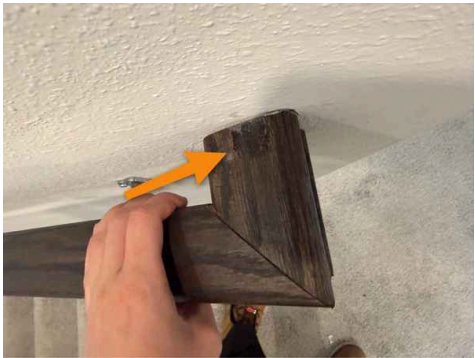
Staircase

**LOOSE HANDRAIL STRUCTURE**

The stairway handrail is loose and unsupported. This should be strengthened or replaced with a sufficient handrail structure, handrail, and baluster system.

Recommendation  
Contact a qualified professional.

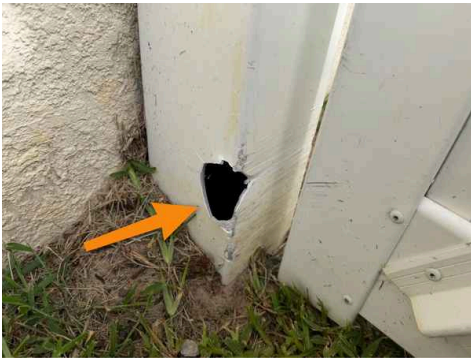
Left

**DAMAGE TO FENCE**

Damage was observed to the vinyl fence post cover near grade level. The damaged section may allow moisture, debris, or pests to enter the post cavity and detracts from the fence's appearance. Recommend repair or replacement of the damaged component.

Recommendation  
Contact a qualified fencing contractor

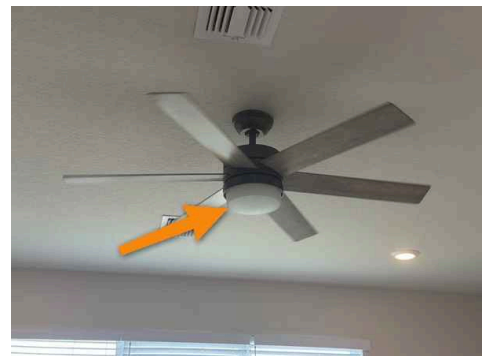
Living

Recommendation**INOPERATIVE LIGHT FIXTURES**

A light fixture did not illuminate when operated by the wall switch. This condition may be due to a failed bulb, defective fixture, wiring issue, switch malfunction, or another electrical defect. The exact cause could not be determined during the inspection. Recommend evaluation and repair by a qualified licensed electrician if replacing the bulb does not restore normal operation.

Contact a qualified electrical contractor.

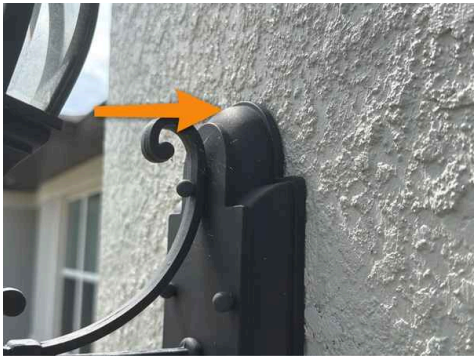
Front

Recommendation**FIXTURE - IMPROPERLY SEALED**

Light fixture improperly sealed from the outdoor elements. Will allow for water penetration and could cause interior damage to structure. Recommend reinstallation using approved caulking, sealants, etc.

Recommendation  
Contact a qualified handyman.

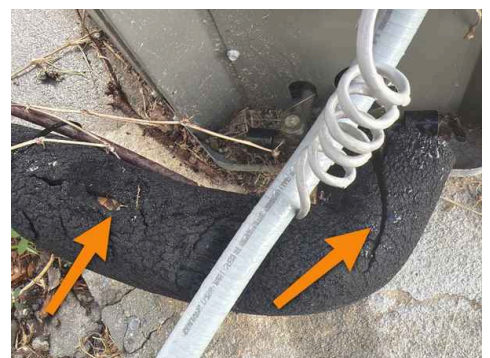
Back

#### CONDENSER - FREON INSULATION MISSING OR DAMAGED

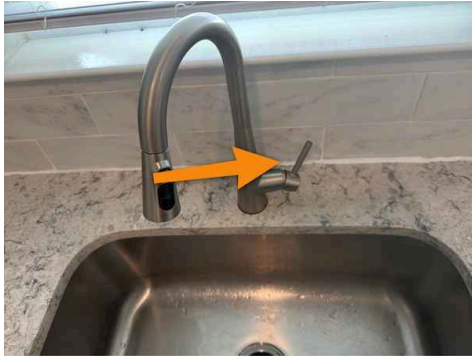
Kitchen hot water

#### NO WATER TO THE FIXTURE

The water to this fixture is turned off at the localized valve or is not connected. Due to liability considerations, we are unable to connect or turn on the water on to this fixture. As such, inspector is limited in locating deficiencies with the fixture.

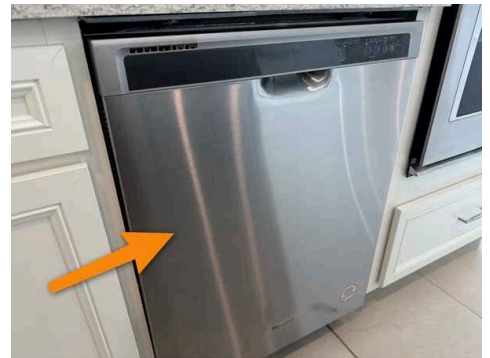
Kitchen

#### **WATER TO DISHWASHER TURNED OFF**

The water to the dishwasher is turned off or disconnected. Due to liability considerations, the inspector is unable to turn on the water and is limited in the ability to locate deficiencies. Recommend rescheduled inspection to evaluate these water distribution components.

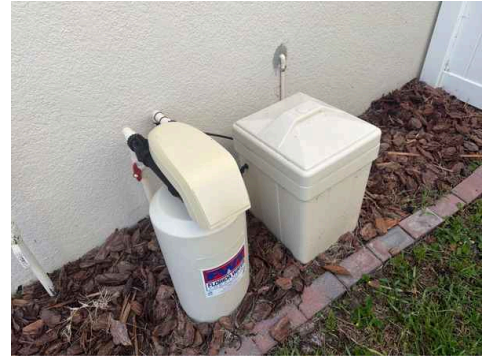
Right

**WATER SOFTENER SYSTEM - OUT OF SCOPE**

The water softener system was inspected for visual leaks. No inspection was made to determine the operation of the water filtration unit nor it's effectiveness. This type of inspection is considered outside the scope of work of this inspection.
