# MERIT PROPERTY INSPECTIONS

## PROPERTY INSPECTION REPORT COPY

1234 Main Street  
St. Petersburg, FL 33716

06/13/2026 9:00AM

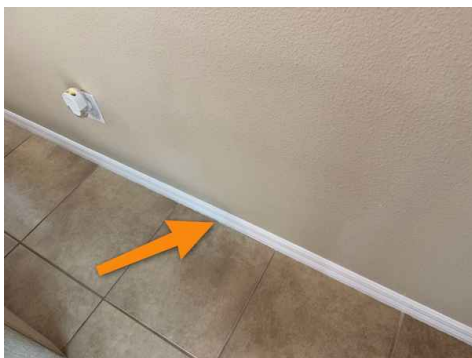
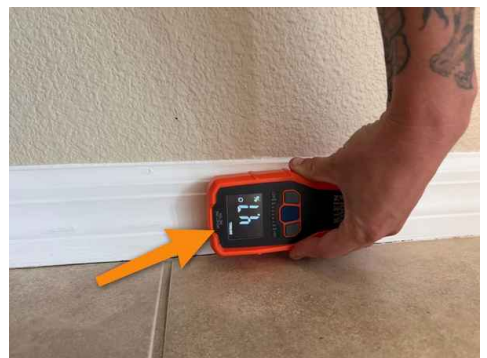
Living

Areas in the structure are showing separation. Separation of trim/baseboards are primarily considered cosmetic and can be resolved by sanding, recaulking, and/or re-painting. That said, these finish areas are some of the most sensitive areas of the home and susceptible to small changes in movement of the foundation and framing. These types of separations are the first signs of foundation issues and should be monitored. The best way to monitor for future separation is to fix these problems professionally and monitor the areas for reappearing.

Contact a qualified carpenter.

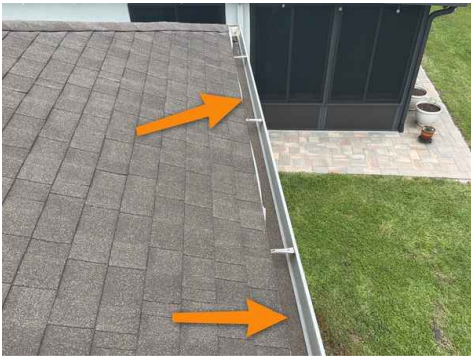
Back

The gutters are full of debris. Recommend removal for functional use of gutters.

Contact a handyman or DIY project

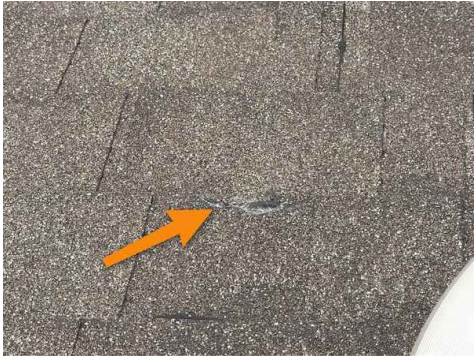
Left

2.3.1 C. Roof Covering Materials  
**DAMAGED COVERINGS/SCUFFING**

Roof coverings exhibited general damage and/or scuffing that could affect performance. Recommend a qualified roofer evaluate and repair.

Recommendation  
Contact a qualified roofing professional.

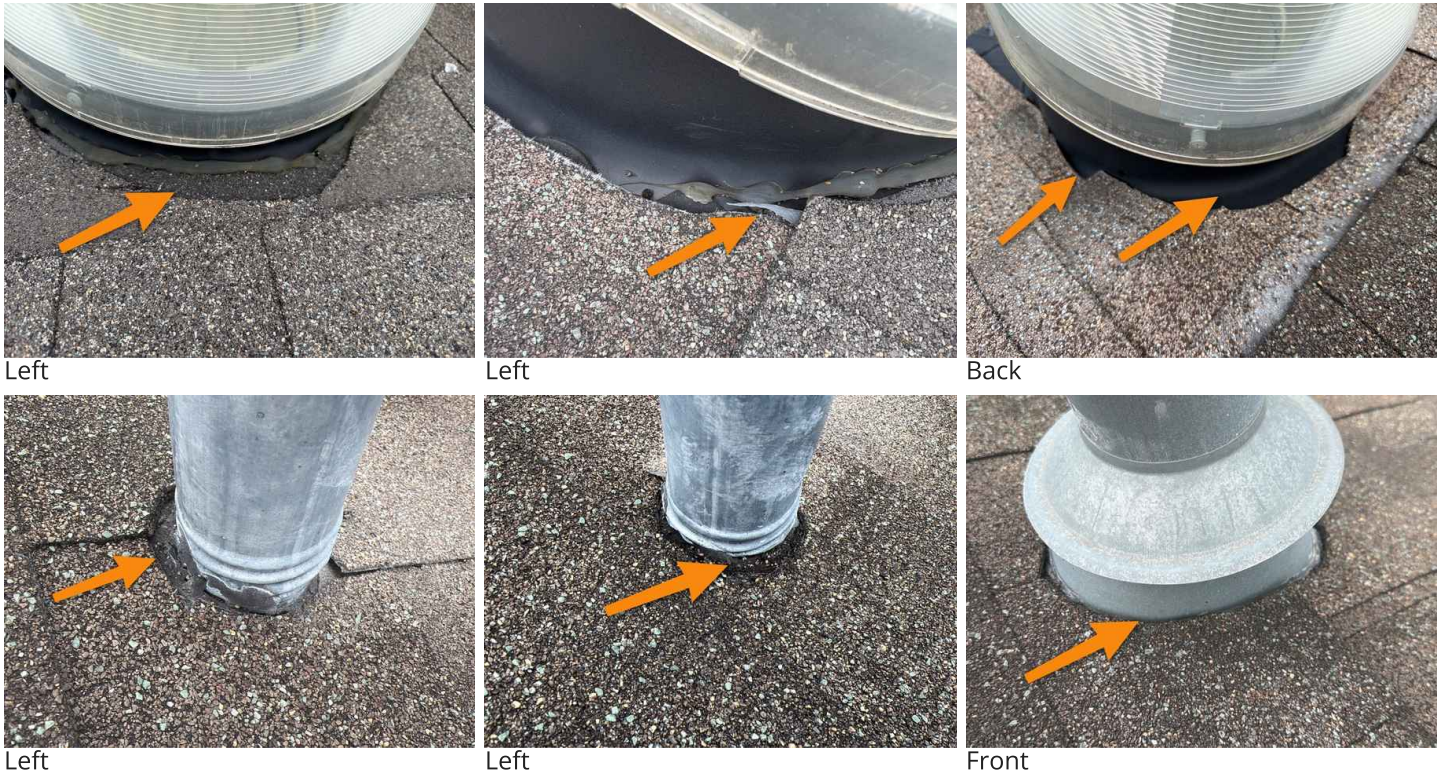
Observed areas that appeared to be missing sufficient coverings and sealant at roof penetrations. Recommend qualified roofing contractor evaluate & repair.

Recommendation  
Contact a qualified roofing professional.

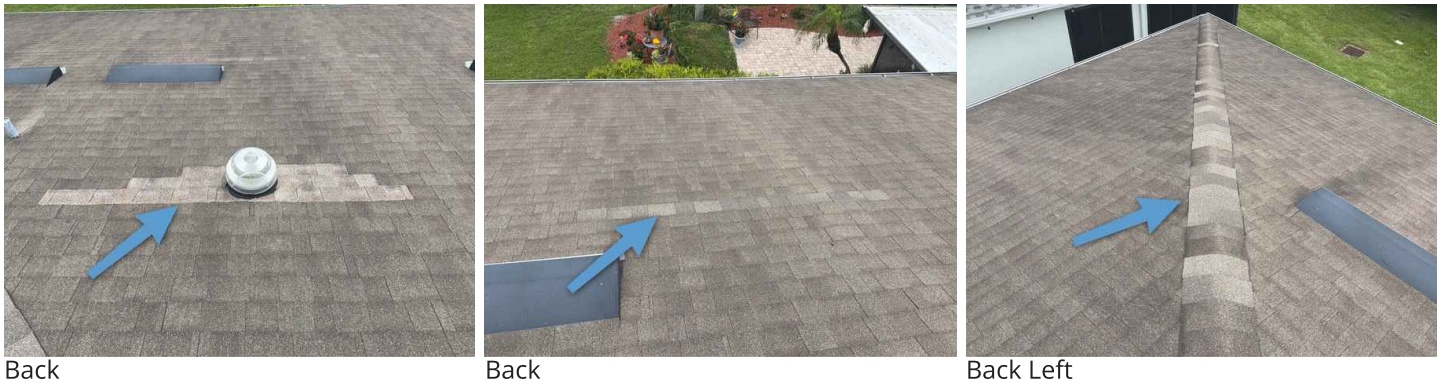
2.3.4 C. Roof Covering Materials

ROOF PATCH

A roof patch was discovered and should be monitored for future leaks.

Recommendation  
Recommend monitoring.

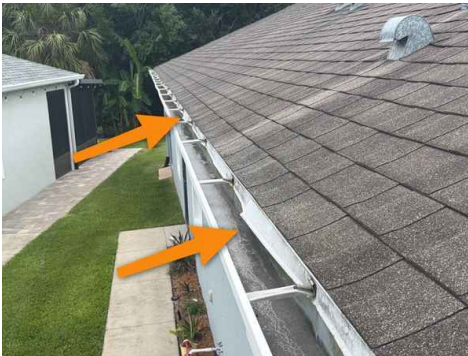
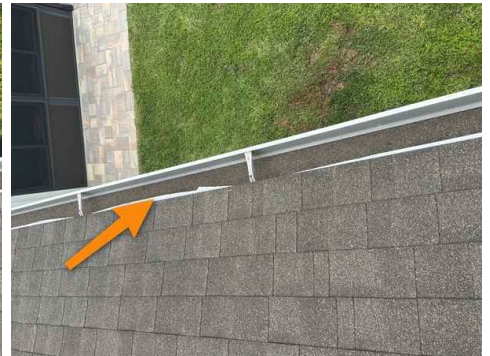
Left

#### 2.3.5 C. Roof Covering Materials

Areas of the roof show lifted or separated flashing areas. These areas will not seal with the lower shingle areas or siding and can allow for water intrusion. Recommend a roofing contractor to replace.

Contact a qualified roofing professional.

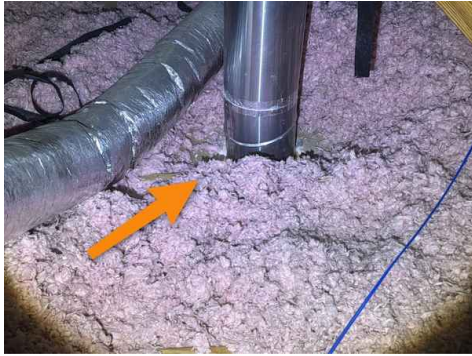
Attic

#### 2.4.1 D. Roof Structures and Attics

Insulation in the attic unevenly distributed and not smooth / even across the attic surface. This is common in older structures where attic insulation has been moved for repairs and installations. Insulation that is not smooth and even across the attic surface will be less efficient and will be unable to create a thermal barrier as intended. Recommend a insulation contractor smooth the insulation and/or install new insulation in areas of the attic, as necessary.

Contact a qualified insulation contractor.

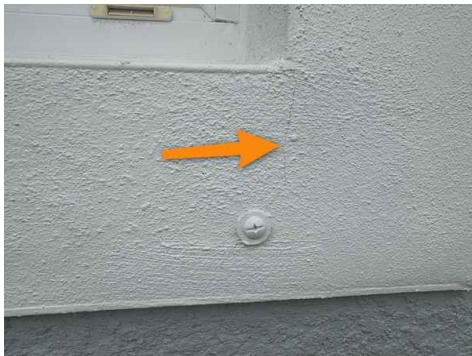
Left

### MINOR STUCCO CRACKS

Cracks were observed in the exterior stucco. **These openings can allow for moisture intrusion** and should be sealed with a compatible elastomeric sealant and repainted as needed. Recommend repair by a qualified stucco contractor to help prevent damage.

Contact a stucco repair contractor

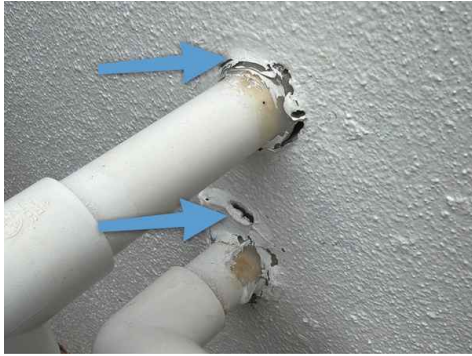
Front

### CAULKING DETERIORATED AND/OR MISSING

Caulking is necessary to seal gaps less than 1/2-inch. Caulking that is missing can provide for water penetration and allow insect access into the structure.

Contact a qualified general contractor.

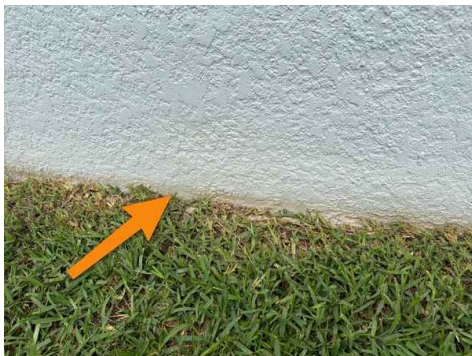
Back Left

Discoloration was observed at the exterior stucco wall covering near grade level. The discoloration is consistent with moisture exposure, organic growth, or accumulation of dirt and debris. While the full extent and cause could not be determined during the inspection, prolonged moisture exposure may contribute to deterioration of exterior finishes over time. Recommend monitoring and further evaluation if conditions worsen or moisture intrusion is suspected.

Contact a stucco repair contractor

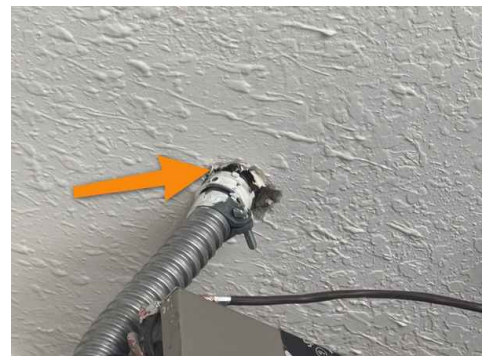
Garage

The garage ceiling was observed without fire-rated sealant at the ceiling penetration. Openings in the garage ceiling can allow smoke and fire to spread into the living space above and reduce the effectiveness of the fire separation. Recommend sealing the penetration with approved fire-rated sealant by a qualified contractor.

Contact a qualified fire suppression contractor.

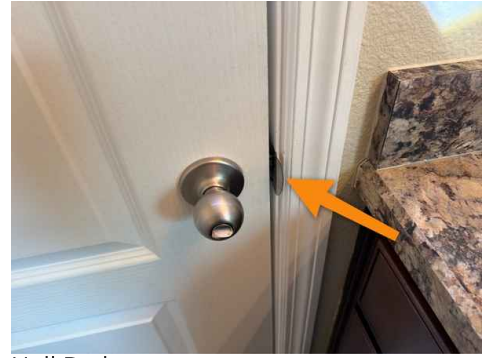
Hall Bathroom

### 2.7.1 G. Doors (Interior and Exterior)

Door doesn't latch to close properly. Recommend handyman repair door, latch, frame, and/or strike plate.

Contact a qualified handyman.

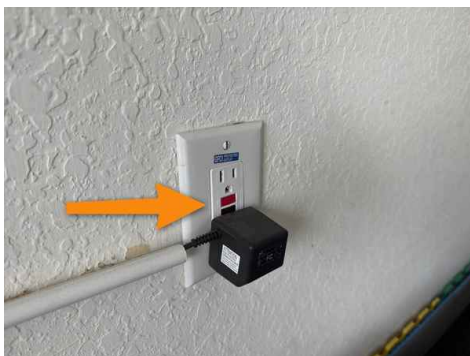
Garage

**Observations****3.2.1 B. Branch Circuits, Connected Devices, and Fixtures****OUTLET - LOOSE AND NOT SECURE**

An outlet is loose and not securely fastened to the gang-box and/or the structure behind the sheetrock. Loose outlets will become worse over time as contact points start to wear down and wires bend back and forth. Loose outlets can eventually lead to broken wires, dead circuits, flickering lights, or other electrical problems (including electrical fire). Recommend an electrical contractor tighten the outlet so it does not move.

Contact a qualified electrical contractor.

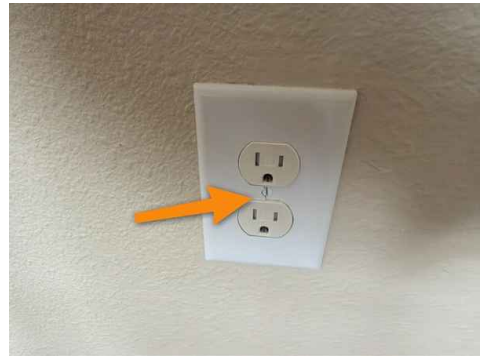
1st Bedroom

#### **COVER PLATE IS DAMAGED**

Electrical receptacle plate is damaged. This may cause short and shock risk over time. Recommend replacement of the damaged or missing cover plate.

Contact a qualified electrical contractor.

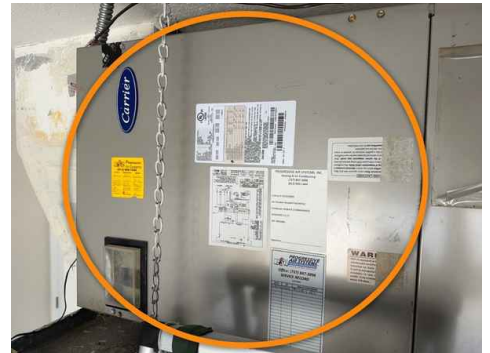
Garage

The heating equipment is nearing the end of its expected service life. It is anticipated that the equipment will need to be replaced within the next five (5) years.

Contact a qualified HVAC professional.

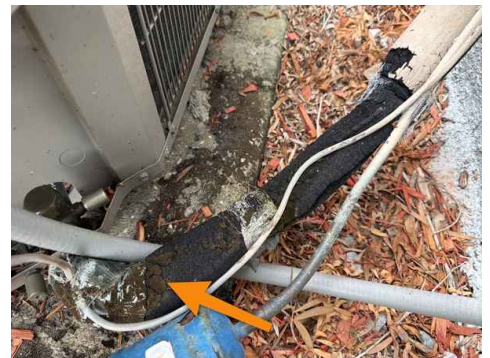
Back

## 4.2.1 B. Cooling Equipment

**CONDENSER - FREON INSULATION MISSING OR DAMAGED**

Missing or damaged insulation on the refrigerant line can cause energy loss and condensation. Recommend contacting an HVAC professional to replace the missing or damaged insulation.

Contact a qualified HVAC professional.

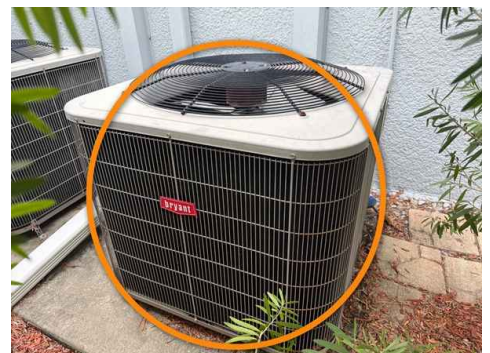
Back

## 4.2.2 B. Cooling Equipment

The condenser (outdoor unit) cooling equipment is nearing the end of its expected service life. It is anticipated that the equipment will need to be replaced within the next five (5) years.

Contact a qualified HVAC professional.

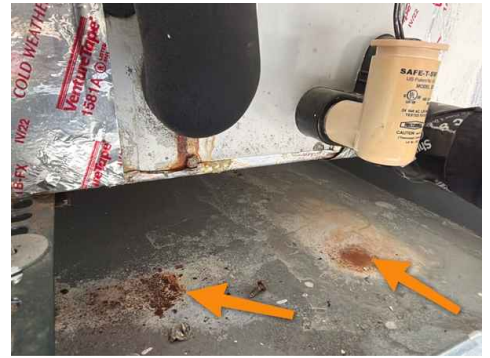
Garage

**EVAPORATOR - RUST PRESENT IN PAN**

Rust is present in the cooling system emergency overflow pan under the AC evaporator (inside unit). This could be caused by malfunctioning with consistent overflows and may not be an active issue. No active condensation leak into the pan is observed. Recommend careful monitoring.

Contact a qualified HVAC professional.

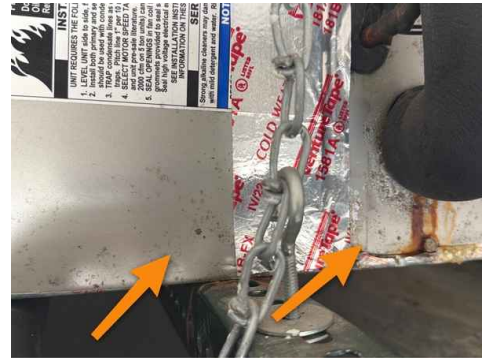
Garage

Mildew (or black mildew-like substance) is present in areas of HVAC evaporator. Areas that have mildew are often higher in moisture content and will need to be cleaned more frequently. Recommend cleaning areas with a antimicrobial and possibly testing for the presence of mold.

Recommended DIY Project

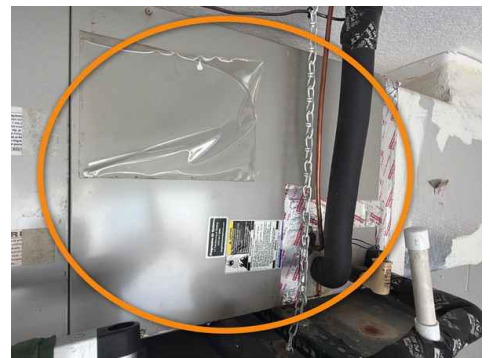
Garage

The evaporator (inside unit) cooling equipment is nearing the end of its expected service life. It is anticipated that the equipment will need to be replaced within the next five (5) years.

Contact a qualified HVAC professional.

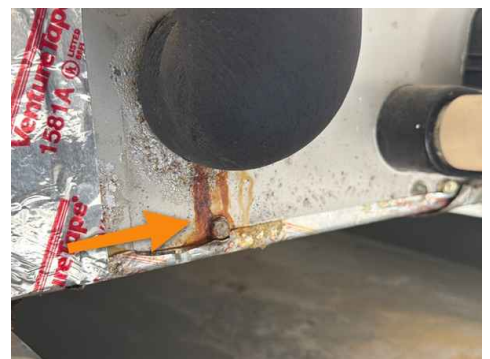
Garage

**EVAPORATOR- CORROSION**

Corrosion was observed at the evaporator coil cabinet. The presence of rust and corrosion may indicate past or ongoing moisture exposure or elevated humidity levels within the system. Continued deterioration could affect the service life of the equipment and surrounding components. Recommend evaluation and repair by a qualified HVAC contractor as needed.

Contact a qualified HVAC professional.

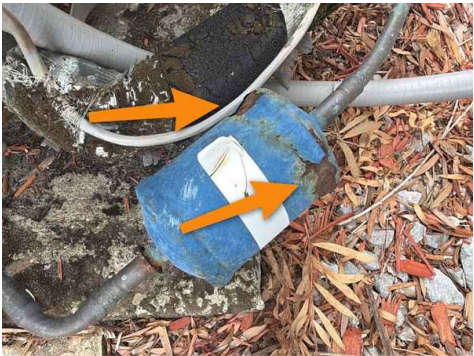
Back

**FILTER DRIER CORROSION**

Corrosion was observed on the HVAC refrigerant filter drier. Corrosion can contribute to deterioration of the component and may indicate prolonged exposure to moisture or environmental conditions. While the system was operational at the time of inspection, recommend evaluation by a qualified HVAC contractor and replacement as needed to help ensure continued system reliability.

Contact a qualified HVAC professional.

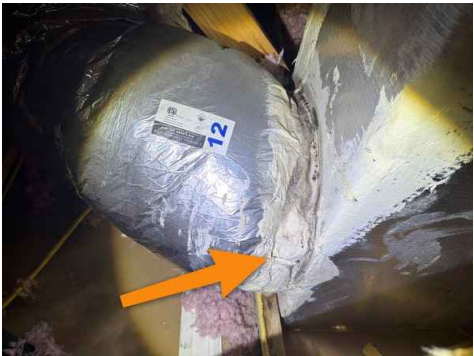
Front Attic

Ductwork was observed not properly sealed. Insufficiently sealed ducts can allow air leakage, reducing system efficiency and potentially introducing contaminants into the system. Recommend sealing by a qualified HVAC contractor.

Contact a qualified HVAC professional.

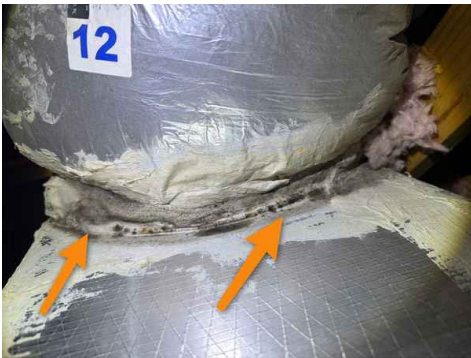
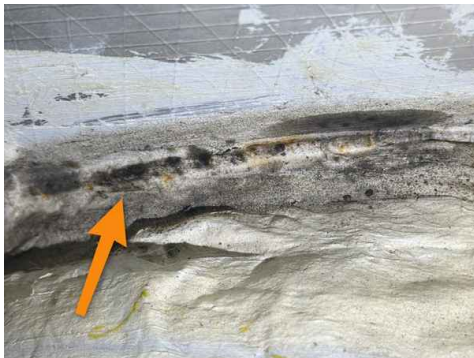
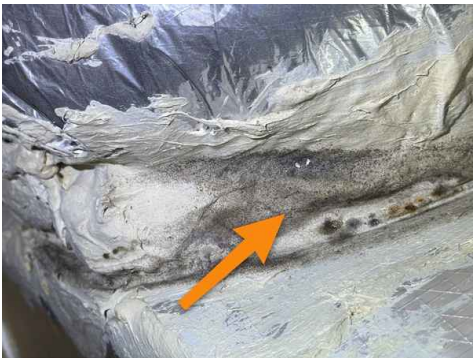
Front Attic

A mold-like substance was observed on HVAC ducting. The substance was not tested for mold identification. Recommend further evaluation and cleaning by a qualified HVAC contractor or mold remediation specialist as needed.

Contact a qualified mold inspection professional.

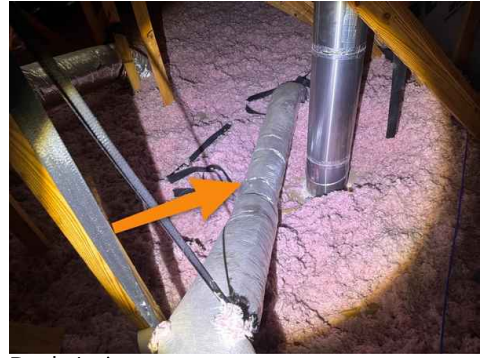
Back Attic

**DUCT IS IMPROPERLY SUPPORTED**

Section of HVAC ductwork were observed sagging/improperly supported. Condition may restrict airflow, reduce system efficiency, and place stress on duct connections. Recommend repair and proper support by a qualified HVAC contractor.

Contact a qualified HVAC professional.

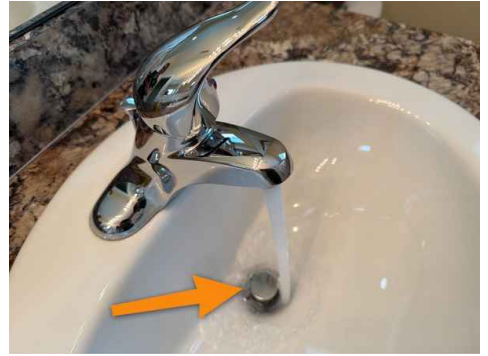
Hall Bathroom

The faucet / spigot drain pull is not functioning properly. Recommend plumbing contractor to resolve issue.

Contact a qualified plumbing contractor.

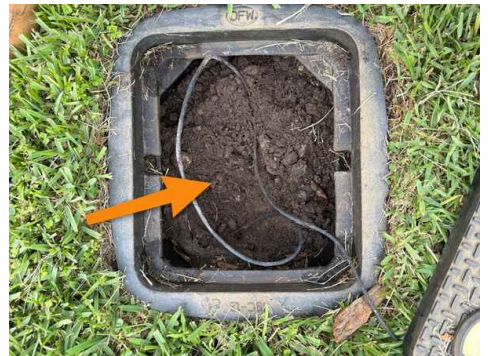
Front

Debris / dirt was observed inside the water meter box. Accumulated debris may interfere with access to the meter or valve components. Recommend clearing the debris to maintain proper access and functionality. This condition can typically be addressed by a general handyman.

Contact a qualified handyman.

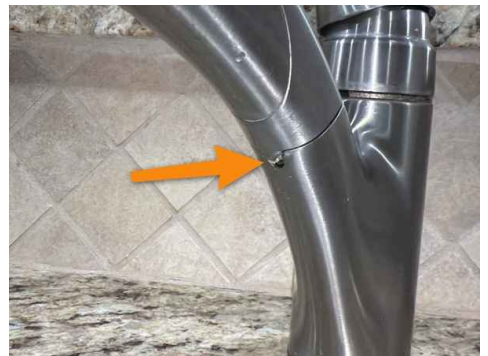
Kitchen

**GENERAL DAMAGE TO FAUCET**

General damage was observed at the faucet fixture. The damaged condition may affect normal operation, appearance, or service life. Recommend repair or replacement as needed.

Contact a qualified plumbing contractor.

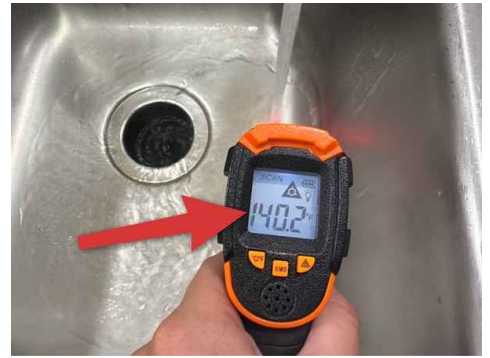
140°F

## 5.3.1 C. Water Heating Equipment

A temperature above one-hundred thirty (130) degrees Fahrenheit is general considered to be unsafe. Recommend a plumbing contractor evaluate why the water heater is producing water that is considered too hot.

Contact a qualified plumbing contractor.

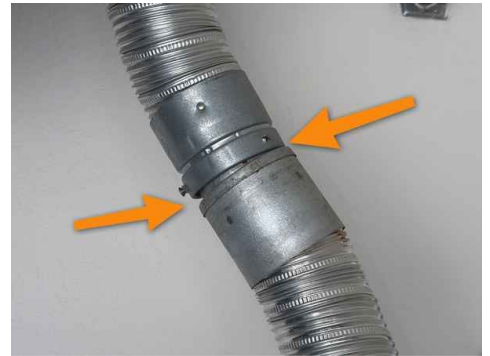
Garage

## 5.3.2 C. Water Heating Equipment

Contact a qualified HVAC professional.

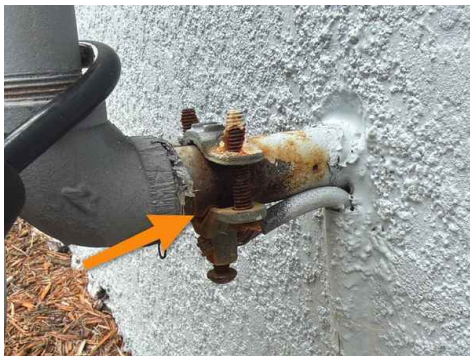
Left

## 5.5.1 F. Gas Distribution Systems and Gas Appliances

**CORROSION AND DETERIORATION OBSERVED**

Contact a qualified plumbing contractor.
