4-Point Inspection Form

Insured/Applicant Name:	Buyer Name	Application / Policy #:				
Address Inspected: 1234	Main St , Tampa, FL 33607					
Actual Year Built: 1976		Date Inspected: 06/20/2025				
Minimum Photo Requirements						
☑ Dwelling: Each side ☑ Roof: Each slope ☑ Plumbing: Water heater, under cabinet plumbing/drains, exposed valves						
☑ Main electrical service panel with interior door label						
☑ Electrical box with panel off						
☑ All hazards or deficiencies noted in this report						
A Florida-licensed inspector must complete, sign and date this form.

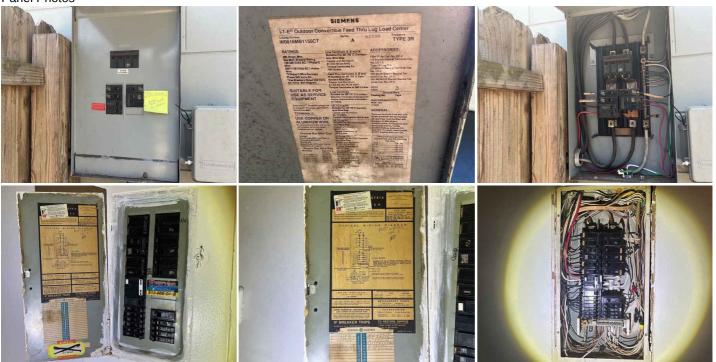
Panel Photos

General condition of the electrical system: ☑ Satisfactory ☐ Unsatisfactory (explain)						
Supplemental information						
Main Panel Second Panel			Wiring Type			
Panel age: Aprx 15 Panel age: Aprx 49			☑ Copper ☑ NM, BX or Conduit			
Year last updated: N/A						
Brand/Model: ITE. Siemens Brand/Model: General E		lectric

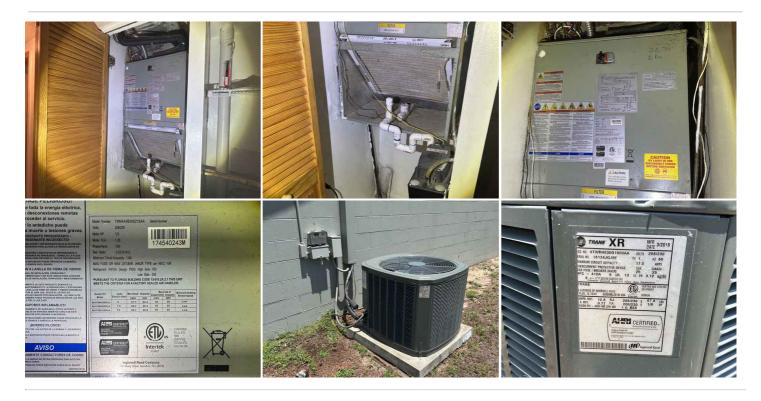
HVAC Equipment

HVAC System						
Central AC: ✓ Yes ☐ No						
Central heat: ☑ Yes ☐ No						
If not central heat, indicate primary heat source and fuel type:						
Are the heating, ventilation and air conditioning systems in good working or	rder? ☑ Yes ☐ No (explain)					
Date of last HVAC servicing/inspection:						
Hazards Present						
Wood burning stove or central gas fireplace not professionally installed?]Yes ☑No					
Space heater used as primary heat source? ☐ Yes ☑ No						
Is the source portable? ☐ Yes ☑ No						
Does the air handler/condensate line or drain pan show any signs of blockage or leakage, including water damage to the surrounding area?						
Supplemental Information						
Age of system: 2018						
Year last updated: N/A						
(Please attach photo(s) of HVAC equipment, including dated manufacturer's	s plate)					
Plumbing System						
Is there a temperature pressure relief valve on the water heater? 🗹 Yes 🗆	∃No

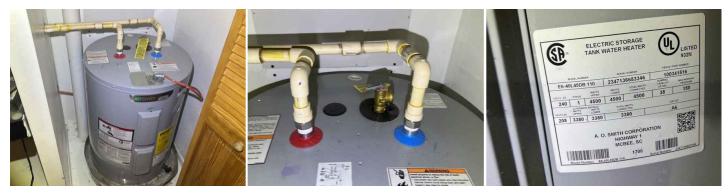
Is there any indication of an active leak? \square Yes \bowtie No Is there any indication of a prior leak? \square Yes \bowtie No						
Water bases baseling						
Water neater location: Hall Closet: Manufactured 2023 General condition of the following plumbing fixtures and connections to applicances:						
	1					
Satisfactory Unsatisfactory N/A Dishwasher ☑ □ □	Satisfactory Unsatisfactory N/A Toilets ☑ ☐ ☐					
Refrigerator	Sinks 🗹 🗆					
Washing Machine ☐ ☐	Sump pump □ □ ☑					
Water Heater	Main shut off valve ☐ ☐					
Showers/Tubs	All other visible					
If unsatisfactory, please provide comments/details (leaks, wet/soft spots, mold, corrosion, grout/caulk, etc.).						
Supplemental Information						
Age of Piping System:	Type of pipes (check all that apply)					
X_ Original to home	☑ Copper					
Completely re-piped	□ PVC/CPVC					
Partially re-piped	☐ Galvanized					
(Provide year and extent of renovation in the comments below)	□PEX

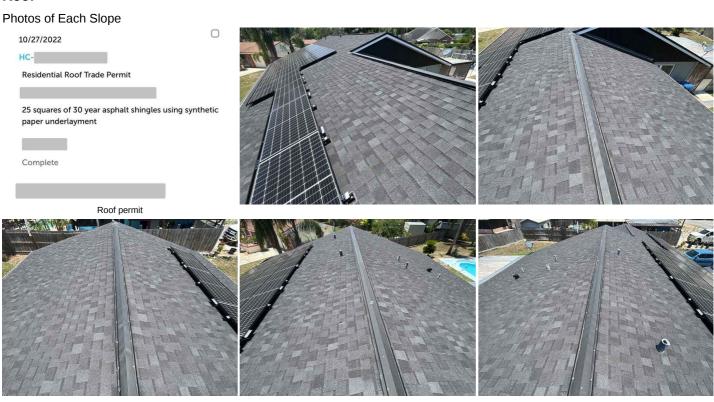
Roof (With photos of each roof slo	pe, this section can take the place of	the Roof Inspection Form.)					
Predominant Roof Covering material: Architectural shi Roof age (years): 3 Remaining useful life (years): 17 Date of last roofing permit: 2022-10- Date of last update: If updated (check one):		Secondary Roof Covering material: Roof age (years): Remaining useful life (years): Date of last roofing permit: Date of last update: If updated (check one):					
☑ Full Replacement ☐ Partial Replacement % of replacement		☐ Full Replacement ☐ Partial Replacement % of replacement					
Overall condition:		Overall condition:					
☑ Satisfactory ☐ Unsatisfactory (explain below)		☐ Satisfactory ☐ Unsatisfactory (explain below)					
Any visible signs of damage / deter (check all that apply and explain below Cracking Cupping/Curling Excessive granule loss Exposed asphalt Exposed felt Missing/loose/cracked tabs or til Soft spots in decking Visible hail damage Any visible signs of leaks Yes Attic/underside of decking Yes Interior ceilings Yes No	v) es ∄ No	Any visible signs of damage / deterioration? (check all that apply and explain below) Cracking Cupping/Curling Excessive granule loss Exposed asphalt Exposed felt Missing/loose/cracked tabs or tiles Soft spots in decking Visible hail damage Any visible signs of leaks Yes No Attic/underside of decking Yes No Interior ceilings Yes No
