SUMMARY
1234 Main St , Tampa, FL 33607
Buyer Name
07/09/2025

Abby Bullock
Professional Home Inspector
Merit Property Inspections
(813)485-4335
info@meritinspects.com

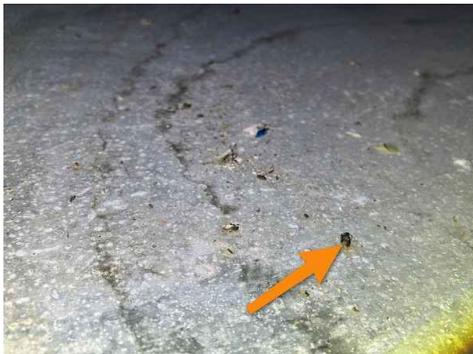
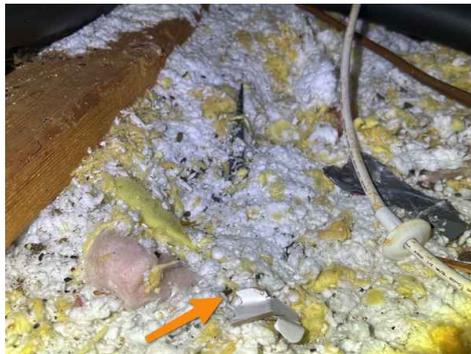
SIGNS OF RODENTS PRESENT

Rodent droppings, chew marks, travel paths, nests, dead rodents, and/or other signs of an active rodent infestation were present. Recommend a rodent control specialist to further evaluate and provide recommendations. Rodent control services may be warranted.

Contact a qualified pest control specialist.

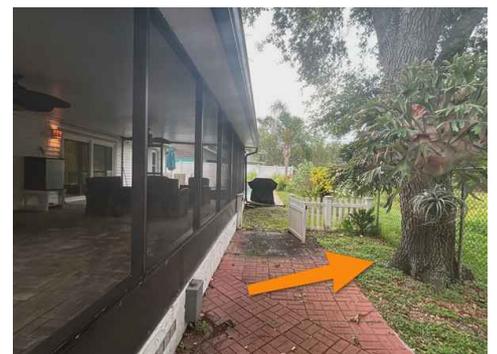
Back

TREES NEAR STRUCTURE

Trees growing near the structure may affect future performance of the foundation. Evaluate, remove, monitor, and/or address as necessary.

Recommended DIY Project

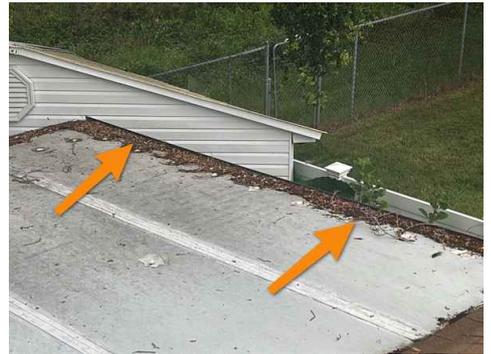
Back

GUTTERS ARE FULL

The gutters are full of leaves and debris. Recommend removal for functional use of gutters.

Contact a handyman or DIY project

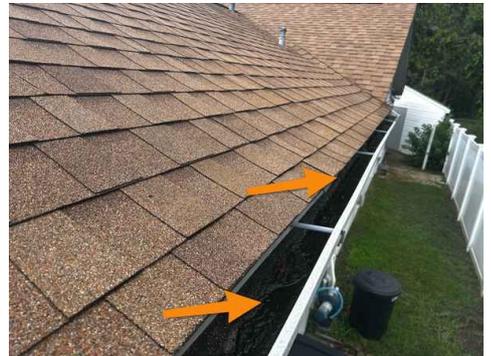
Right

GUTTER IS HOLDING WATER

Gutter is holding water. Gutters holding water are often sagging or clogged; They will hold debris, leak at joints, and/or will too heavy for the fascia. Recommend a gutter contractor to correct the issue.

Contact a handyman or DIY project

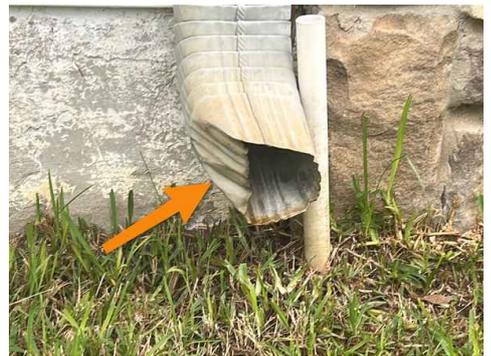
Left

GUTTER IS CRUSHED

A downspout gutter is crushed. This can cause flow restrictions and debris buildup in the gutter system that could lead to an overflow. Recommend replacing the crushed portion of the gutter as necessary.

Contact a handyman or DIY project

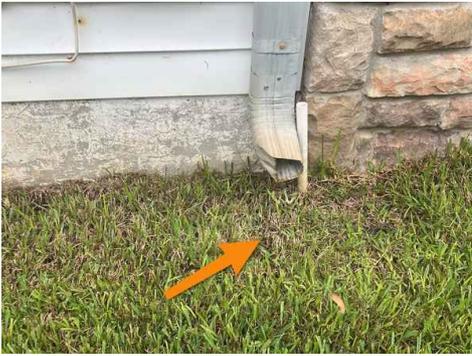
Left

GUTTER MISSING SPLASHBLOCK

Some or all of the gutter downspouts are missing splash blocks. Splash blocks help disperse the water away from the foundation and prevent the erosion of soils. Recommend installing splash blocks at all necessary locations.

Contact a handyman or DIY project

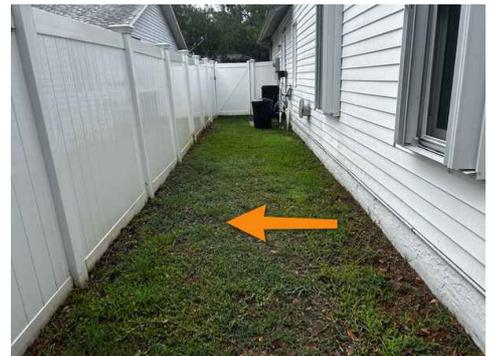
Right

2.2.5 B. Grading and Drainage
NO GRADING (FLAT) SLOPE

The grading around the structure is relatively level (flat). This may not allow for property water drainage away from the foundation. Ideally, the structure should be the highest point on the property to promote good drainage and water run off away from the structure. Evaluate and address as necessary.

Recommendation
 Contact a qualified landscaping contractor

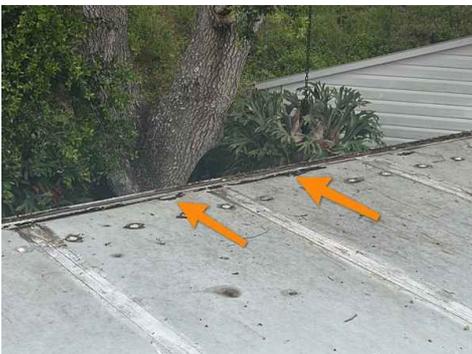
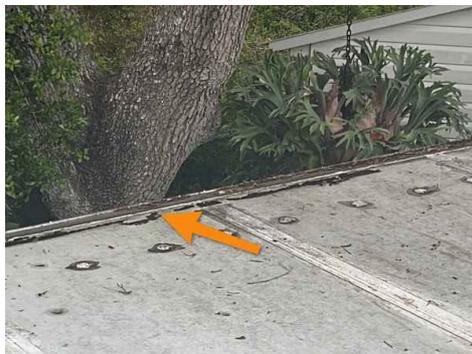
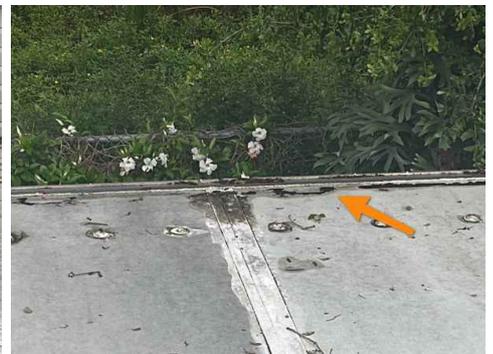
2.3.1 C. Roof Covering Materials
MINOR ROOF SCUFFS

ROOF
 The roof exhibited scuff marks in localized areas. While the damage is currently superficial and does not appear to affect the overall integrity of the roof or had an active leak, continued wear in these areas could lead to premature deterioration. Monitoring is recommended, and repairs should be considered if the condition worsens to prevent potential water intrusion or further degradation.

Recommendation
 Contact a qualified roofing professional.

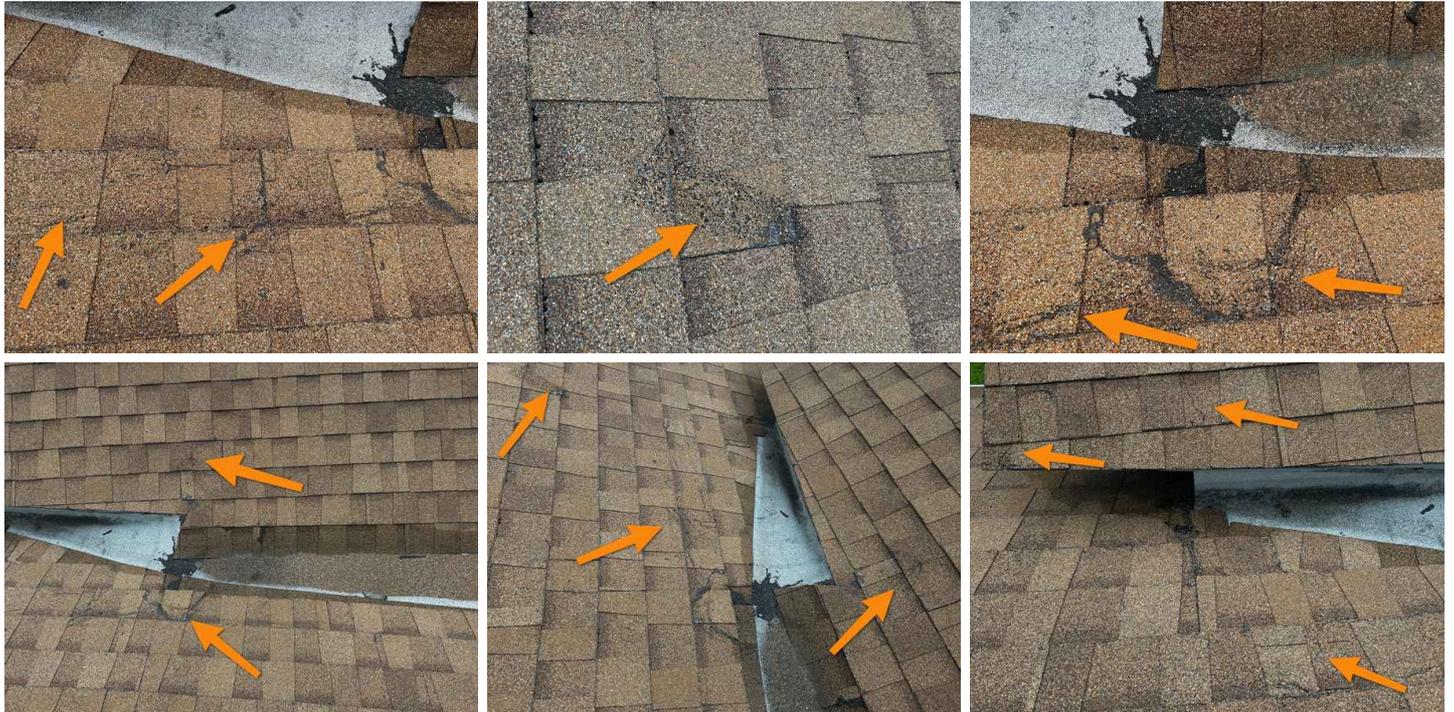
2.3.2 C. Roof Covering Materials
DAMAGED COVERINGS/SCUFFING

Roof coverings exhibited general damage and/or scuffing that could affect performance. Recommend a qualified roofer evaluate and repair.

Contact a qualified roofing professional.

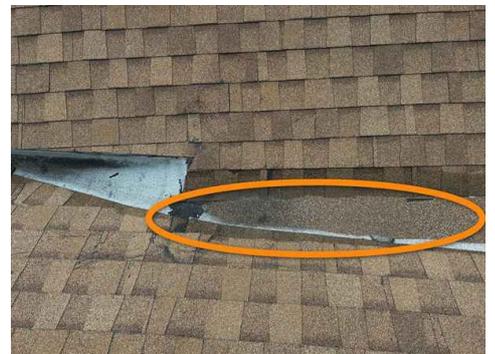
INSUFFICIENT WATER SHEDDING

Areas of the roof have insufficient water shed and ponding. Ponding can lead to accelerated erosion and deterioration. It may lead to leaks. Recommend a qualified roofer evaluate and repair.

Contact a qualified roofing professional.

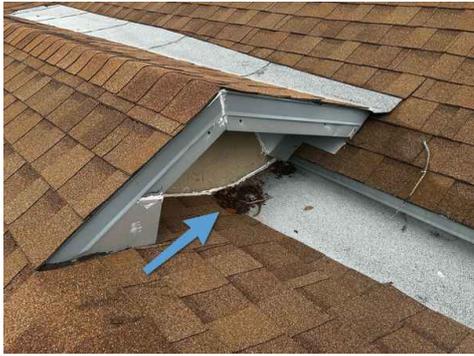
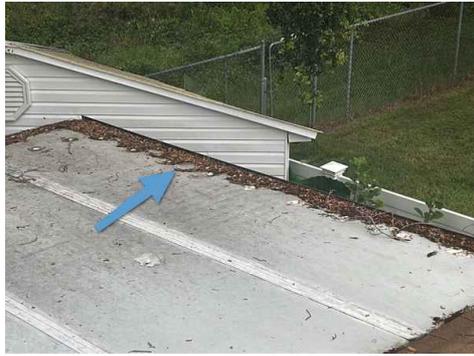
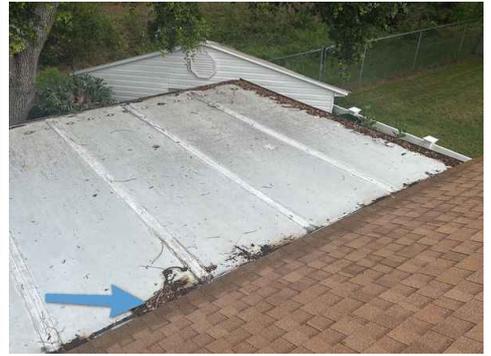
DEBRIS PRESENT

Excessive debris can cause the ponding of water and the leaking of a roof. It can also cause the deterioration of shingles. Recommend removal.

Recommended DIY Project

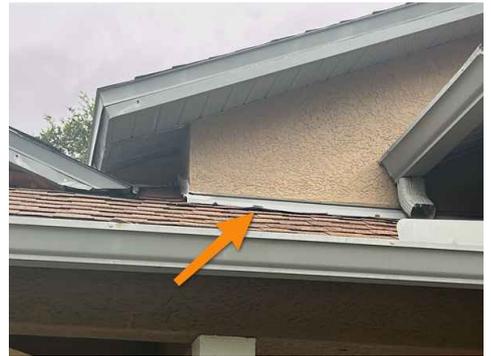
Front

2.3.5 C. Roof Covering Materials
LIFTED SHINGLES

Areas of the roof show lifted shingles. This is typically caused by high gusts of wind. Lifted shingles will not seal with the lower shingles and allow for water intrusion. Recommend a roofing contractor to replace.

Recommendation
 Contact a qualified roofing professional.

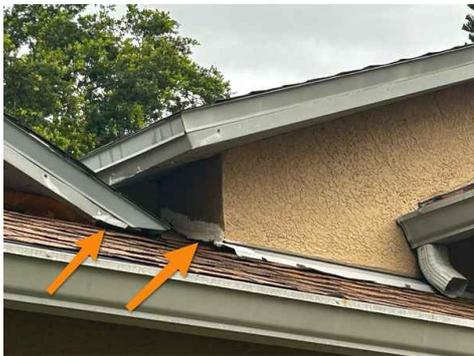
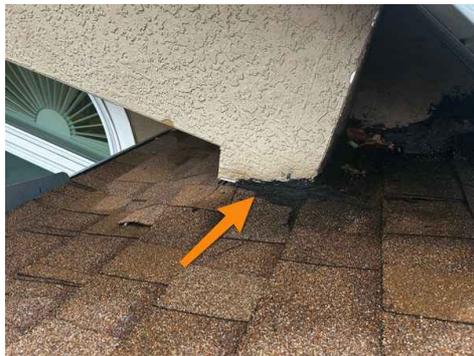
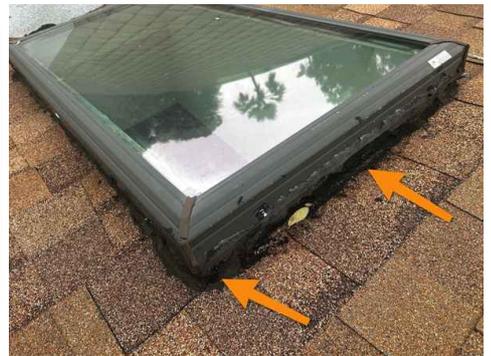
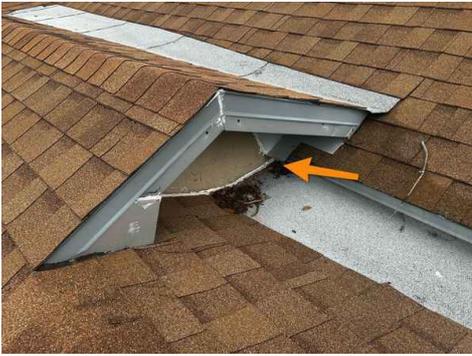
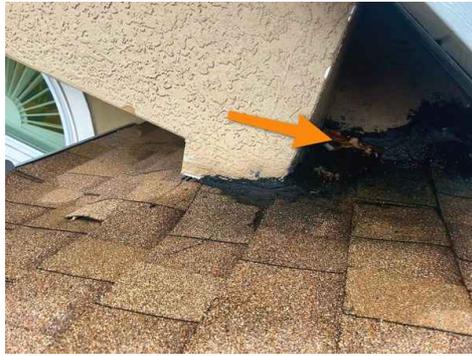
2.3.6 C. Roof Covering Materials
IMPROPER/ INSUFFICIENT FLASHING

Flashing is improperly installed and insufficient in multiple areas. Wall/ skylight is missing proper step flashing and/or counter flashing. Missing and/or incorrectly installed flashing can cause water penetration / rot and eventually structural damage. Recommend replacement of the flashing by correct installation method.

Recommendation
 Contact a qualified roofing professional.

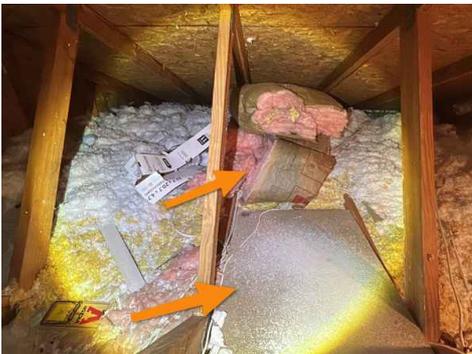
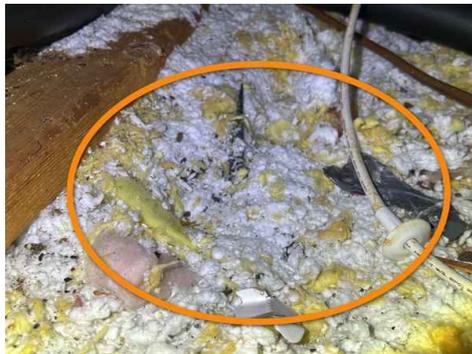
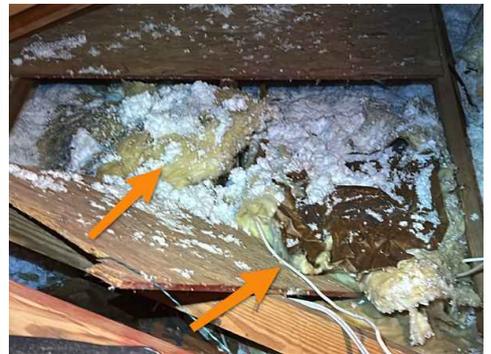
2.4.1 D. Roof Structures and Attics
DAMAGED INSULATION

Insulation appears to have been pulled out and/or damaged by contractors and/or pests. Recommend a qualified insulation contractor evaluate and repair.

Recommendation
Contact a qualified insulation contractor.

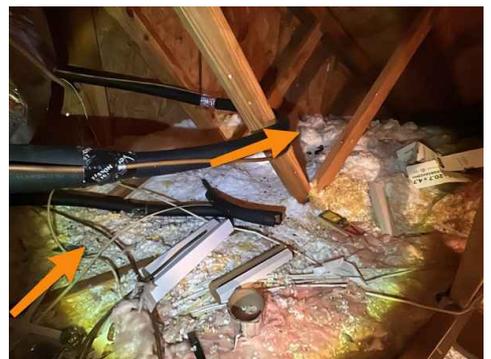
Bedroom Attic

2.4.2 D. Roof Structures and Attics
INSULATION IS UNEVENLY DISTRIBUTED

Insulation in the attic unevenly distributed and not smooth / even across the attic surface. This is common in older structures where attic insulation has been moved for repairs and installations.

Insulation that is not smooth and even across the attic surface will be less efficient and will be unable to create a thermal barrier as intended. Recommend a insulation contractor smooth the insulation and/or install new insulation in areas of the attic, as necessary.

Recommendation
Contact a qualified insulation contractor.

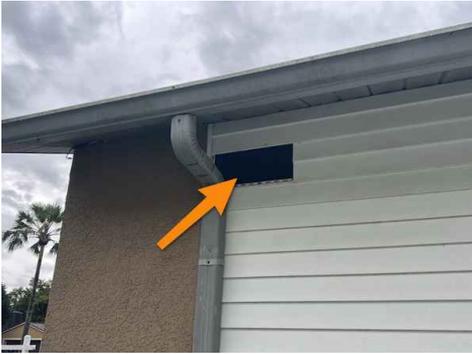
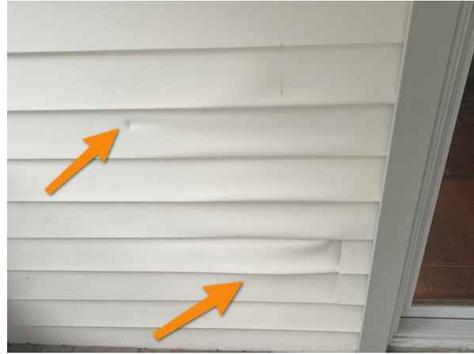
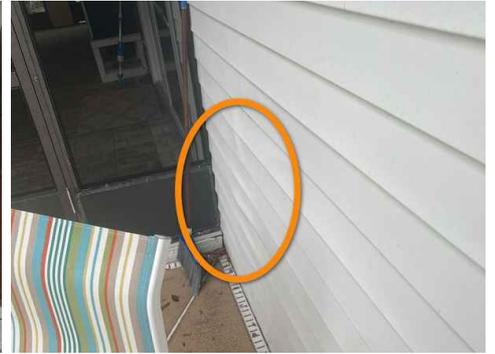
2.5.1 E. Walls (Interior and Exterior)
SIDING IS DAMAGED OR MISSING

The siding is damaged or missing in these areas. Recommend a general contractor to resolve, as necessary.

Recommendation
Contact a qualified general contractor.

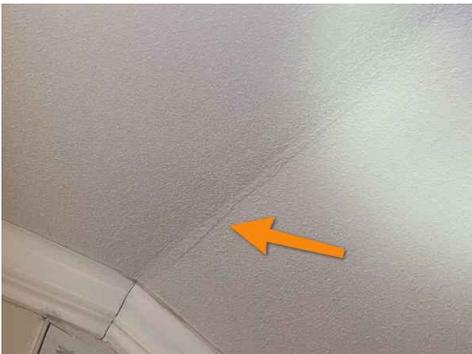
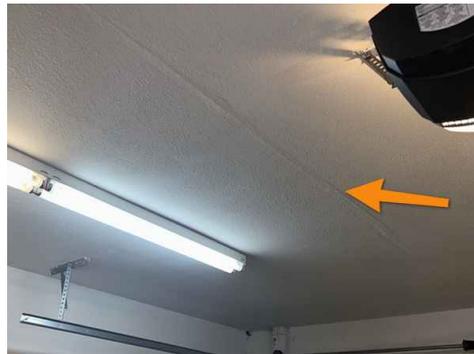
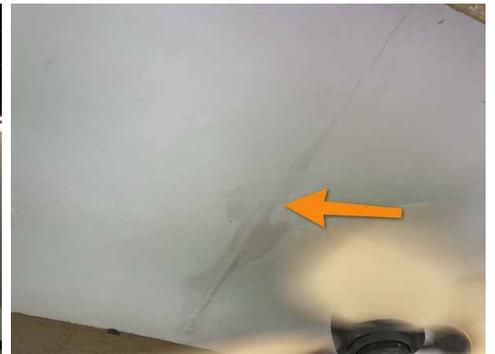
CEILING - SHEETROCK CRACKS MINOR

Minor sheetrock cracking was observed on the ceiling. This is common in structures this age and is often determined to be cosmetic, most often the separation of drywall tape joints. Recommend patching, repainting, monitoring these locations for further cracking.

Contact a qualified painting contractor.

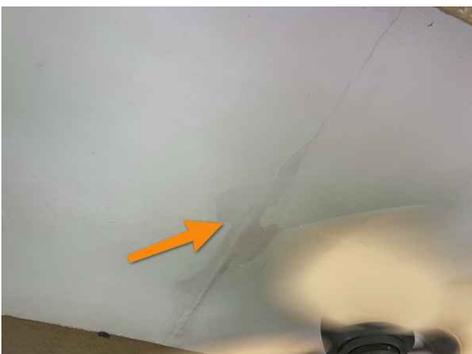
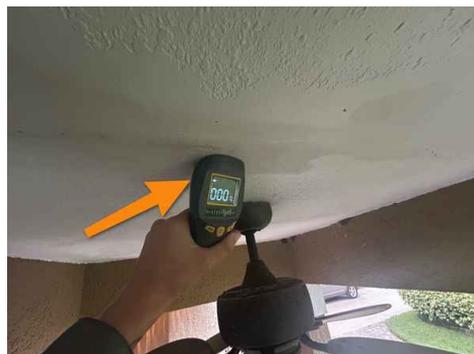
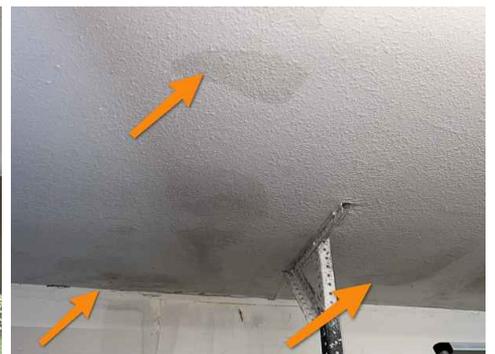
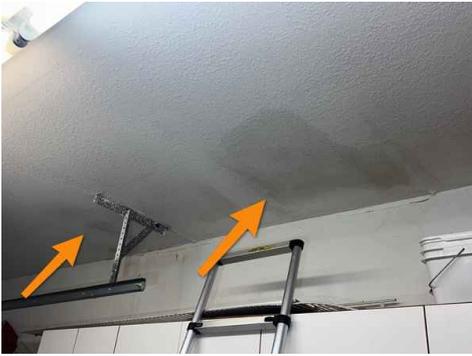
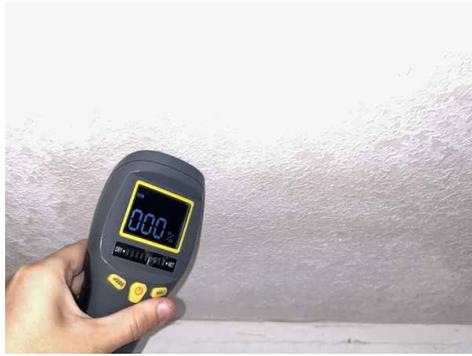
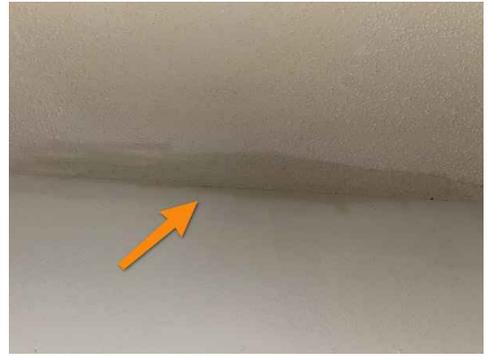
CEILING - WATER STAIN OBSERVED

A stain on the ceiling is present. This stain did not visually appear damp and could be from a previously resolved water leak. No moisture was detected. Recommend repainting, monitoring, and addressing as necessary.

Contact a qualified painting contractor.

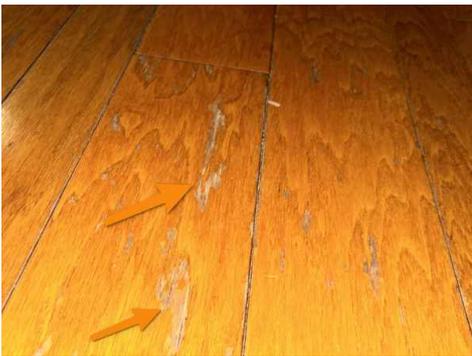
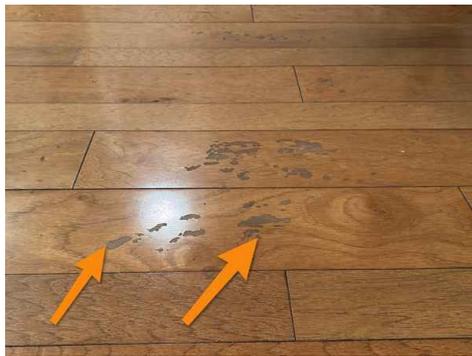
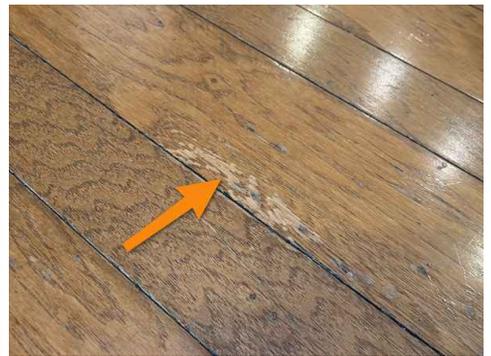
2.6.3 F. Ceilings and Floors
FLOORING - DAMAGED

The flooring had general moderate damage visible at the time of the inspection. Damaged flooring may be primarily cosmetic and should be resolved as necessary. Recommend evaluation by a qualified flooring contractor.

Recommendation
Contact a qualified flooring contractor

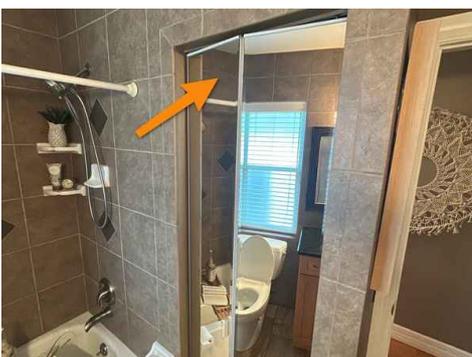
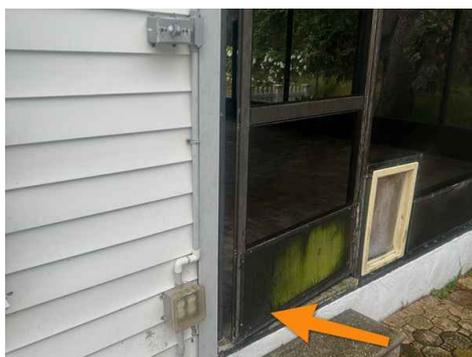
2.7.1 G. Doors (Interior and Exterior)
DOOR RUBS / STICKS AND IS MISALIGNED

Door sticks, rubs the frame, and is tough or impossible to open and/or close. The door is not aligning with the frame. Recommend hiring a door repair and installation contractor to realign the door.

Recommendation
Contact a qualified door repair/installation contractor.

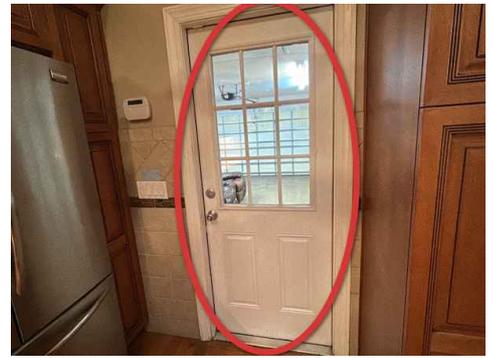
Kitchen/ Garage

DOOR IS NOT FIRE RATED

The door does not appear to be fire-rated and lacks compliance indication with fire safety standards. This may compromise fire safety by failing to slow the spread of fire and smoke, which is especially critical in locations like garage-to-home entries. It is recommended to consult a licensed contractor or fire safety specialist to replace the door with one meeting the required fire-rating standards and ensure proper installation to maintain its fire-resistant integrity.

Contact a qualified door repair/installation contractor.

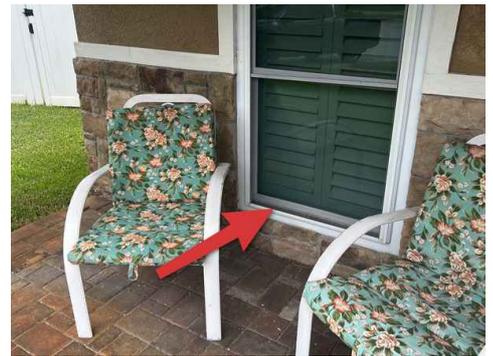
Front

WINDOW IS TOO LOW

Window fails to meet the minimum safety measurement requirements. Windows should be constructed with a sill that is higher than 24 inches. A bar lock in place is necessary for windows that have a sill less than 24 inches. Recommend installing a bar lock or moving/replacing window.

Contact a qualified window repair/installation contractor.

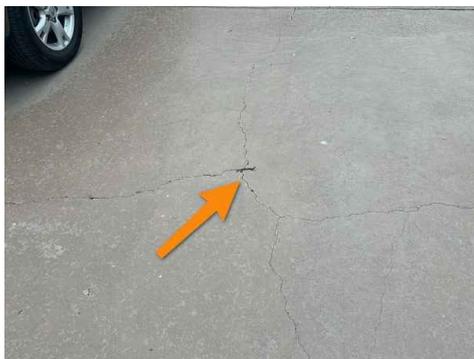
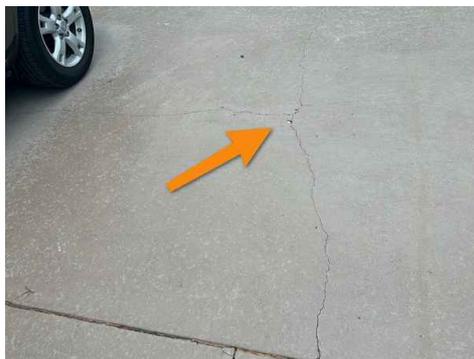
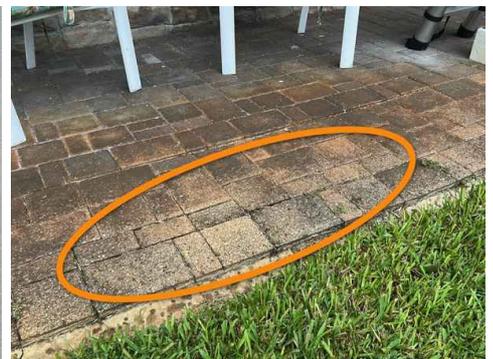
CRACKS, SEPARATION, OR HEAVING

The porch show signs of aged cracking, separation, heaving, and/or deterioration. Compromised concrete will continue to exhibit decay, failure, collapse, and uplift if not remediated. Recommend caulking larger cracks and applying a concrete sealer. Cracking can also be a safety tripping hazard for pedestrians.

Recommend monitoring.

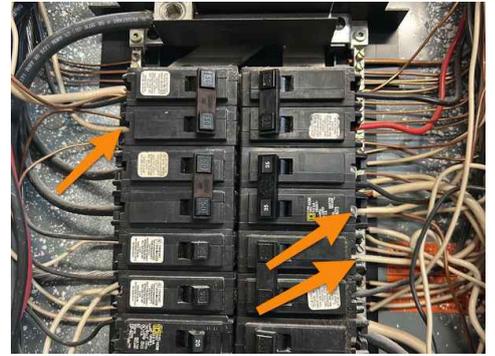
Garage

WHITE HOT WIRE NOT TAPED BLACK

A white wire is connected directly to a breaker without black electrical tape, which would indicate that it is a hot conductor. This white wire is being used as a phase or hot conductor rather than neutral, which in-itself is not an issue, but should be denoted as such with black electrical tape wrapped around a portion of it. This will allow an electrician servicing the panel to better understand how the electrical wires are routed. Recommend denoting the white wire as a hot conductor by wrapping it with black electrical tape.

Contact a qualified electrical contractor.

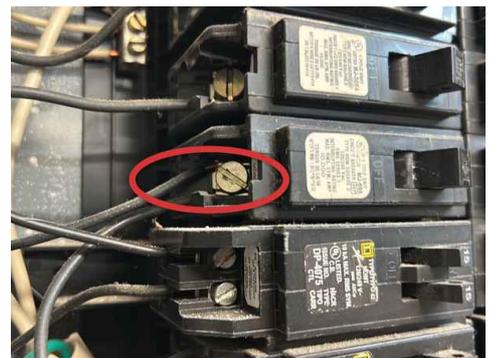
Garage

DOUBLE-TAPPED BREAKER

A breaker has been double-tapped. The junction of two or more electrical wires should be completed before the breaker. This is considered a fire hazard. No more than one (1) wire should be connected to each breaker terminal. Recommend separating the double tapped breaker into two breakers (if room allows) or making the junction of the wires prior to the breaker.

Contact a qualified electrical contractor.

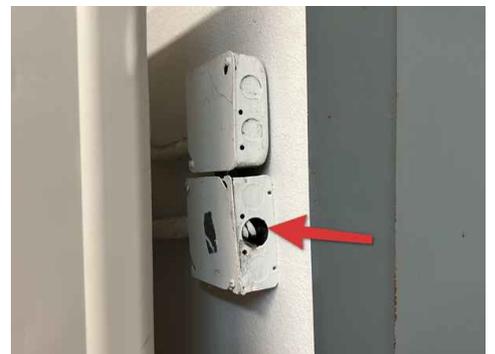
Garage

MISSING KNOCKOUT PLATE FILLER

Without filler plates, fingers can fit through the opening creating a safety hazard. Recommend installing the filler plates or contacting an electrician who can install them.

Contact a qualified electrical contractor.

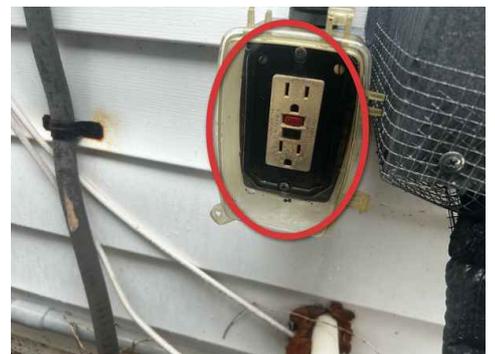
Left

COVER PLATES ARE NOT WATER RESISTANT

The outdoor outlet did not have a water-resistant cover installed, which helps prevent electrical shocks in damp weather. The current standard is an "in-use" cover (or "bubble cover"), which can be fully closed with an extension cord in use.

Contact a qualified electrical contractor.

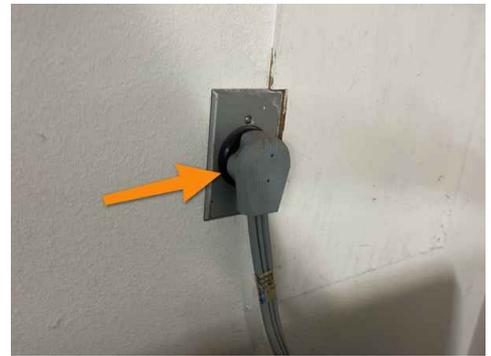
Garage

LAUNDRY PLUG IS A 3-PRONG STYLE

Laundry plug is a 3-prong style. The ground and neutral wires on 3-pronged outlets are grouped, creating the potential for an electrical shock. Electric dryers more recently contain 4-prong dryer cords that feature two hot wires, a neutral wire and a dedicated ground wire. This eliminates the possibility for a ground current traveling to the machine and considered safer.

Switching from 3-prong to 4-prong can be accomplished by using "dogbone" converters or switching out dryer cables. That said, this is a band-aid and not considered to be the preferred method. The safest method is to change out the wire (or run a separate ground) from the electrical panel to the outlet and changing out the plug itself.

Recommendation
Contact a qualified electrical contractor.

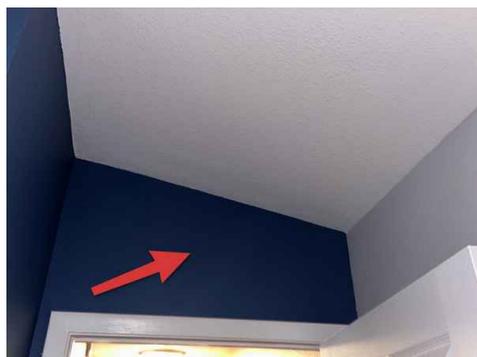
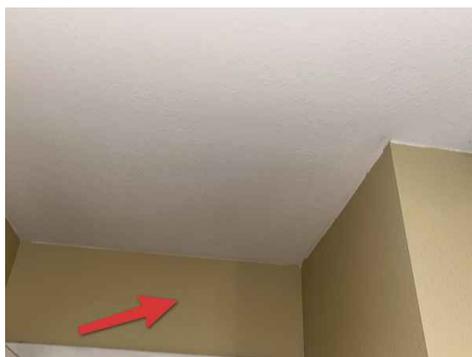
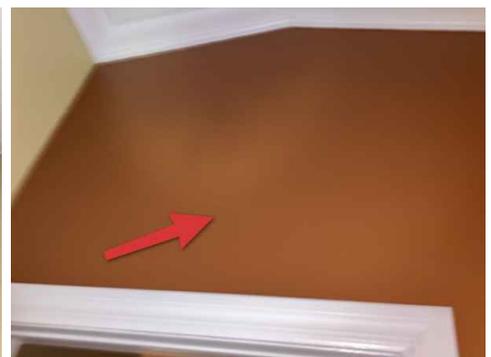
SMOKE ALARMS - MISSING (ENTIRE STRUCTURE)

Smoke alarms/detectors are missing in the structure in multiple locations. It is recommended that smoke alarms be installed inside each bedroom, outside each sleeping area and on every level of the structure. On levels without bedrooms, it is recommended that alarms be installed in the living room (or den or family room) or near the stairway to the upper level, or in both locations. Recommend installation of smoke alarms/detectors in all areas of the structure, throughout the property, in all areas that require them.

Please see recommendations provided by the National Fire Protection Association (NFPA) about smoke alarms and their recommended placement. All smoke detectors should be installed in accordance with the manufacturer's recommendation and be UL listed.

Recommendation
Contact a qualified electrical contractor.

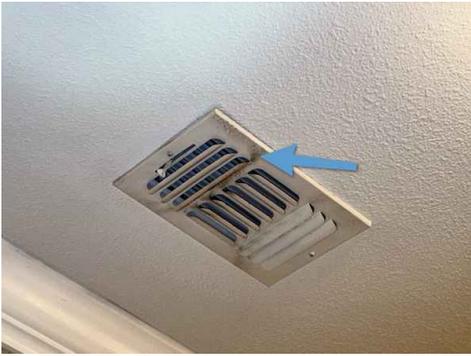
Primary Bathroom

DUCT CLEANING IS RECOMMENDED

Inspector has discovered evidence that the HVAC duct system should be cleaned. This includes either a visual investigation of the plenums through access ports (if available) or supply vents that are dirty, dusty, and/or clogged with debris.

Recommendation
Contact a qualified HVAC professional.

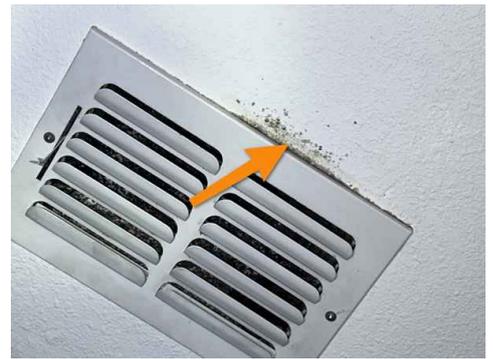
1st Bedroom

4.3.2 C. Duct Systems, Chases, and Vents
SUPPLY VENT(S) - MILDEW / MOLD PRESENT

A dark mold or mildew-like substance is suspected to be present on supply vents coming from the HVAC cooling equipment. This indicates the presence of moisture in and around the HVAC equipment, duct work, and/or at the supply registers. Recommend mold inspector identifying source of moisture intrusion and possibly sending samples to a lab for testing.

Recommendation
Contact a qualified mold inspection professional.

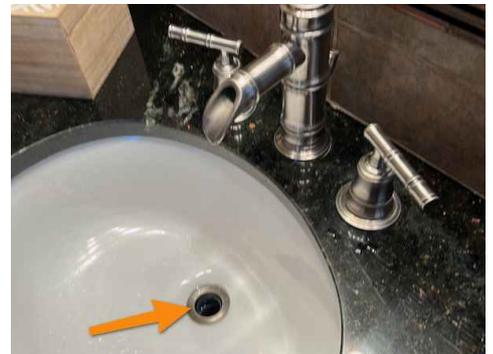
Primary Bathroom

5.1.1 A. Plumbing Supply, Distribution Systems, and Fixtures
FAUCET DRAIN PULL MISSING

The faucet drain pull is missing. Recommend plumbing contractor to resolve issue.

Recommendation
Contact a qualified plumbing contractor.

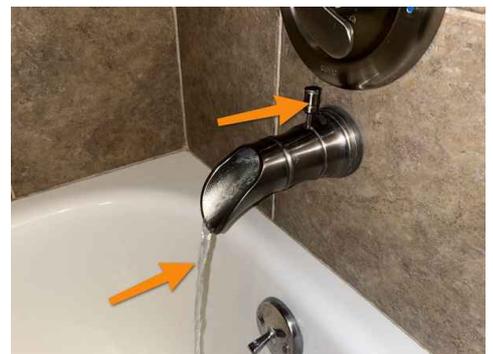
Primary Bathroom

5.1.2 A. Plumbing Supply, Distribution Systems, and Fixtures
TUB SPOUT DIVERTER IS NOT EFFECTIVE

The tub spout divert is not fully diverting water to the shower. A leaking and/or inefficient shower diverter wastes water and creates a lower-pressure shower experience. Repairing a shower diverter can be a DIY project, or you may want to consult a plumbing contractor.

Recommendation
Contact a qualified plumbing contractor.

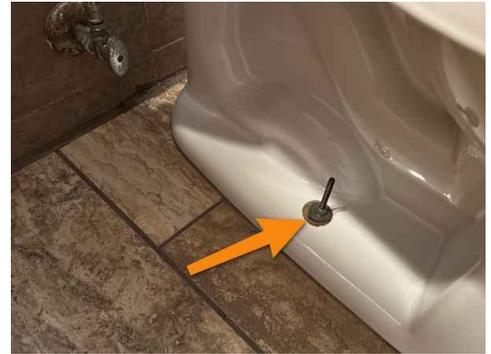
Primary Bathroom

TOILET IS LOOSE

The toilet is loose at toilet bolts- this may cause leaks, and is generally unsafe. Recommend tightening the toilet bolts or hiring a qualified plumbing contractor to tighten and further investigate.

Recommendation
Contact a qualified plumbing contractor.

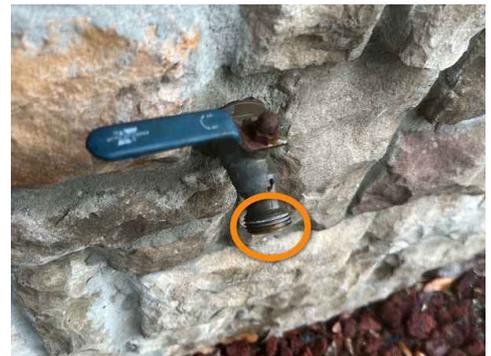
Front

NO BACKFLOW PREVENTER ON SPIGOT

A backflow preventer or vacuum breaker is required on all outdoor waterhose spigots to prevent the potential backflow of surface water from your yard into the public water supply in the event there is a municipal water supply problem. A vacuum breaker is acquired at a minimal expense and can be purchased in bulk online.

Recommendation
Recommended DIY Project

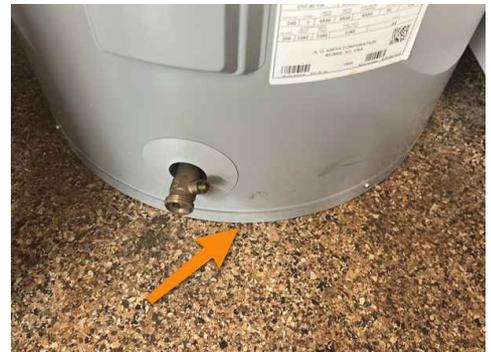
Garage

5.3.1 C. Water Heating Equipment
WATER HEATER SITTING ON THE GROUND

The water heater is not elevated off the ground. Water heaters that are sitting on the ground with rust-out faster than elevated water heaters.

Recommendation
Contact a qualified plumbing contractor.

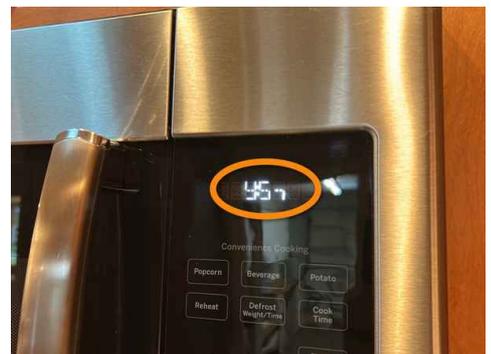
Kitchen

6.5.1 E. Microwave Ovens
CONTROL PANEL ISSUE

The microwave control panel is not easily read. Control panels age over time and can become harder to see, eventually becoming impossible. Some microwaves have settings to control the panel brightness. Recommend exploring settings or budgeting for a new microwave. Some higher-end microwaves may warrant service by an appliance repair technician.

Recommendation
Contact a qualified appliance repair professional.

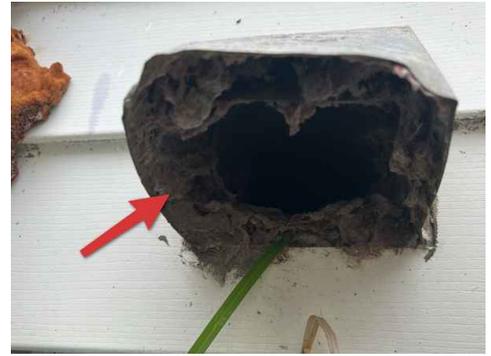
Right

VENT IS DIRTY

The dryer vent is dirty and may be partially clogged. Consider cleaning the vent prior to use to prevent the buildup of debris and possible fire hazard.

Contact a qualified plumbing contractor.

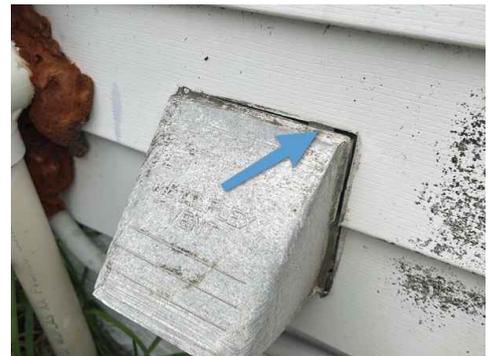
Right

VENT COVER IS NOT SEALED

The vent cover is not sealed to the wall, allowing for moisture and insect access. Recommend re-caulking.

Contact a qualified handyman.
