# Executive Summary

# Engineer's Foundation Evaluation

On 3/26/2024 a foundation evaluation was performed at the property located at address 123 Main St, Your City, FL, 12345, which consists of a 3079 square-foot single family attached structure built in 2008 (18 years old) with a slab on grade foundation.

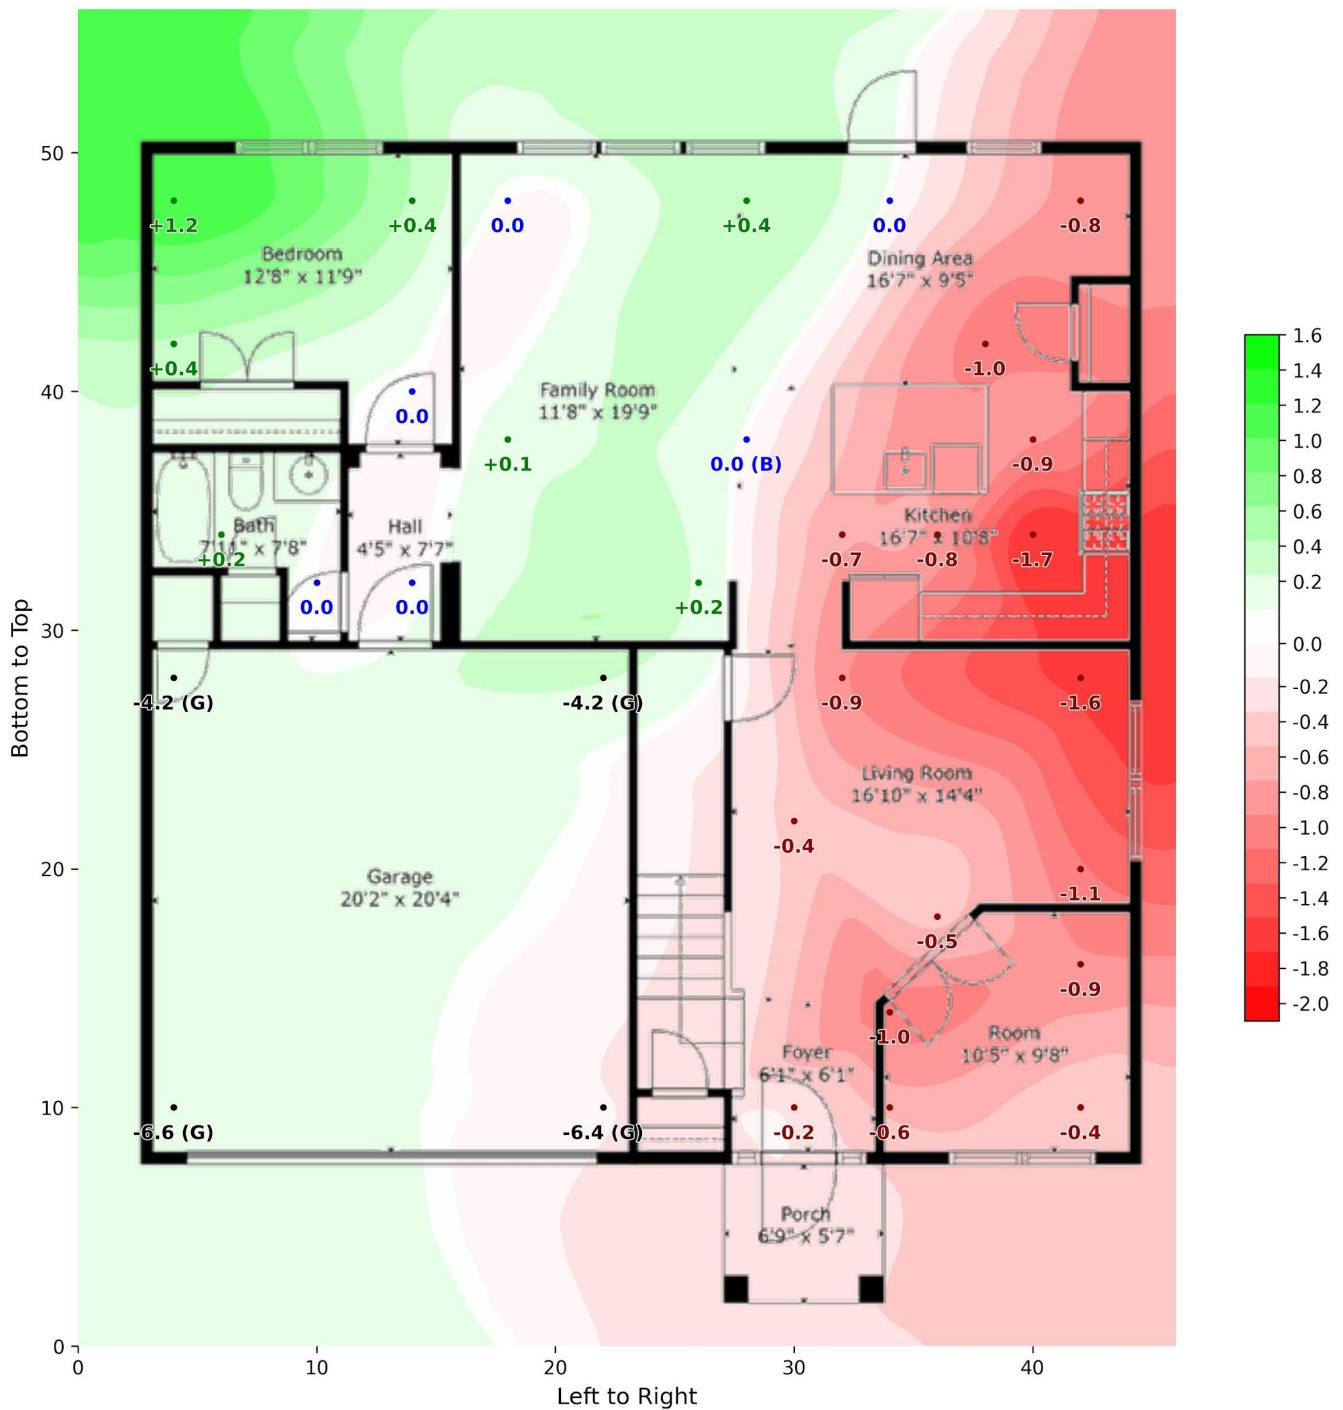
**Elevation Plot Graphic (Figure A)**

The elevation plot resulted in the graphic as depicted above in Figure A. The red-points and areas are elevation measurements that were lower than the base station elevation (0.0). The green-points and areas are elevation measurements that were higher than the base station elevation (0.0). The blue-points (and white areas) are equal to the base station elevation (0.0). The base station is depicted with a (B) symbol. The elevation plot takes into account differences in flooring thicknesses. The maximum elevation point was determined to be 1.2 inches and the minimum was -1.7 inches, resulting in an elevation difference of 2.9 inches of difference across the structure.

The elevation plot graphic above will show points labeled with a (G) symbol representing Garage. These elevation points were measured and plotted so they can be compared year-to-year, however, they are excluded from the foundation analysis. This is because garages can be non-monolithic and/or they are poured to purposefully slope toward the exterior garage door making any conclusions derived difficult to interpret.

Elevation differences across the structure are the first indicator that a foundation problem may or may-not exist. As documented above, the maximum elevation point of this structure was determined to be 1.2 inches and the minimum was -1.7 inches, resulting in an elevation difference of 2.9 inches of difference across the structure. The elevation plot takes into account differences in flooring thicknesses. The elevation deflection across an entire structure should, best-case-scenario, remain within 0.5 to 1-inch depending on the age of the structure. Measured differences approaching 2-inches are an initial sign of possible foundation fatigue. The maximum allowable elevation difference is subjective, depending on other factors such as the visual condition, size, and age of the structure (18 year(s) old) along with how the foundation performs when calculating deflection and tilt.

Based on observed elevations of the foundation from the elevation plot, the elevation differences do not fall within industry standards and tolerable limits. These findings indicate that the foundation does not have consistent and uniform elevation measurements. Note: elevation measurements alone are not the only indicator of foundation problems; see the deflection and tilt calculations (and the report's overall conclusion) for a complete understanding of foundation stabilization. If elevations fall outside of industry standard/tolerable limits, it is a first indicator that the foundation will fail in deflection and/or tilt.

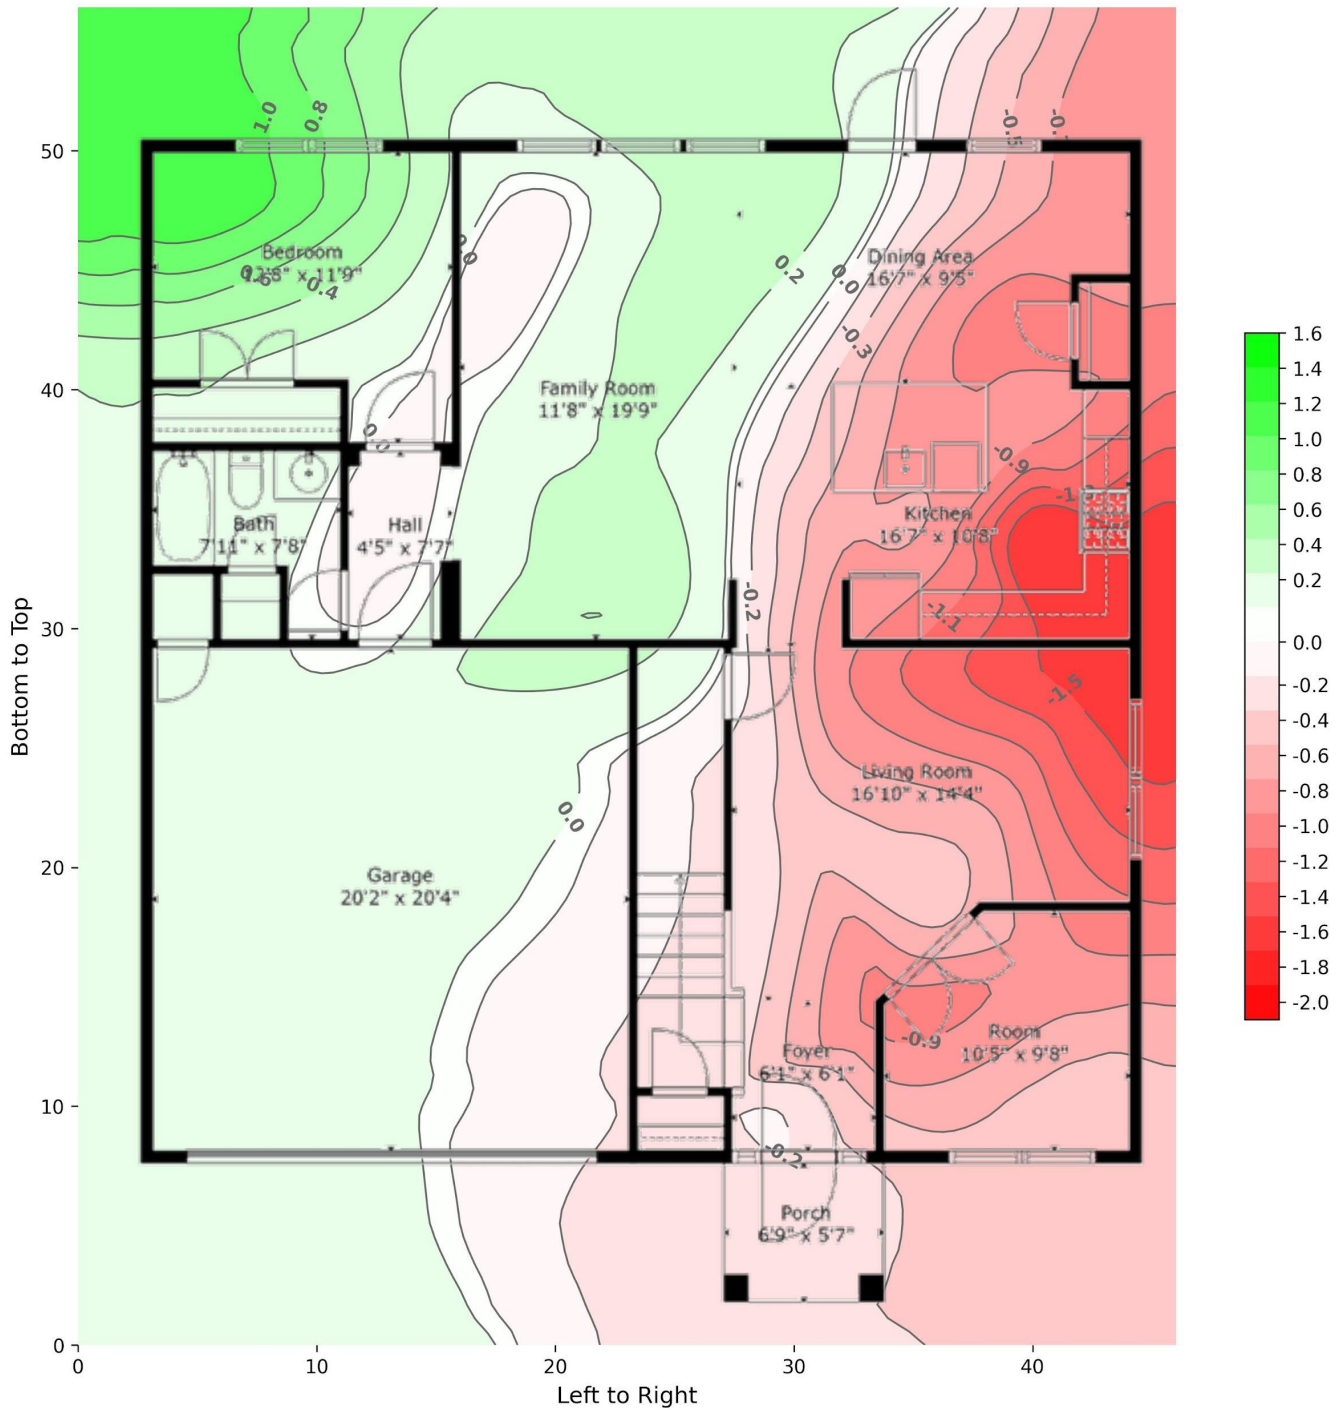
**Mesh Contour Graphic (Figure B)**

The mesh contours graphic depicted above in Figure B is similar to the elevation plot. The red, green, and white areas depict areas that are lower, higher, and equal to the base station elevation (0.0). The lines or contours (similar to map topography) are labeled at specific intervals.

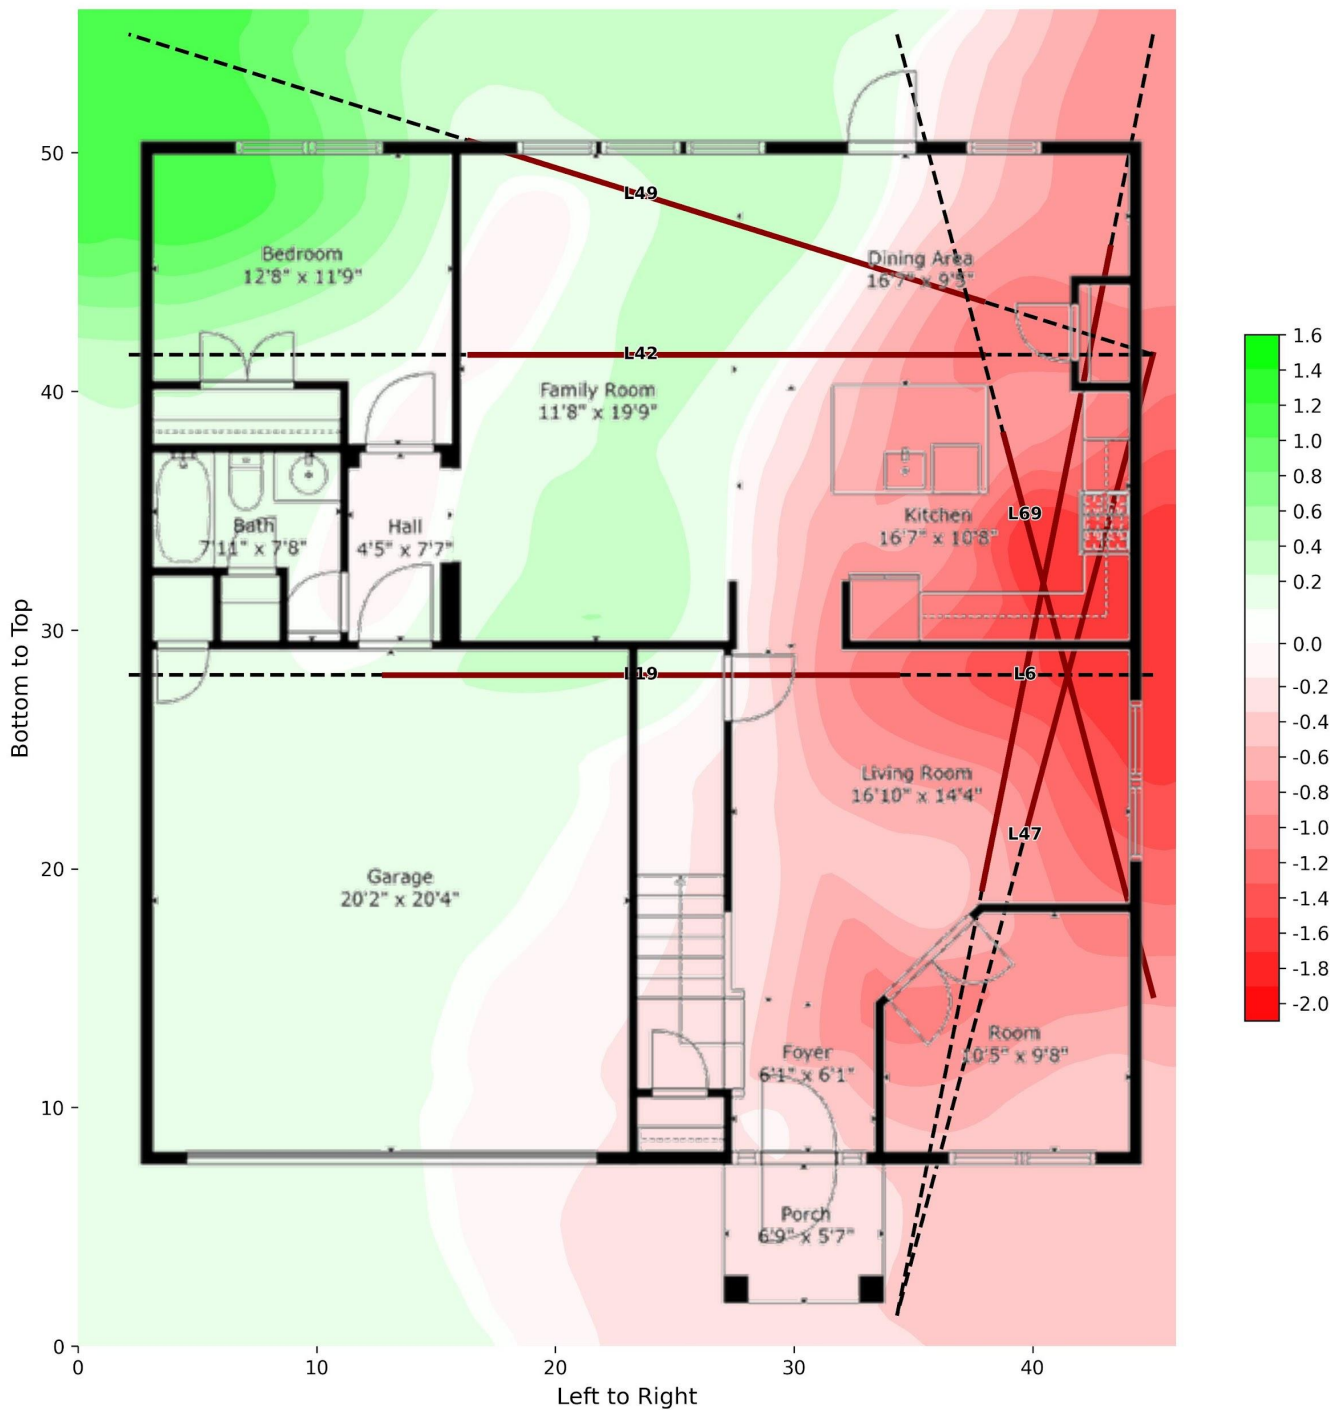
**Deflection Failures Graphic (Figure D)**

Below is a graphic that indicates the locations of the 6 deflection calculation failures.

The above Figure D shows deflection failures along the foundation. Deflection failures can be considered localized failures in (sometimes) isolated portions of the foundation. The profile lines that were calculated are represented by a dashed black line and the areas where the deflection failures occur are represented by a dark red line segment. Of the 75 deflection profiles calculated, 6 profile failures were identified.

Deflection failures can be considered localized failures of the foundation in (sometimes) isolated portions of the foundation. Of the 75 deflection profiles calculated, 6 failures were identified.

Deflection failures are above standard acceptable limits; they exceed industry-standard thresholds and the structure should be considered actively moving/settling in areas where deflection failures are occurring. See the report's overall conclusion for a complete understanding of the overall foundation stabilization issue.
