MERIT PROPERTY INSPECTIONS

PROPERTY INSPECTION REPORT

1234 Main St Tampa, FL 33607

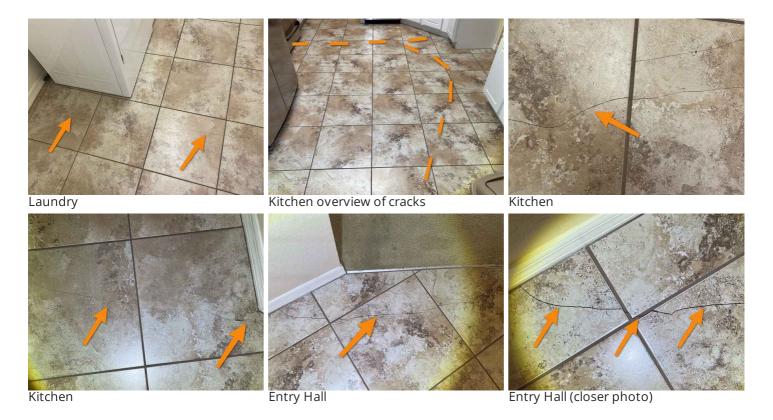
FLOORING - TILES LOOSE / CRACKED OR MISSING

Loose tiles that are popped or missing and/or cracking was observed. This is possibly due to structural foundation issues and is considered evidence of a structural deficiency if on the interior of the structure. Recommend a qualified foundation repair company / contractor evaluate and advise on course of action prior to repair of the flooring.

Contact a qualified flooring contractor

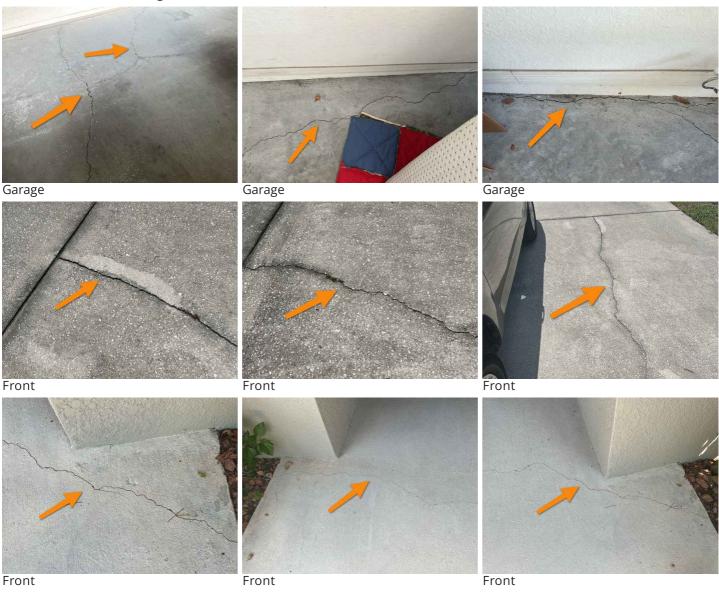
OLD CONCRETE - PORCH CRACKS, SEPARATION, OR HEAVING

The porch show signs of aged cracking, separation, heaving, and/or deterioration. This is common in areas of the state that have clay-based soils. Compromised concrete will continue to exhibit decay, failure, collapse, and uplift if not remediated. Recommend caulking larger cracks and applying a concrete sealer. Cracking can also be a safety tripping hazard for pedestrians.

Recommend monitoring.
