**SUMMARY**

1234 Main St , Tampa, FL 33607

Buyer Name
05/30/2025Abby Bullock
Professional Home Inspector
Merit Property Inspections
+8134854335
info@meritinspects.com

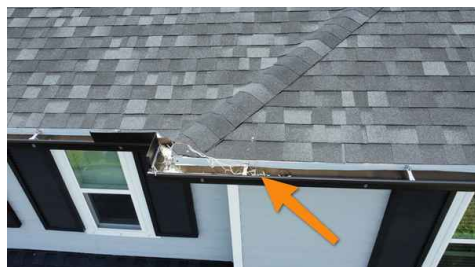
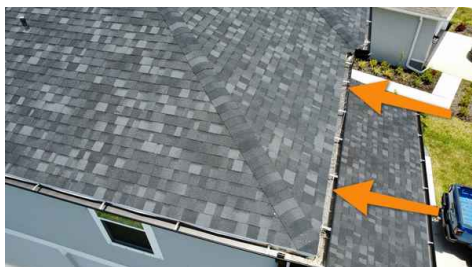
2.2.1 B. Grading and Drainage

DEBRIS IN GUTTERS

Debris in gutters. Recommend removal for functional use of gutters.

Contact a handyman or DIY project

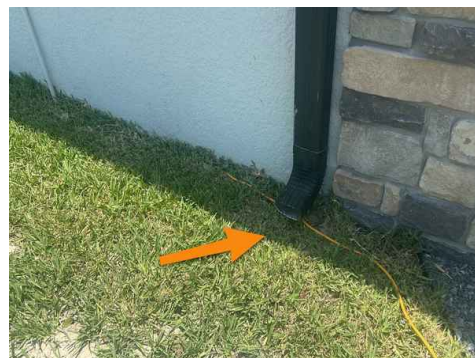
Left

2.2.2 B. Grading and Drainage

GUTTER MISSING SPLASHBLOCK

Some or all of the gutter downspouts are missing splash blocks. Splash blocks help disperse the water away from the foundation and prevent the erosion of soils. Recommend installing splash blocks at all necessary locations.

Contact a handyman or DIY project

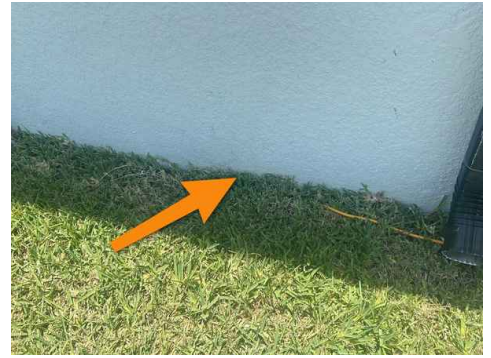
Across Structure

2.2.3 B. Grading and Drainage

LOW CLEARANCE TO GRADE

The clearance from the finished floor elevation (i.e. top of slab) to the exterior grade (i.e. ground) should be 6-inches or greater. This will prevent pooling surface water runoff from storm events from entering the structure. Recommend re-grading the build-up of material to expose the foundation and create a greater clearance.

Additionally, soil and vegetation should not be in contact with the siding or any wood.

Contact a qualified landscaping contractor

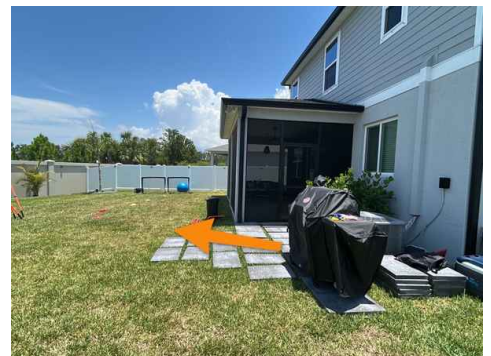
Back

2.2.4 B. Grading and Drainage

NO GRADING (FLAT) SLOPE

The grading around the structure is relatively level (flat). This may not allow for property water drainage away from the foundation. Ideally, the structure should be the highest point on the property to promote good drainage and water run off away from the structure. Evaluate and address as necessary.

Contact a qualified landscaping contractor

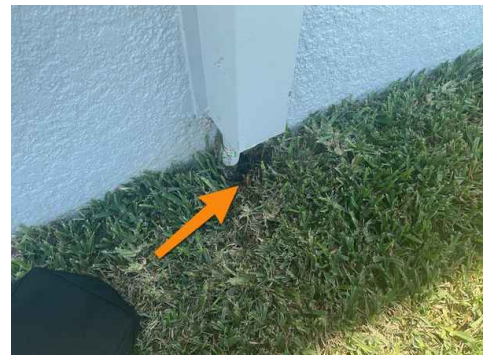
Left

2.2.5 B. Grading and Drainage

STANDING WATER PRESENT

Standing water observed, which could indicate poor drainage and/or grading. Recommend monitor and/or have landscaper correct.

Contact a qualified landscaping contractor

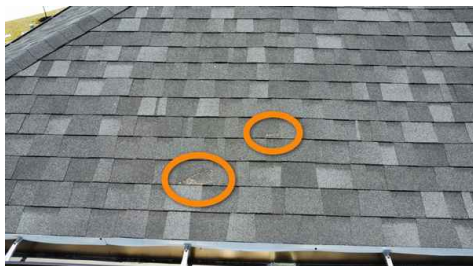
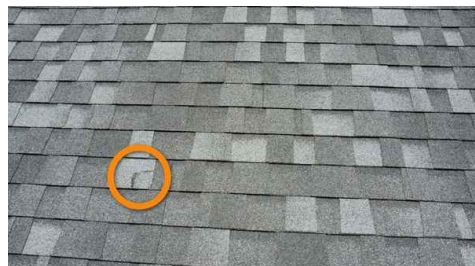
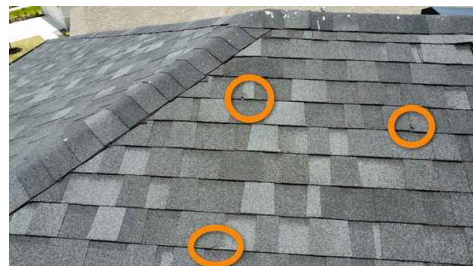
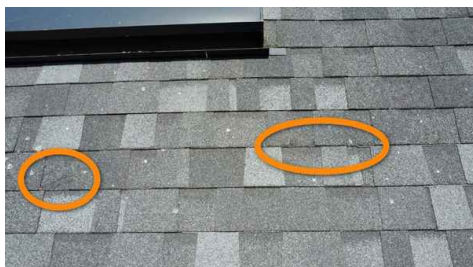
2.3.1 C. Roof Covering Materials

DAMAGED COVERINGS/SCUFFING

Roof coverings exhibited general damage and/or scuffing that could affect performance. Recommend a qualified roofer evaluate and repair.

Contact a qualified roofing professional.

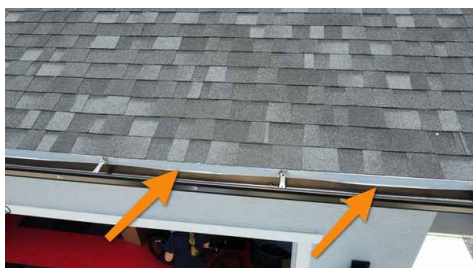
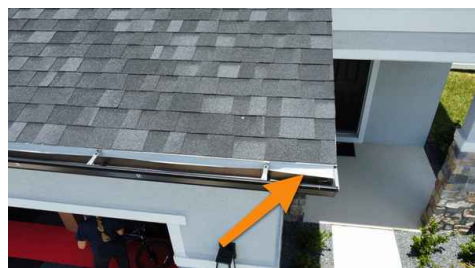
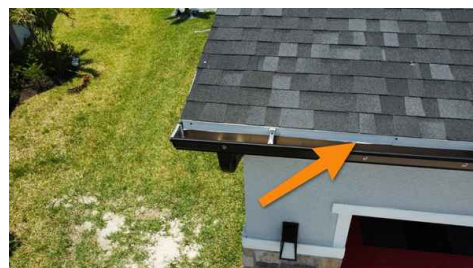
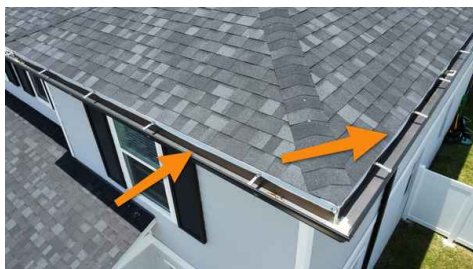
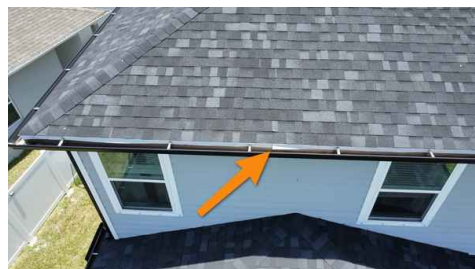
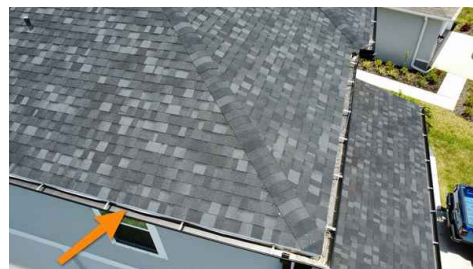
2.3.2 C. Roof Covering Materials

LIFTED FLASHING (ACROSS STRUCTURE)

Areas of the roof show lifted flashing areas. Lifted flashing areas will not seal with the lower shingle areas or siding and can allow for water intrusion. Recommend a roofing contractor to replace.

Contact a qualified roofing professional.

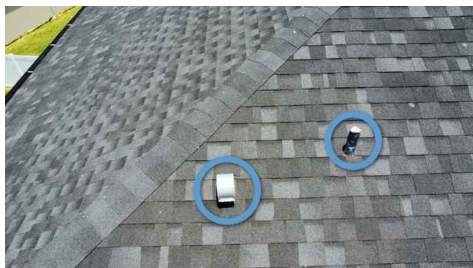
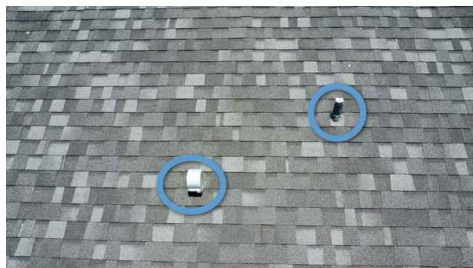
2.3.3 C. Roof Covering Materials

VENTS UNPAINTED OR SHOULD BE REPAINTED

Roof vents are unpainted or should be repainted with a rust preventative paint (typically matching the roof color or black). Unpainted vents are more likely to cause discoloration of the roof by runoff as vents rust and rubber deteriorates.

Contact a qualified roofing professional.

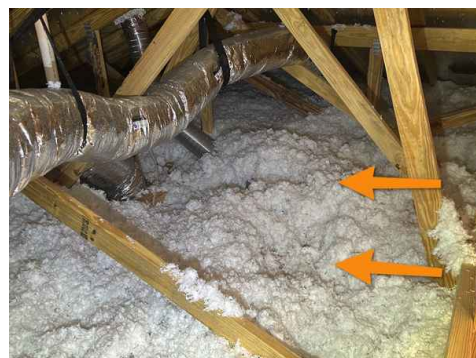
Attic

2.4.1 D. Roof Structures and Attics

INSULATION IS UNEVENLY DISTRIBUTED

Insulation in the attic unevenly distributed and not smooth / even across the attic surface. This is common in older structures where attic insulation has been moved for repairs and installations.

Insulation that is not smooth and even across the attic surface will be less efficient and will be unable to create a thermal barrier as intended. Recommend a insulation contractor smooth the insulation and/or install new insulation in areas of the attic, as necessary.

Contact a qualified insulation contractor.

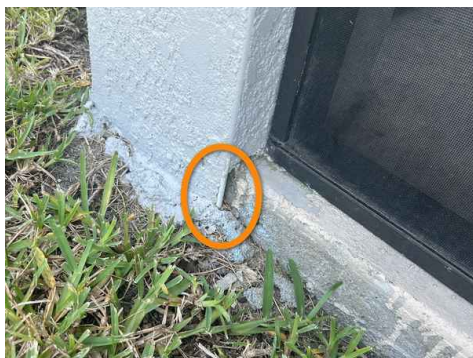
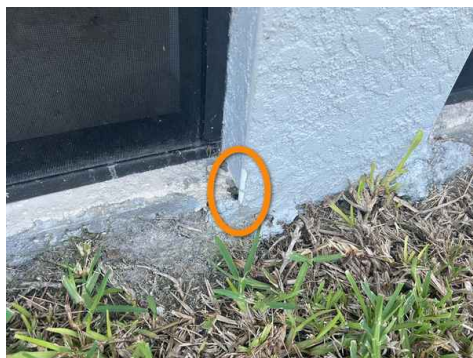
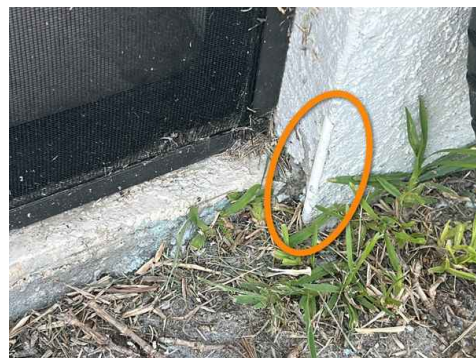
2.5.1 E. Walls (Interior and Exterior)

SIDING IS DAMAGED OR MISSING

The siding is damaged or missing in these areas. Recommend a general contractor to resolve, as necessary.

Contact a qualified general contractor.

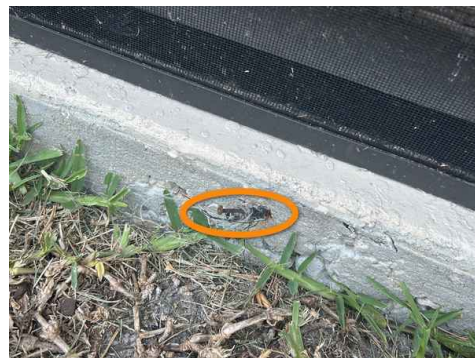
Right

2.5.2 E. Walls (Interior and Exterior)

EXPOSED NAILS ON SIDING

The siding has exposed nails and/or nails that are not caulked and painted correctly. Over time, nails that are exposed to the elements will rust and discolor the siding causing streaking. Serious imperfections can eventually lead to water intrusion and falling siding. Recommend a general contractor to resolve, as necessary.

Contact a qualified general contractor.

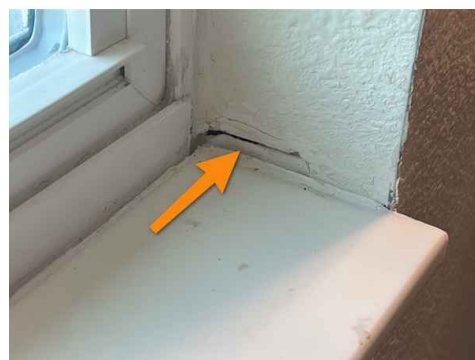
Primary Bathroom

2.5.3 E. Walls (Interior and Exterior)

HOLE IN WALL

There is a hole in the wall that should be patched. Wall holes could allow for insects to enter, water infiltration (if exterior), but also allow for airflow escape causing a HVAC inefficiency. Recommend repairing the hole or sealing off the hole as necessary.

Contact a qualified professional.

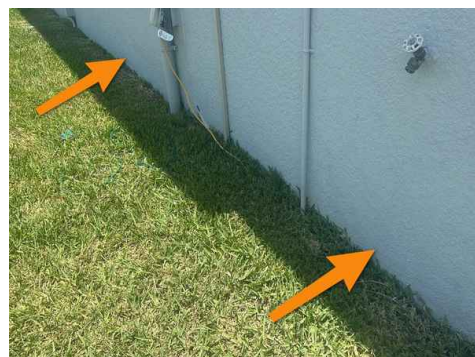
Across Structure

2.5.4 E. Walls (Interior and Exterior)

NO STUCCO WEEP SCREED

No weep screed material was observed at the base of the wall stucco finish. The weep screed is a special piece of metal flashing that runs along the bottom of walls that wicks moisture out of holes that are located at the bottom of the flashing. It hangs below the lower sill plate to ensure that the water wicks past any material that could become damaged by excessive amounts of water. Recommend a stucco repair contractor to evaluate a resolution. We also recommend a mold inspection be performed to determine if mold is present and sending air quality (or tape) samples to a lab for testing.

Contact a stucco repair contractor

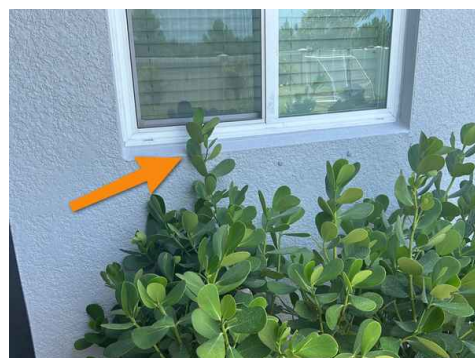
Back

2.5.5 E. Walls (Interior and Exterior)

VEGETATION RUBBING AGAINST SIDING

Vegetation is rubbing against siding. This may promote moisture and pest intrusion. Recommend a qualified professional trim back vegetation.

Contact a qualified landscaping contractor

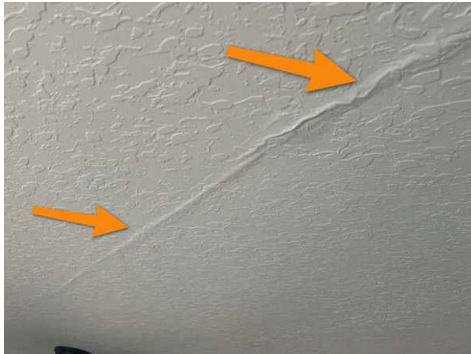
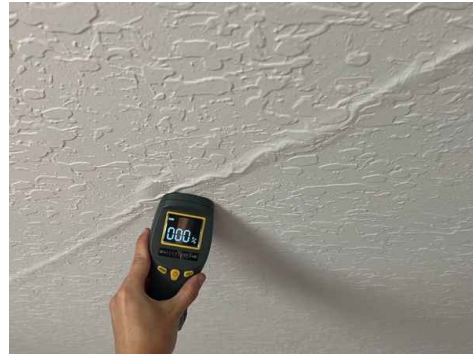
2.6.1 F. Ceilings and Floors

CEILING - SHEETROCK CRACKS MINOR

Minor sheetrock cracking was observed on the ceiling. This is common in structures this age and is often determined to be cosmetic, most often the separation of drywall tape joints. Recommend patching, repainting, monitoring these locations for further cracking.

Contact a qualified painting contractor.

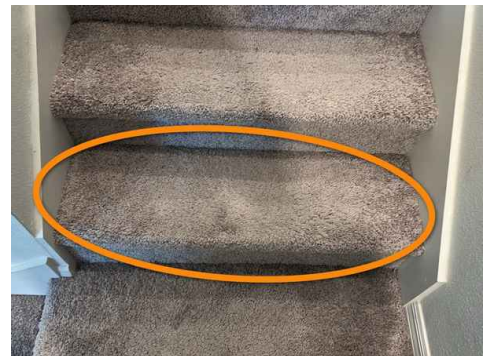
Staircase

2.6.2 F. Ceilings and Floors

FLOORING - SPONGY FEELING AND/OR SQUEAKS

The flooring is spongy, moves, and/or squeaks as weight is distributed across it. This is typically a sign of weakness in the underlying joists, rotting subfloor, or separation of the flooring from the subfloor. A flooring contractor is recommended for further evaluation.

Contact a qualified flooring contractor

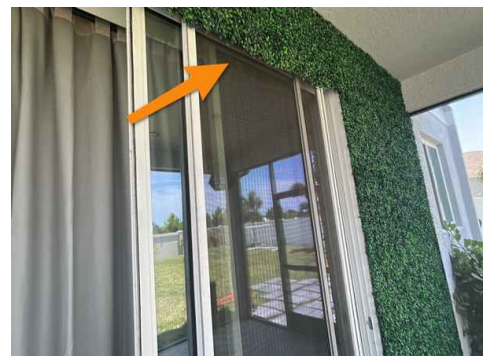
Back

2.7.1 G. Doors (Interior and Exterior)

SCREEN DOOR RAIL ISSUE

The screen door is not sliding on its tracks / rails correctly. Recommend a contractor evaluate and reinstall correctly.

Contact a qualified door repair/installation contractor.

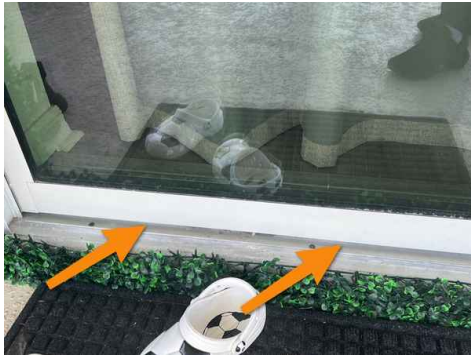
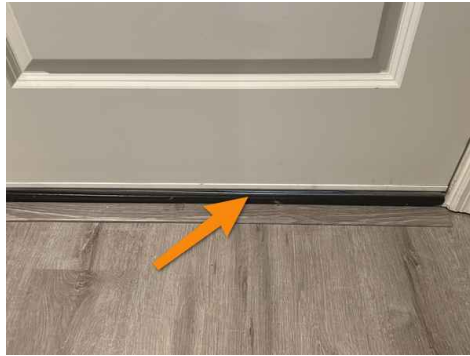
2.7.2 G. Doors (Interior and Exterior)

DOOR WEATHER-STRIPPING MISSING OR INSUFFICIENT

Door has missing or insufficient weather-stripping. This can result in significant energy loss and moisture intrusion. Recommend installation of standard weather-stripping.

Recommended DIY Project

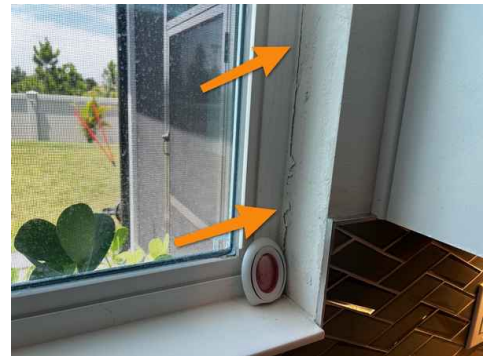
Kitchen

2.9.1 H. Windows

WINDOW LEAKS AT SILL

The window sill shows signs of a window leaking water down the walls and onto the sill. This is common in structures that lack the correct flashing or necessary caulking on the exterior siding to prevent water intrusion. Recommend re-caulking the windows exterior trim or having a siding contractor evaluate a remedy as necessary.

Contact a qualified window repair/installation contractor.

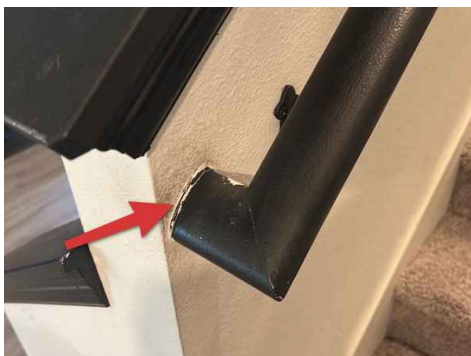
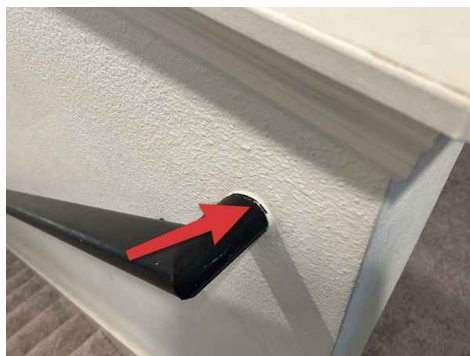
2.10.1 I. Stairways (Interior and Exterior)

LOOSE HANDRAIL STRUCTURE

The stairway and/or balcony handrail is loose and unsupported. This is considered a safety issue and should be strengthened or replaced with a sufficient handrail structure, handrail, and baluster system.

Contact a qualified professional.

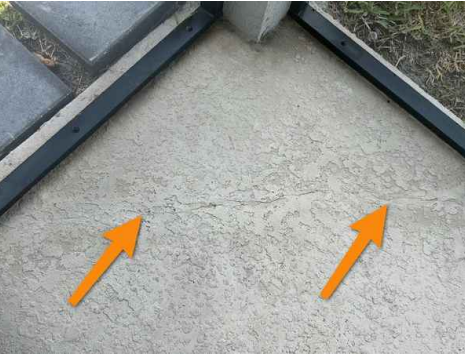
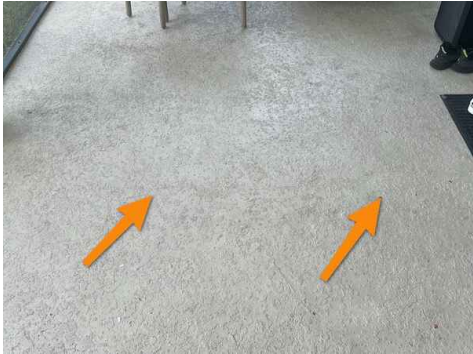
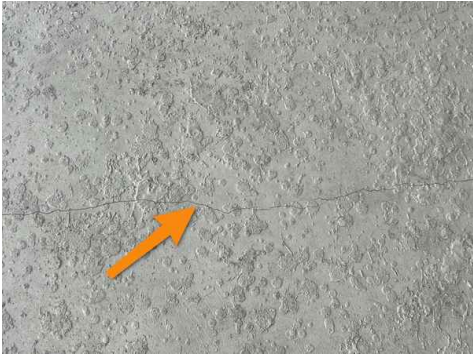
2.11.1 K. Porches, Balconies, Decks, and Carports

NEW CONCRETE - PORCH CRACKS

The porch show signs of new cracking, separation, heaving and/or deterioration. This is uncommon for concrete that appears to be freshly poured and/or recently installed. Fresh or recently poured concrete that exhibits immediate cracking (beyond shrinkage cracking) could have been mixed and/or installed incorrectly. Compromised concrete will continue to exhibit decay, failure, collapse, and uplift if not remediated. Recommend caulking larger cracks and applying a concrete sealer. Severe cracking can also be a safety tripping hazard for pedestrians.

Recommendation
Contact a qualified concrete contractor.

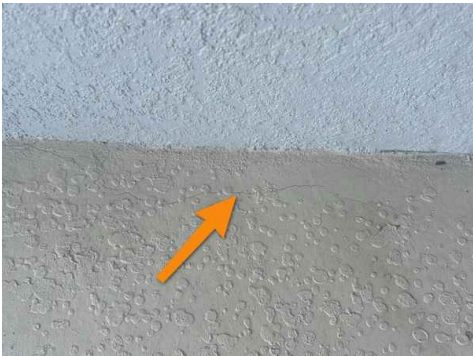
Front

2.11.2 K. Porches, Balconies, Decks, and Carports

NEW CONCRETE - SHRINK CRACKS

The concrete porch exhibited shrinkage cracks. Shrinkage cracks in new concrete is common and occurs as newly-placed concrete dries and cures, particularly at high-stress areas. Shrinkage cracks are surface cracks and don't penetrate deep into the foundation. Recommend monitoring.

Recommendation
Recommend monitoring.

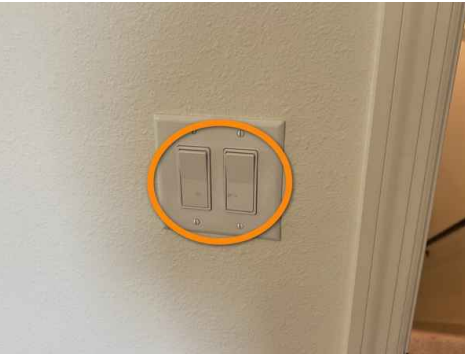
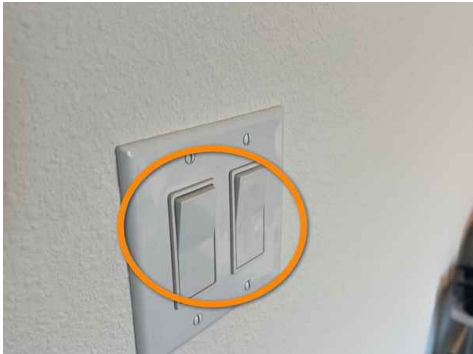
3.2.1 B. Branch Circuits, Connected Devices, and Fixtures

SWITCH - INOPERABLE

Switch did not appear to operate a light or devise. Recommend further investigation by an electrical contractor if the switch's use remains undetermined.

Recommendation
Contact a qualified electrical contractor.

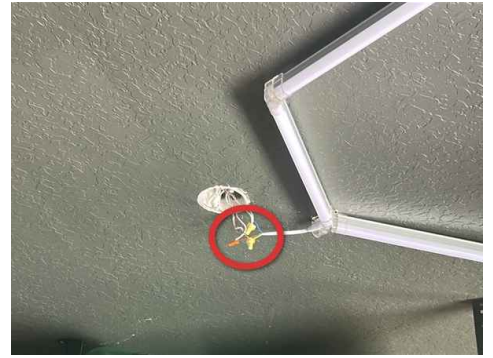
Garage

3.2.2 B. Branch Circuits, Connected Devices, and Fixtures

HIGH-VOLTAGE EXPOSED ENDS & SPLICES

All wire connections & charged wires with exposed ends and splices should be covered in junction boxes for safety. Recommend a qualified electrician correct.

Contact a qualified electrical contractor.

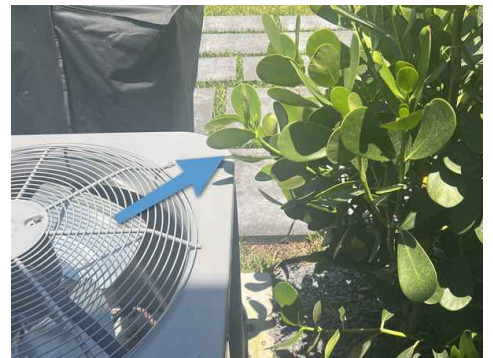
Back

4.2.1 B. Cooling Equipment

CONDENSER - VEGETATION IS TOO CLOSE

A tree and/or vegetative growth is too close to the condenser unit. The condenser utilizes the air-space around it to release heat from the structure. Growth around the condenser will lower the efficiency and/or could cause the unit to overheat. Recommend removing or trimming the growth away from the condenser by at least 3-feet on the sides and 10-feet above the unit.

Contact a qualified landscaping contractor

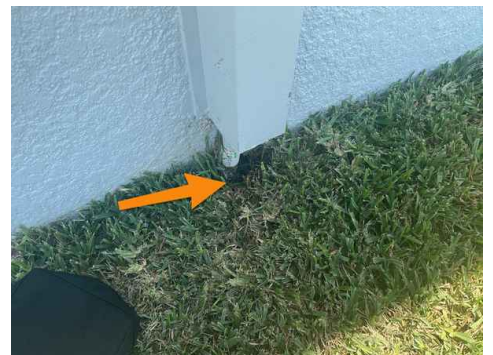
Left

4.2.2 B. Cooling Equipment

EVAPORATOR - CONDENSATE LINE ROUTED INCORRECTLY

In this case, the primary condensate drain line is routed directly to the outside and is being deposited near or at the foundation. This is an incorrect installation and can lead to portions of the foundation to be constantly wetter than others, leading to future foundation issues. Recommend routing the primary drain to the septic drain system.

Contact a qualified HVAC professional.

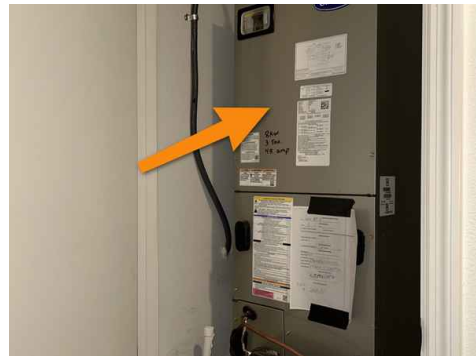
Hall Closet

4.2.3 B. Cooling Equipment

HVAC - BLOWER FAN HAS EXCESSIVE NOISE

The HVAC blow fan was excessively noisy during operation. Recommend a qualified HVAC technician evaluate and repair.

Contact a qualified HVAC professional.

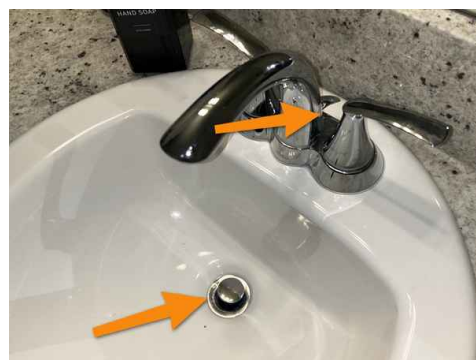
Primary Bathroom

5.1.1 A. Plumbing Supply, Distribution Systems, and Fixtures

FAUCET / SPIGOT DRAIN PULL ISSUE

The faucet / spigot drain pull is not functioning properly or missing. Recommend plumbing contractor to resolve issue.

Contact a qualified plumbing contractor.

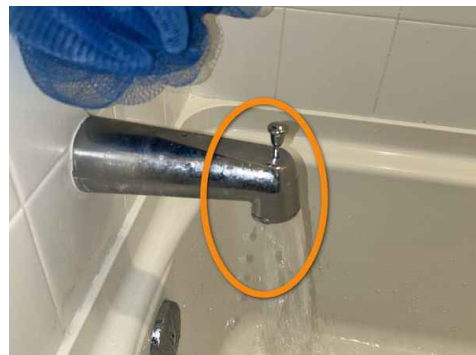
2nd Floor Hall Bathroom

5.1.2 A. Plumbing Supply, Distribution Systems, and Fixtures

TUB SPOUT DIVERTER IS NOT EFFECTIVE

The tub spout divert is not fully diverting water to the shower. A leaking and/or broken shower diverter wastes water and creates a lower-pressure shower experience. Repairing a shower diverter can be a DIY project, or you may want to consult a plumbing contractor.

Contact a qualified plumbing contractor.

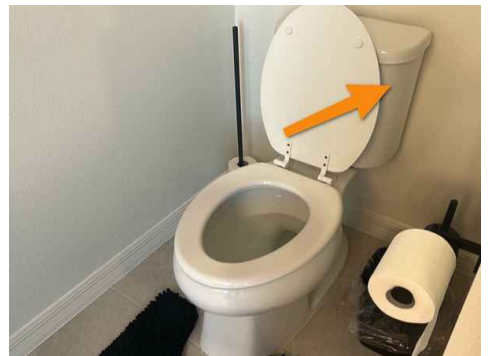
Primary Bathroom

5.1.4 A. Plumbing Supply, Distribution Systems, and Fixtures

TOILET IS RUNNING

Toilet is running and can be heard continually filling. A running toilet is inefficient and can run up costs on the municipal water bill. Recommend further investigation and possibly a plumber to resolve.

Contact a qualified plumbing contractor.

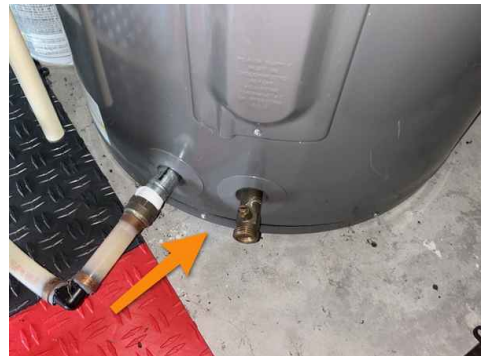
Garage

5.3.1 C. Water Heating Equipment

WATER HEATER SITTING ON THE GROUND

The water heater is not elevated off the ground. Water heaters that are sitting on the ground with rust out faster than elevated water heaters.

Contact a qualified plumbing contractor.

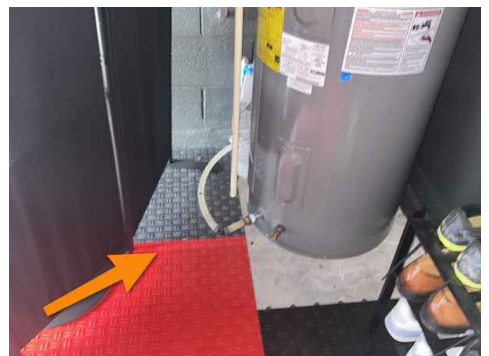
Garage

5.3.2 C. Water Heating Equipment

MISSING BOLLARD

A bollard is used to protect the water heater from vehicle impact. Recommend a qualified professional install a bollard.

Contact a qualified general contractor.
