MERIT PROPERTY INSPECTIONS

## PROPERTY INSPECTION REPORT

1234 Main St  
Tampa, FL 33607

05/30/2025

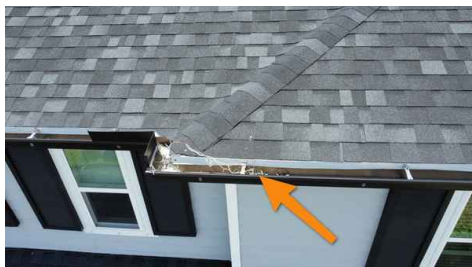
Front

Debris in gutters. Recommend removal for functional use of gutters.

Contact a handyman or DIY project

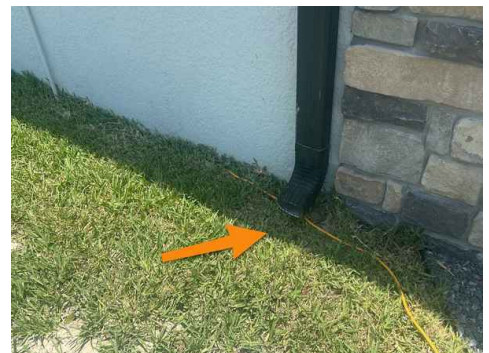
Left

**GUTTER MISSING SPLASHBLOCK**

Some or all of the gutter downspouts are missing splash blocks. Splash blocks help disperse the water away from the foundation and prevent the erosion of soils. Recommend installing splash blocks at all necessary locations.

Contact a handyman or DIY project

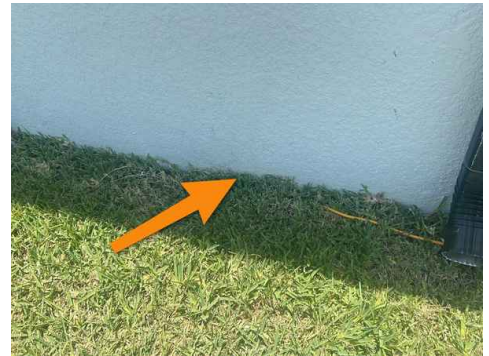
Across Structure

The clearance from the finished floor elevation (i.e. top of slab) to the exterior grade (i.e. ground) should be 6-inches or greater. This will prevent pooling surface water runoff from storm events from entering the structure. Recommend re-grading the build-up of material to expose the foundation and create a greater clearance.

Contact a qualified landscaping contractor

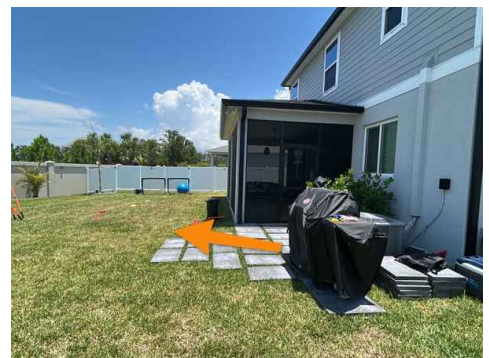
Back

The grading around the structure is relatively level (flat). This may not allow for property water drainage away from the foundation. Ideally, the structure should be the highest point on the property to promote good drainage and water run off away from the structure. Evaluate and address as necessary.

Contact a qualified landscaping contractor

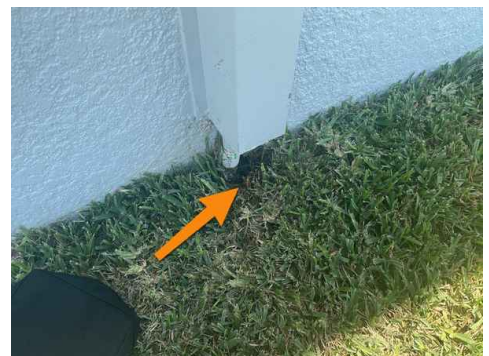
Left

Standing water observed, which could indicate poor drainage and/or grading. Recommend monitor and/or have landscaper correct.

Contact a qualified landscaping contractor

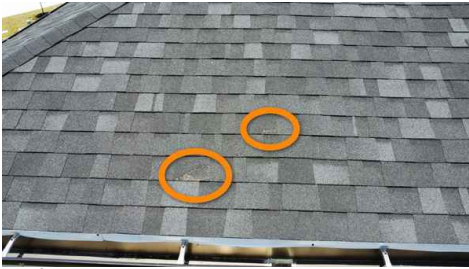
Right

**DAMAGED COVERINGS/SCUFFING**

Roof coverings exhibited general damage and/or scuffing that could affect performance. Recommend a qualified roofer evaluate and repair.

Contact a qualified roofing professional.

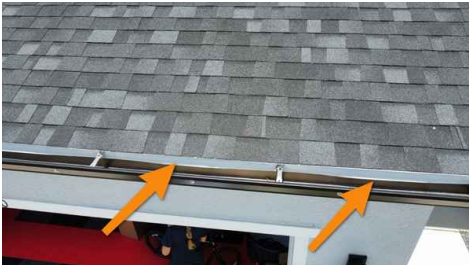
Front

Areas of the roof show lifted flashing areas. Lifted flashing areas will not seal with the lower shingle areas or siding and can allow for water intrusion. Recommend a roofing contractor to replace.

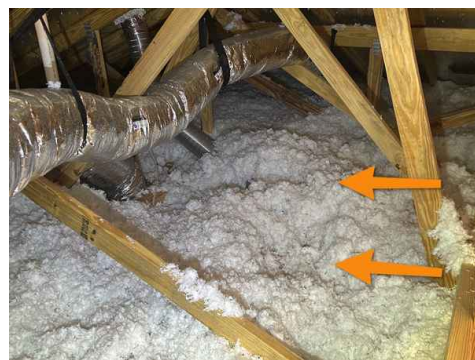
Attic

Insulation in the attic unevenly distributed and not smooth / even across the attic surface. This is common in older structures where attic insulation has been moved for repairs and installations.

Insulation that is not smooth and even across the attic surface will be less efficient and will be unable to create a thermal barrier as intended. Recommend a insulation contractor smooth the insulation and/or install new insulation in areas of the attic, as necessary.

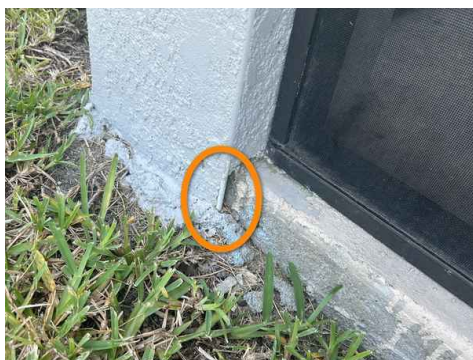
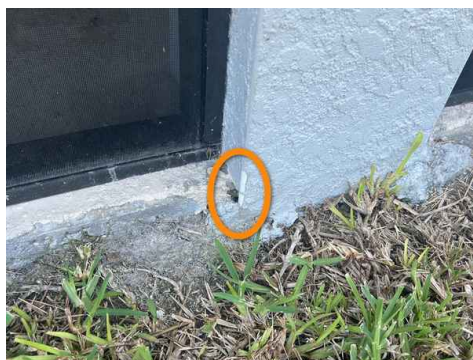
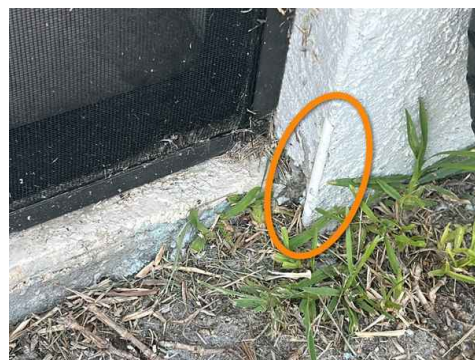
**SIDING IS DAMAGED OR MISSING**

The siding is damaged or missing in these areas. Recommend a general contractor to resolve, as necessary.

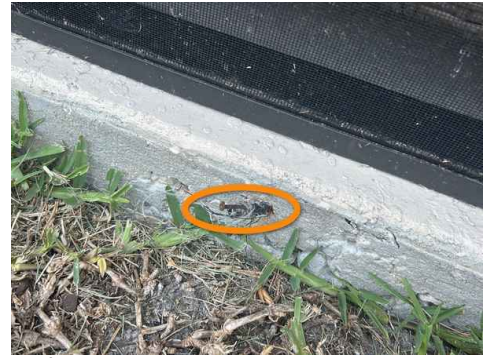
Right

The siding has exposed nails and/or nails that are not caulked and painted correctly. Over time, nails that are exposed to the elements will rust and discolor the siding causing streaking. Serious imperfections can eventually lead to water intrusion and falling siding. Recommend a general contractor to resolve, as necessary.

Contact a qualified general contractor.

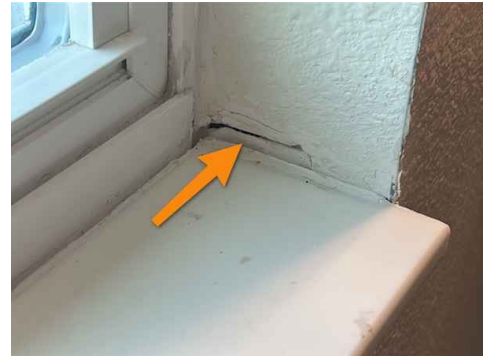
Primary Bathroom

There is a hole in the wall that should be patched. Wall holes could allow for insects to enter, water infiltration (if exterior), but also allow for airflow escape causing a HVAC inefficiency. Recommend repairing the hole or sealing off the hole as necessary.

Contact a qualified professional.

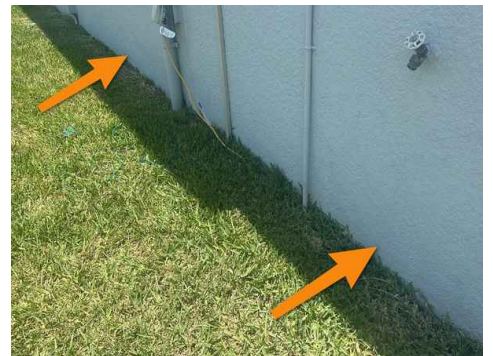
Across Structure

No weep screed material was observed at the base of the wall stucco finish. The weep screed is a special piece of metal flashing that runs along the bottom of walls that wicks moisture out of holes that are located at the bottom of the flashing. It hangs below the lower sill plate to ensure that the water wicks past any material that could become damaged by excessive amounts of water. Recommend a stucco repair contractor to evaluate a resolution. We also recommend a mold inspection be performed to determine if mold is present and sending air quality (or tape) samples to a lab for testing.

Contact a stucco repair contractor

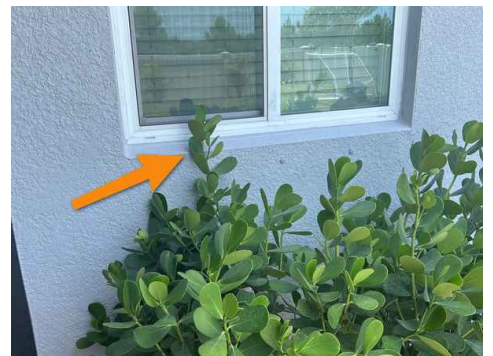
Back

Vegetation is rubbing against siding. This may promote moisture and pest intrusion. Recommend a qualified professional trim back vegetation.

Contact a qualified landscaping contractor

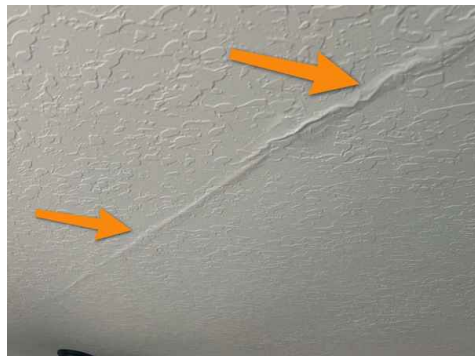
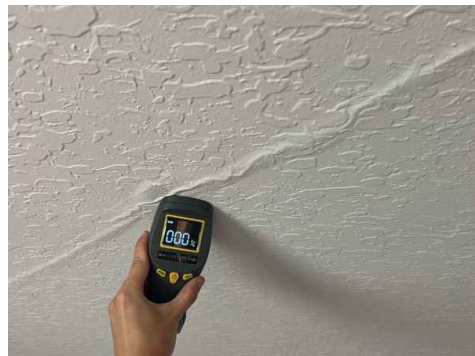
Primary Bedroom

**CEILING - SHEETROCK CRACKS MINOR**

Minor sheetrock cracking was observed on the ceiling. This is common in structures this age and is often determined to be cosmetic, most often the separation of drywall tape joints. Recommend patching, repainting, monitoring these locations for further cracking.

Contact a qualified painting contractor.

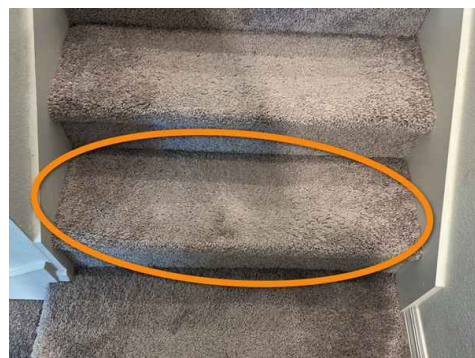
Staircase

The flooring is spongy, moves, and/or squeaks as weight is distributed across it. This is typically a sign of weakness in the underlying joists, rotting subfloor, or separation of the flooring from the subfloor. A flooring contractor is recommended for further evaluation.

Contact a qualified flooring contractor

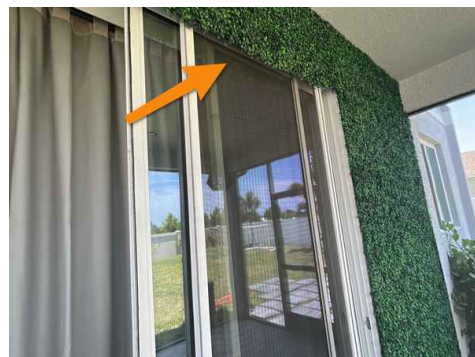
Back

The screen door is not sliding on its tracks / rails correctly. Recommend a contractor evaluate and reinstall correctly.

Contact a qualified door repair/installation contractor.

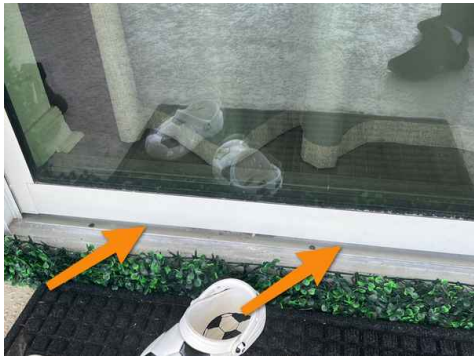
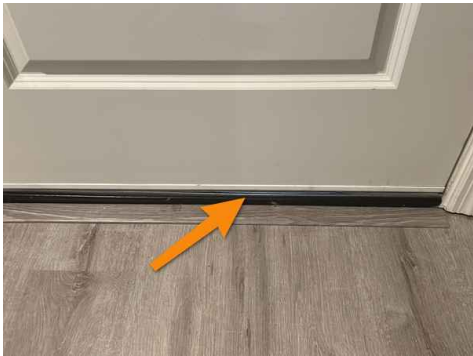
**DOOR WEATHER-STRIPPING MISSING OR INSUFFICIENT**

Door has missing or insufficient weather-stripping. This can result in significant energy loss and moisture intrusion. Recommend installation of standard weather-stripping.

Recommendation  
Recommended DIY Project

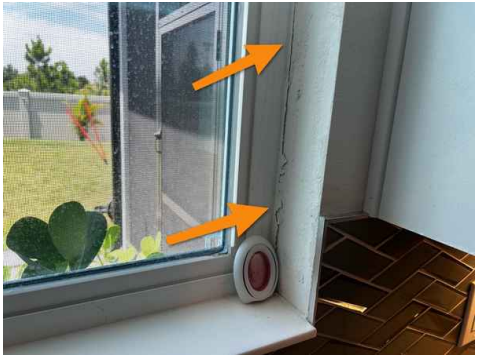
Kitchen

**WINDOW LEAKS AT SILL**

The window sill shows signs of a window leaking water down the walls and onto the sill. This is common in structures that lack the correct flashing or necessary caulking on the exterior siding to prevent water intrusion. Recommend re-caulking the windows exterior trim or having a siding contractor evaluate a remedy as necessary.

Recommendation  
Contact a qualified window repair/installation contractor.

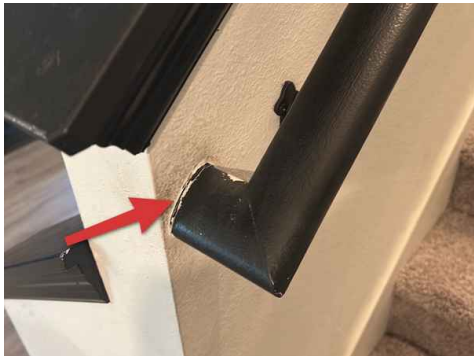
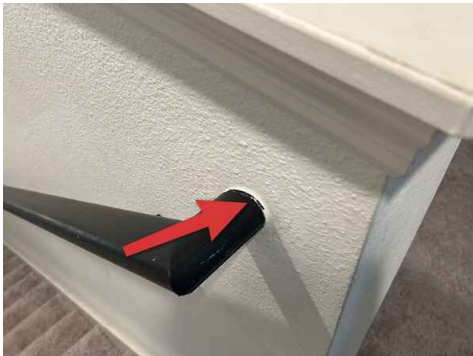
**LOOSE HANDRAIL STRUCTURE**

The stairway and/or balcony handrail is loose and unsupported. This is considered a safety issue and should be strengthened or replaced with a sufficient handrail structure, handrail, and baluster system.

Safety Hazard

Recommendation  
Contact a qualified professional.

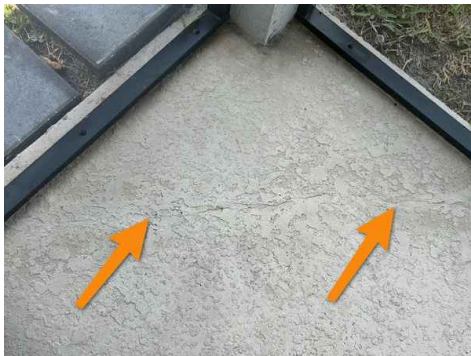
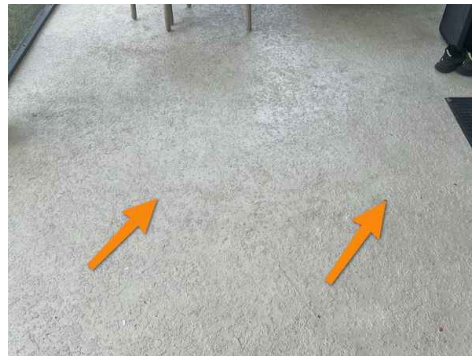
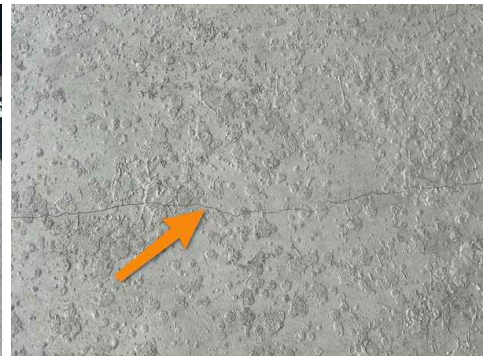
**NEW CONCRETE - PORCH CRACKS**

The porch show signs of new cracking, separation, heaving and/or deterioration. This is uncommon for concrete that appears to be freshly poured and/or recently installed. Fresh or recently poured concrete that exhibits immediate cracking (beyond shrinkage cracking) could have been mixed and/or installed incorrectly. Compromised concrete will continue to exhibit decay, failure, collapse, and uplift if not remediated. Recommend caulking larger cracks and applying a concrete sealer. Severe cracking can also be a safety tripping hazard for pedestrians.

Contact a qualified concrete contractor.

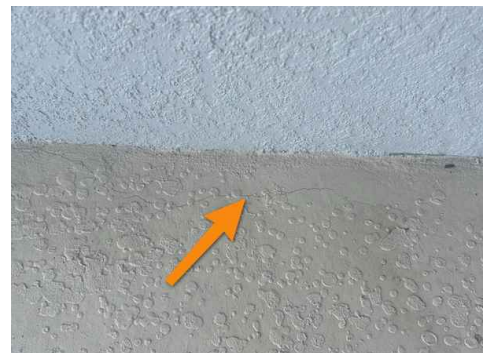
Front

**NEW CONCRETE - SHRINK CRACKS**

The concrete porch exhibited shrinkage cracks. Shrinkage cracks in new concrete is common and occurs as newly-placed concrete dries and cures, particularly at high-stress areas. Shrinkage cracks are surface cracks and don't penetrate deep into the foundation.

Recommend monitoring.

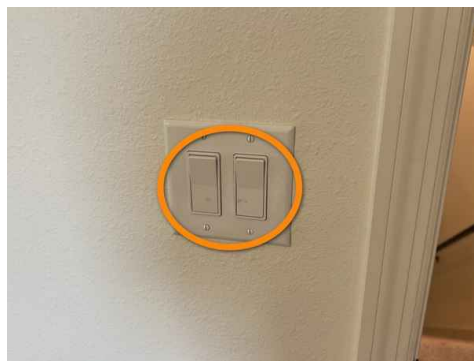
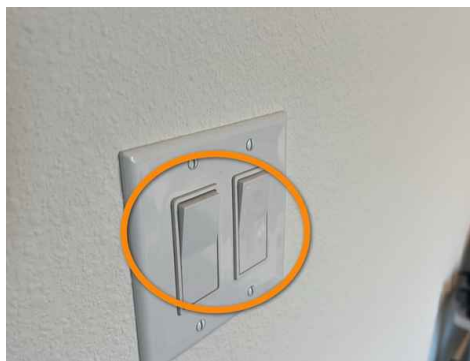
Switch did not appear to operate a light or device. Recommend further investigation by an electrical contractor if the switch's use remains undetermined.

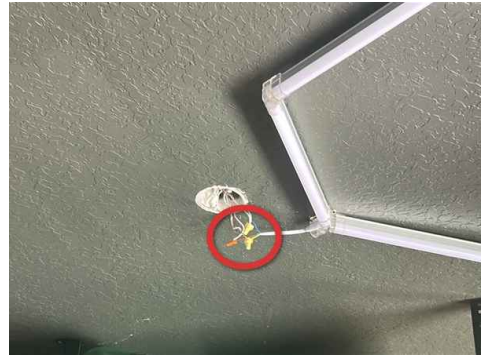
Garage

Safety Hazard

All wire connections & charged wires with exposed ends and splices should be covered in junction boxes for safety. Recommend a qualified electrician correct.

Contact a qualified electrical contractor.

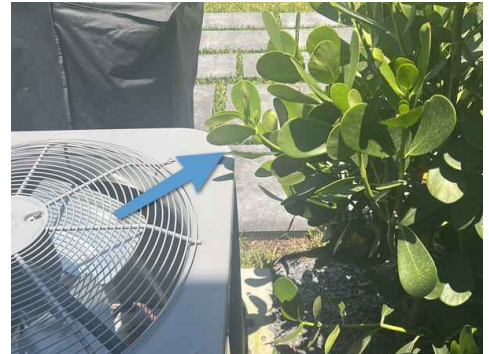
Back

- 🔧 4.2.1 III. Heating, Ventilation and Air Conditioning Systems - B. Cooling Equipment: Condenser - vegetation is too close
- ⊖ 4.2.2 III. Heating, Ventilation and Air Conditioning Systems - B. Cooling Equipment: Evaporator - condensate line routed incorrectly

Contact a qualified landscaping contractor

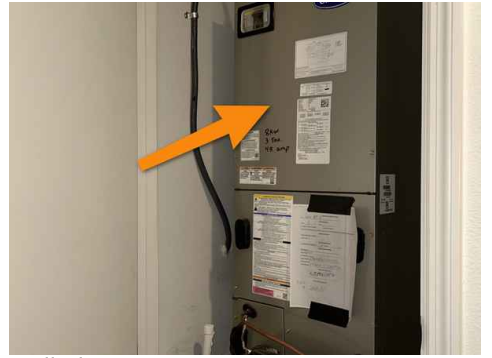
Hall Closet

- ⊖ 4.2.3 III. Heating, Ventilation and Air Conditioning Systems - B. Cooling Equipment: HVAC - blower fan has excessive noise
- ⊖ 5.1.1 IV. Plumbing Systems - A. Plumbing Supply, Distribution Systems, and Fixtures: Faucet / spigot drain pull issue

Contact a qualified HVAC professional.

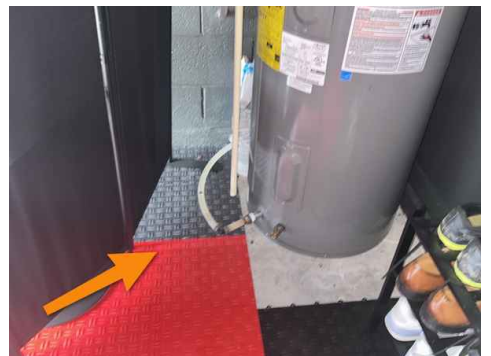
Garage

5.3.2 IV. Plumbing Systems - C. Water Heating Equipment: Missing bollard

Contact a qualified general contractor.
