Report V1.0

# Engineer's Foundation Evaluation

123 Main St, Your City, FL, 12345

On 3/29/2024 a foundation evaluation was performed at the property located at address 123 Main St, Your City, FL, 12345, which consists of a 3548 square-foot single family attached structure built in 1990 (35 years old) with a slab on grade foundation.

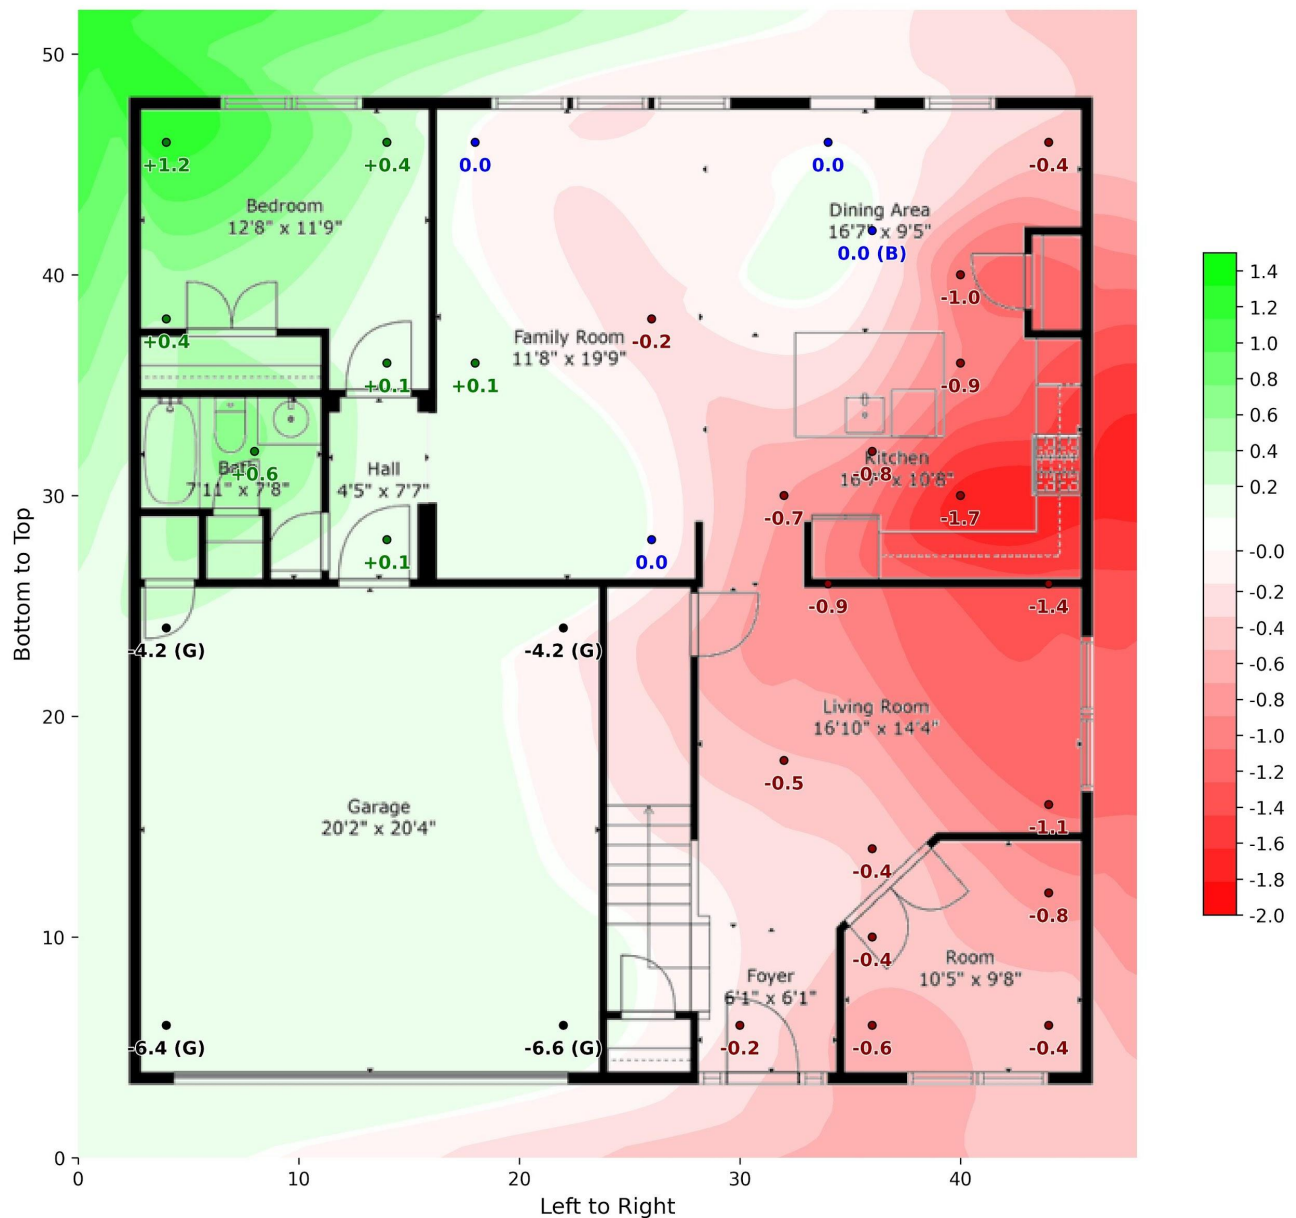
**Elevation Plot Graphic (Figure A)**

The elevation plot resulted in the graphic as depicted above in Figure A. The red-points and areas are elevation measurements that were lower than the base station elevation (0.0). The green-points and areas are elevation measurements that were higher than the base station elevation (0.0). The blue-points (and white areas) are equal to the base station elevation (0.0). The base station is depicted with a (B) symbol. The elevation plot takes into account differences in flooring thicknesses. The maximum elevation point was determined to be 1.2 inches and the minimum was -1.7 inches, resulting in an elevation difference of 2.9 inches of difference across the structure.

The elevation plot graphic above will show points labeled with a (G) symbol representing Garage. These elevation points were measured and plotted so they can be compared year-to-year, however, they are excluded from the foundation analysis. This is because garages can be non-monolithic and/or they are poured to purposefully slope toward the exterior garage door making any conclusions derived difficult to interpret.

Elevation differences across the structure are the first indicator that a foundation problem may or may-not exist. As documented above, the maximum elevation point of this structure was determined to be 1.2 inches and the minimum was -1.7 inches, resulting in an elevation difference of 2.9 inches of difference across the structure. The elevation plot takes into account differences in flooring thicknesses. The elevation deflection across an entire structure should, best-case-scenario, remain within 0.5 to 1-inch depending on the age of the structure. Measured differences approaching 2-inches are an initial sign of possible foundation fatigue. The maximum allowable elevation difference is subjective, depending on other factors such as the visual condition, size, and age of the structure (35 year(s) old) along with how the foundation performs when calculating deflection and tilt.

Based on observed elevations of the foundation from the elevation plot, the elevation differences do not fall within industry standards and tolerable limits. These findings indicate that the foundation does not have consistent and uniform elevation measurements. Note: elevation measurements alone is not the only indicator of foundation problems; see the deflection and tilt calculations (and the report's overall conclusion) for a complete understanding of foundation stabilization. If elevations fall outside of industry standard/tolerable limits, it is a first indicator that the foundation will fail in deflection and/or tilt.

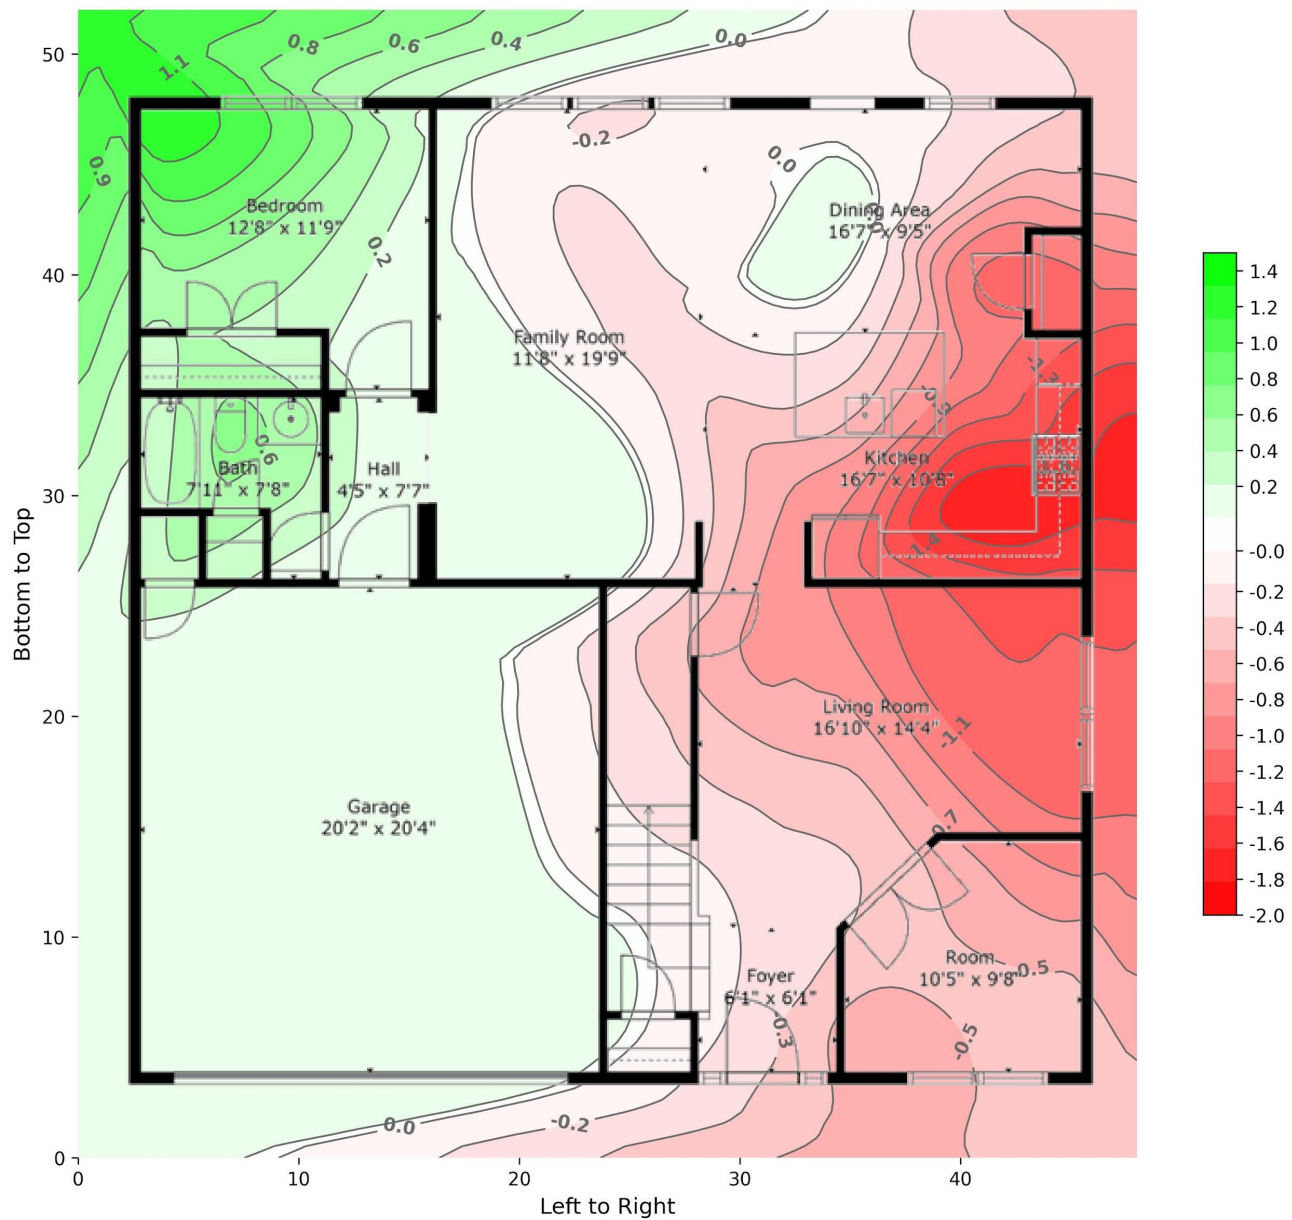
**Mesh Contour Graphic (Figure B)**

The mesh contours graphic depicted above in Figure B is similar to the elevation plot. The red, green, and white areas depict areas that are lower, higher, and equal to the base station elevation (0.0). The lines or contours (similar to map topography) are labeled at specific intervals.

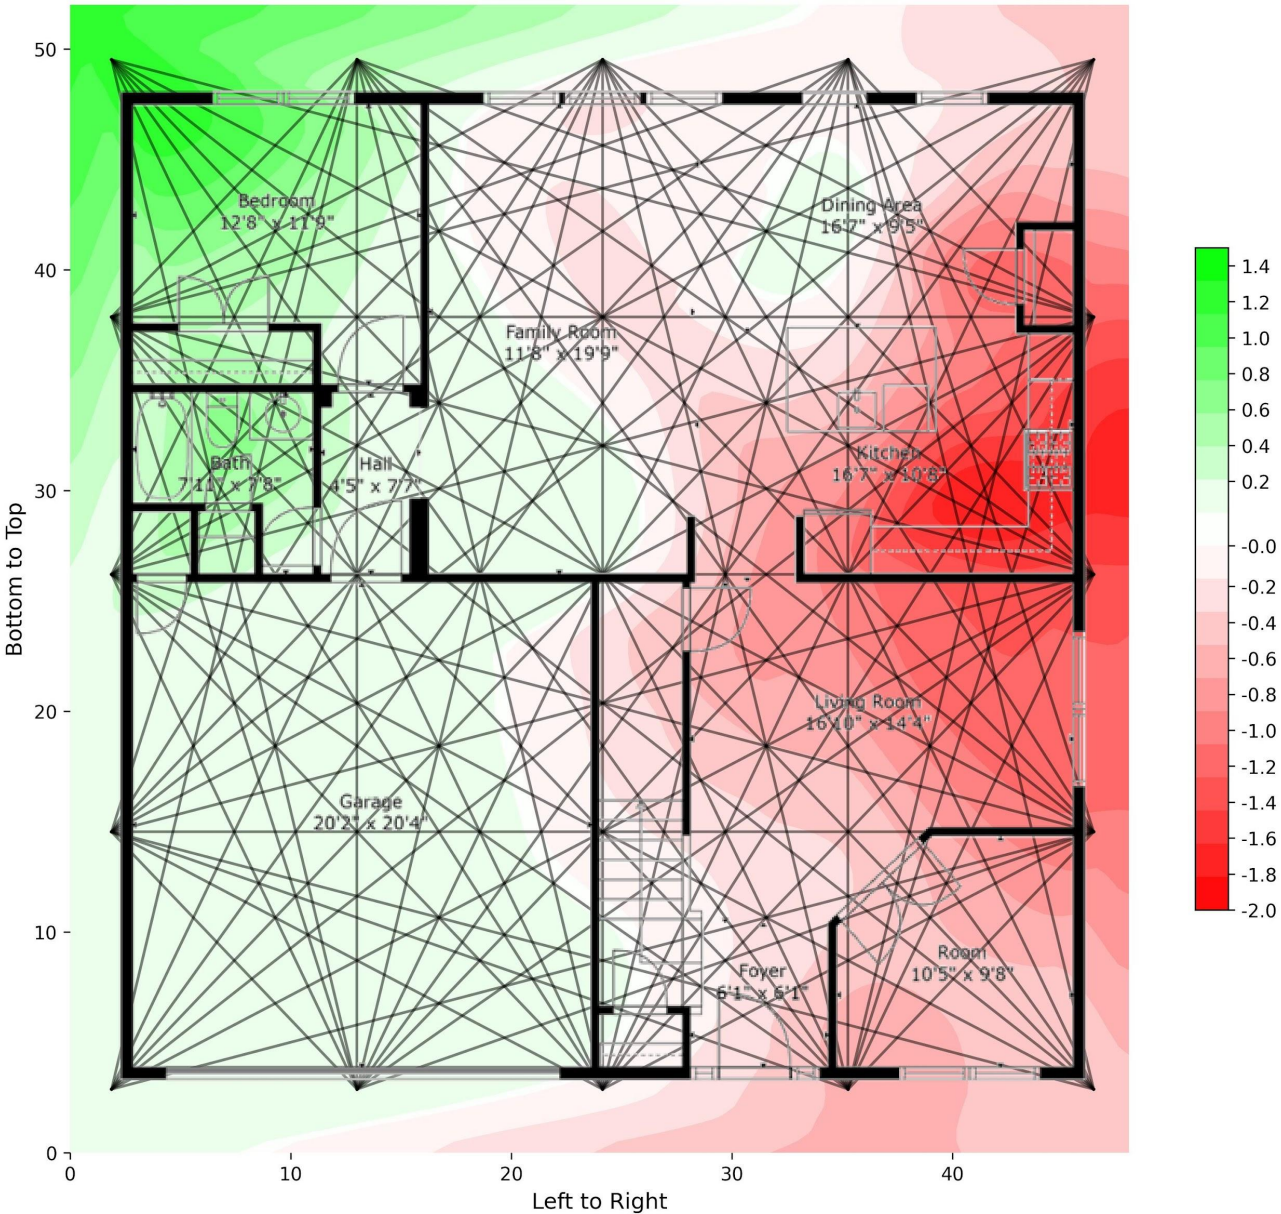
All Profiles Graphic (Figure C)

Below is a graphic that shows the locations of deflection and tilt profiles that were calculated. The total profiles calculated was 79 with a total usable profiles (above the effective length threshold) of 75.

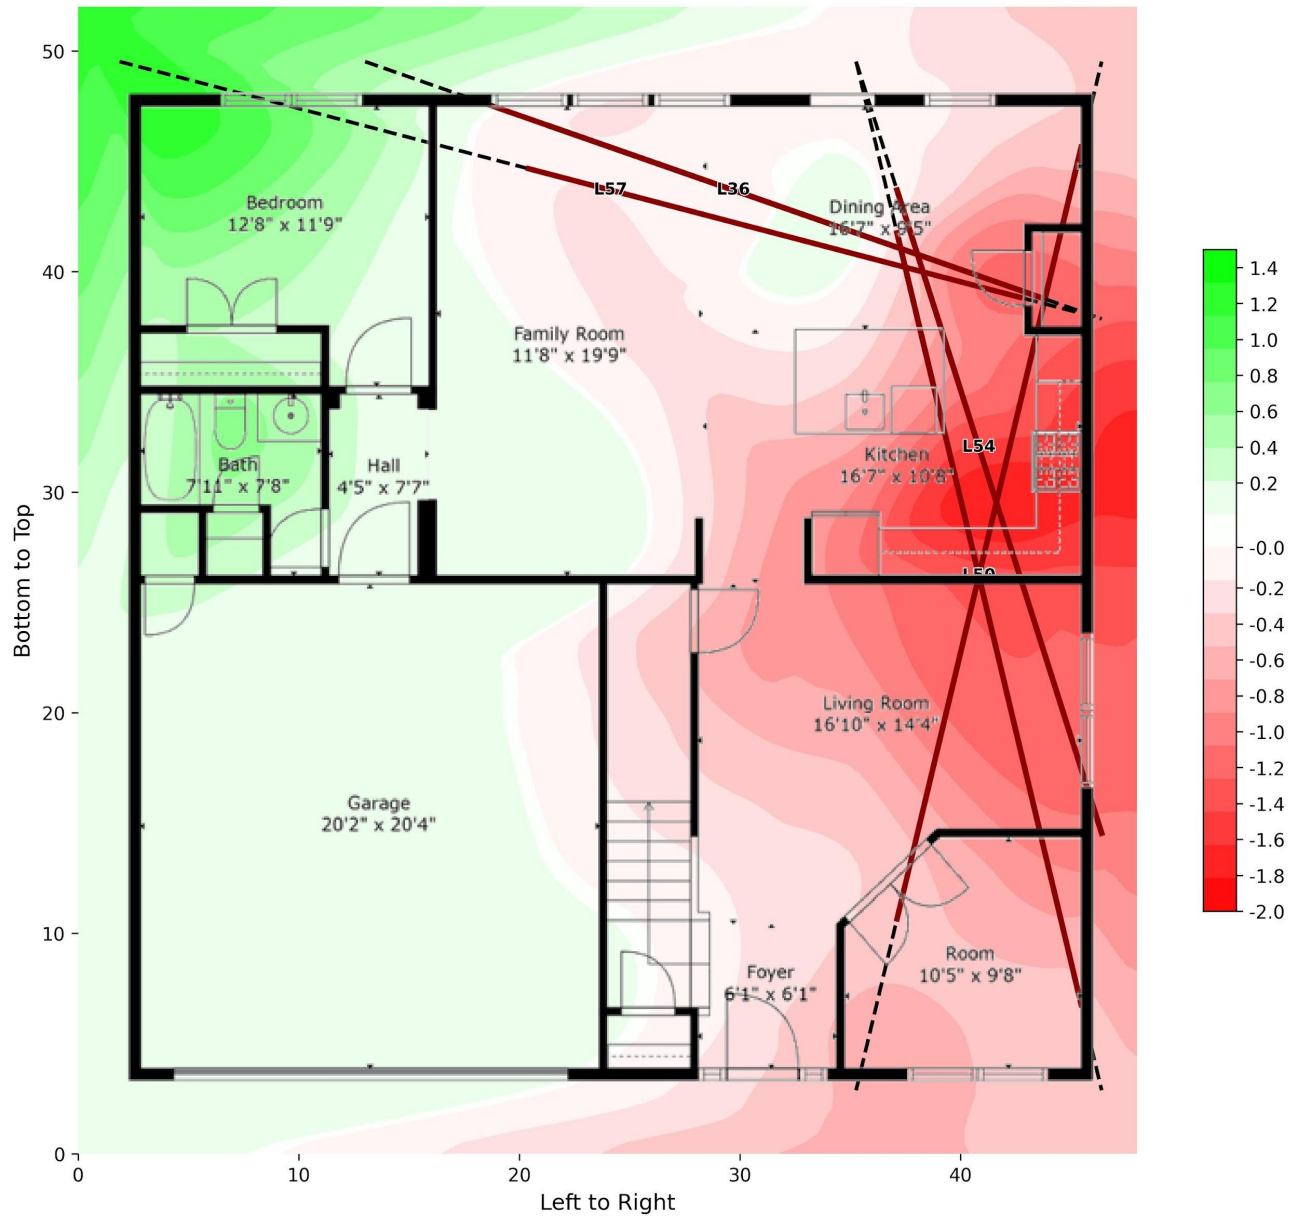
**Deflection Failures Graphic (Figure D)**

The above Figure D shows deflection failures along the foundation. Deflection failures can be considered localized failures in (sometimes) isolated portions of the foundation. The profile lines that were calculated are represented by a dashed black line and the areas that the deflection failures occur are represented by a dark red line segment. Of the 75 deflection profiles calculated, 5 profile failures were identified.

Deflection failures can be considered localized failures of the foundation in (sometimes) isolated portions of the foundation. Of the 75 deflection profiles calculated, 5 failures were identified.

Deflection failures are above standard acceptable limits; they exceed industry-standard thresholds and the structure should be considered actively moving/settling in areas where deflection failures are occurring. See the report's overall conclusion for a complete understanding of the overall foundation stabilization issue.

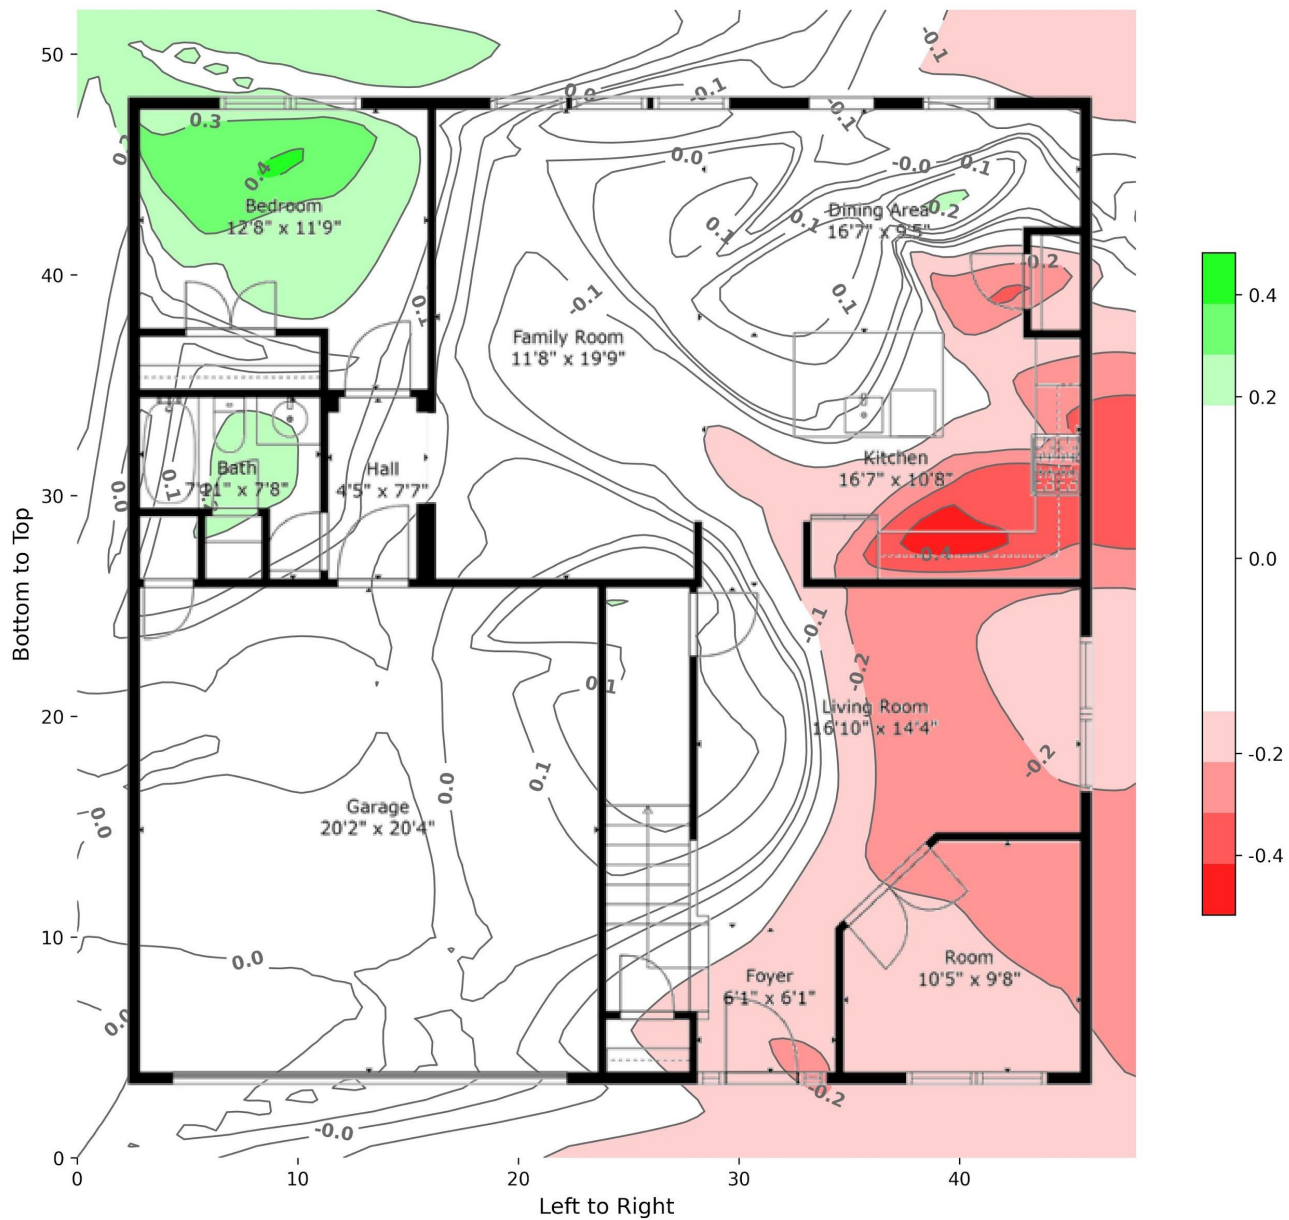
**Elevation Plot Difference Graphic (Figure F)**

A previous elevation plot completed in 2022 was available to use as a baseline of movement progression. Elevation differences are shown that show us the clear progression of movement from one date to another. As part of this evaluation, a contour mesh showing the elevation differences between the current contour mesh and the baseline was processed and is shown below.

The mesh contour graphic above in Figure F shows areas in red that are lower than the baseline elevation plot and areas of green that are higher than the baseline elevation plot (from the provided drawing completed in 2022). The darker the color (both red and green) the larger/smaller the elevation differences.

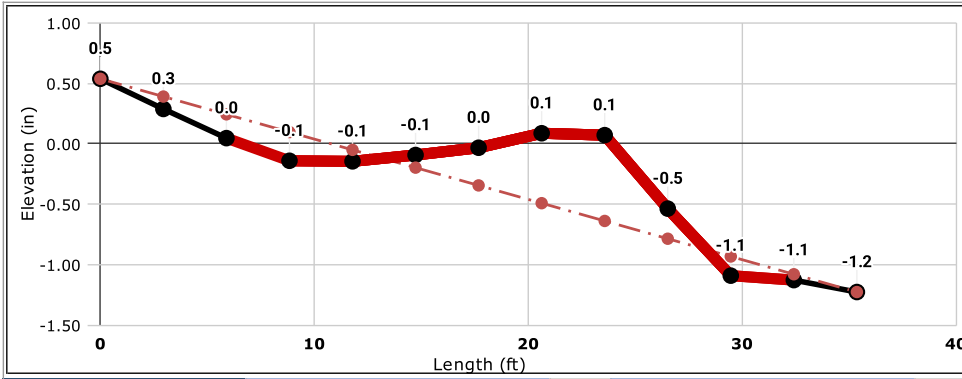
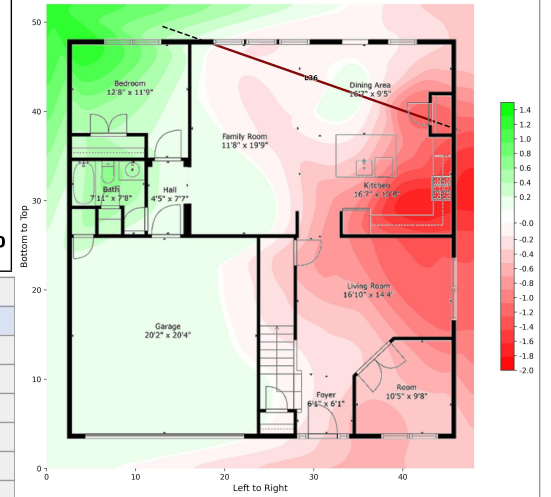
## Exhibit B: Identified Deflection/Tilt Failure (L36)

| Profile Data for L36 | | Actual Length (ft) | | | | | | Effective Length (ft) | | | | | |
|---|---|---|---|---|---|---|---|---|---|---|---|---|---|
| Deflection 4 (Failures) | | | 0.0 | -0.1 | -0.1 | -0.1 | 0.0 | 0.1 | 0.1 | -0.5 | -1.1 | -1.1 | |
