MERIT PROPERTY INSPECTIONS

PROPERTY INSPECTION REPORT

1234 Main St
Tampa, FL 33607

05/14/2025

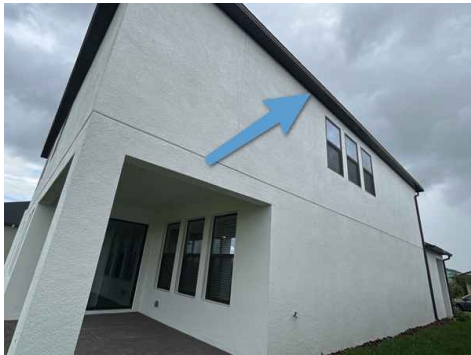
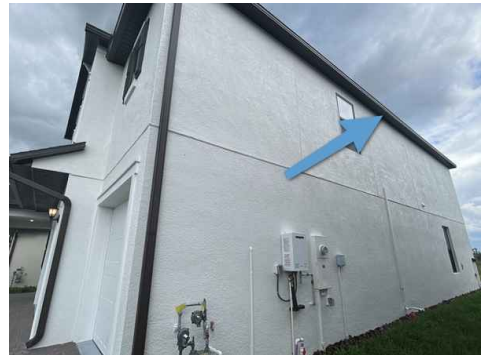
Gutters are used to direct rain water away from the foundation of the building which can help protect the foundation, reduce erosion, and prevent leaks/flooding from forming. The structure is missing gutters on a portion of the rooflines. Recommend installation as necessary.

Contact a qualified gutter contractor

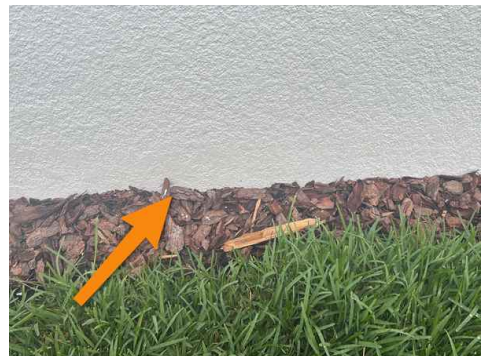
Across structure

2.2.2 B. Grading and Drainage

The clearance from the finished floor elevation (i.e. top of slab) to the exterior grade (i.e. ground) should be 6-inches or greater. This will prevent pooling surface water runoff from storm events from entering the structure. Recommend regrading the build-up of material to expose the foundation and create a greater clearance.

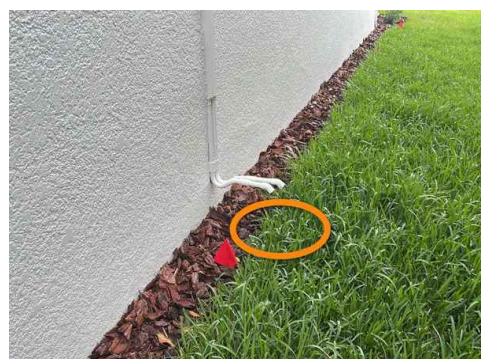
Right

2.2.3 B. Grading and Drainage

Area where water can occur, which could indicate poor drainage and/or grading. Recommend monitor and/or installing a splash block to disperse water.

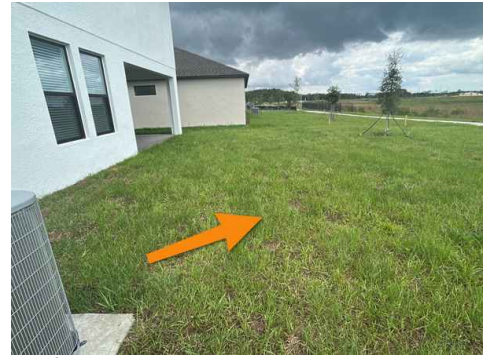
Back

2.2.4 B. Grading and Drainage

Grading is sloping towards the structure in some areas. The slope away from the structure should be at least 0.5 inch per foot for 10 feet. This drainage slope could lead to water intrusion and foundation issues. Recommend qualified landscaper or foundation contractor regrade so water flows away from structure.

Contact a qualified landscaping contractor

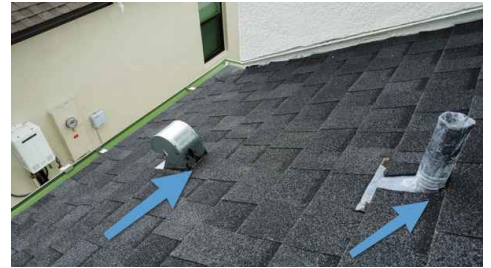
2.3.1 C. Roof Covering Materials

Areas of the roof need re-caulking to prevent water intrusion. Recommend hiring a contractor to re-caulk with approved roofing caulk and/or silicon sealant as necessary.

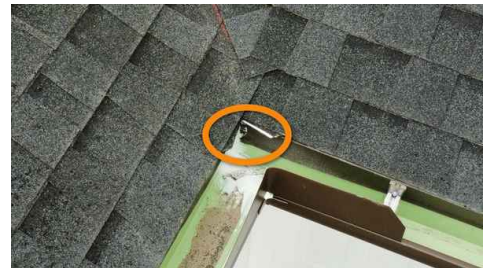
Front

2.3.2 C. Roof Covering Materials

DAMAGED COVERING

Roof coverings exhibited general damage that could affect performance. Recommend a qualified roofer evaluate and repair.

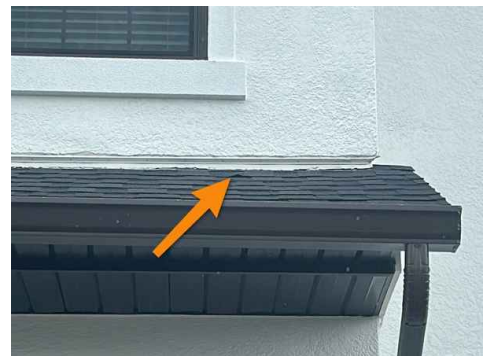
Front

2.3.3 C. Roof Covering Materials

Areas of the roof show lifted shingles. This is typically caused by high gusts of wind. Lifted shingles will not seal with the lower shingles and allow for water intrusion. Recommend a roofing contractor to replace.

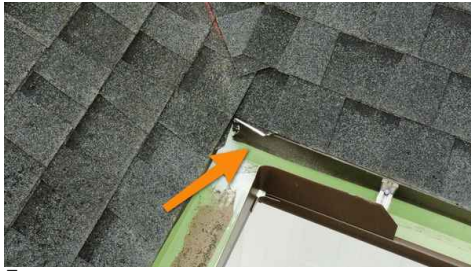
Front

2.3.4 C. Roof Covering Materials

Areas of the roof show lifted flashing areas. Lifted flashing areas will not seal with the fascia or siding and can allow for water intrusion. Recommend a roofing contractor to replace.

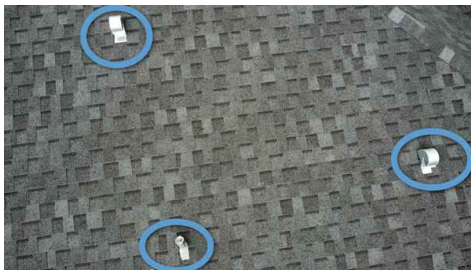
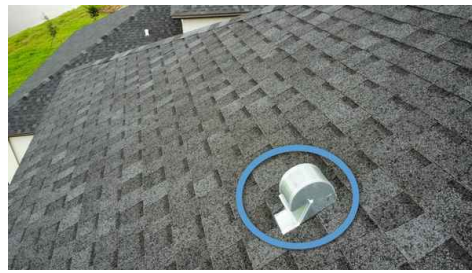
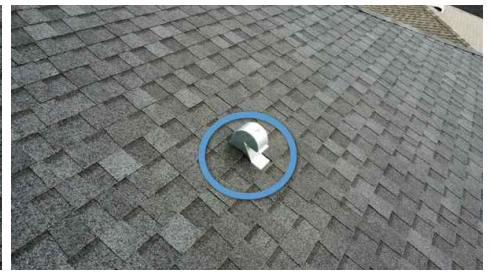
Roof vents are unpainted or should be repainted with a rust preventative paint (typically matching the roof color or black). Unpainted vents are more likely to cause discoloration of the roof by runoff as vents rust and rubber deteriorates.

Contact a qualified roofing professional.

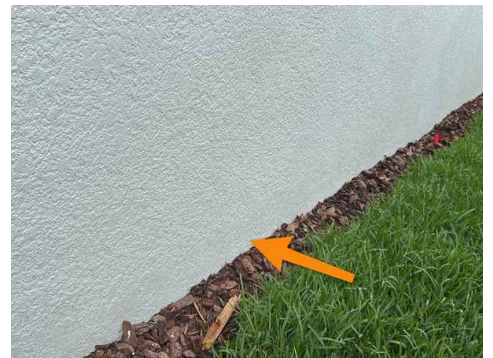
Across structure

2.5.1 E. Walls (Interior and Exterior)

NO STUCCO WEEP SCREED

No weep screed material was observed at the base of the wall stucco finish. The weep screed is a special piece of metal flashing that runs along the bottom of walls that wicks moisture out of holes that are located at the bottom of the flashing. It hangs below the lower sill plate to ensure that the water wicks past any material that could become damaged by excessive amounts of water. Recommend a stucco repair contractor to evaluate a resolution. We also recommend a mold inspection be performed to determine if mold is present and sending air quality (or tape) samples to a lab for testing.

Contact a stucco repair contractor

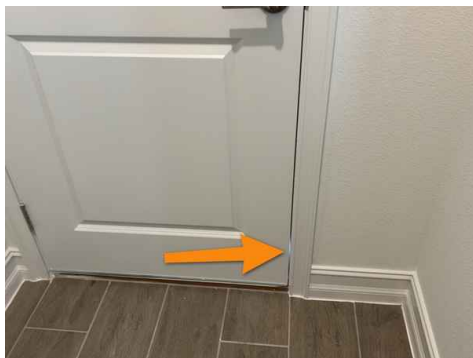
Garage

2.7.1 G. Doors (Interior and Exterior)

One or more gaps could result in energy loss. Recommend handyman or door contractor evaluate.

Contact a qualified door repair/installation contractor.

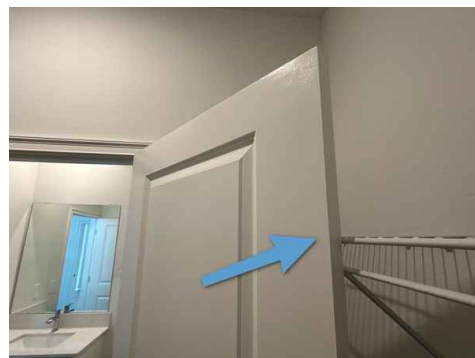
5th Bedroom Closet

2.7.2 G. Doors (Interior and Exterior)

Door has no doorstop. Without a doorstop, the doorknob can be lodged into the sheetrock and create a hole. Recommend installation of a doorstop.

Recommended DIY Project

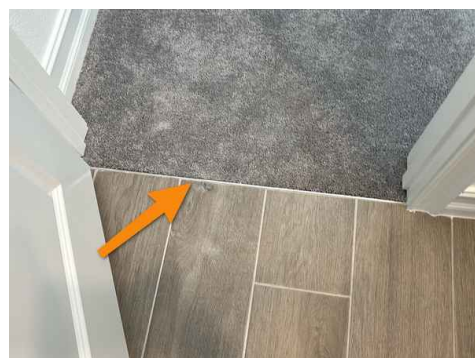
Staircase Bathroom

2.7.3 G. Doors (Interior and Exterior)

DOOR THRESHOLD MISSING (ACROSS STRUCTURE)

The door threshold is missing. The door threshold provides for an even transition from the exterior to the interior; it also allows for the door to seal properly and transition to the interior flooring. The door threshold should be firm, fully supported, and even across the bottom of the door.

Contact a qualified door repair/installation contractor.

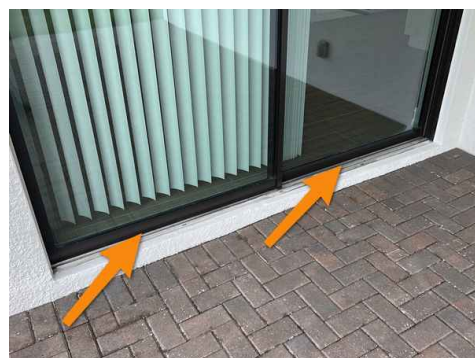
Back

2.7.4 G. Doors (Interior and Exterior)

DOOR WEATHER-STRIPPING MISSING OR INSUFFICIENT

Door has missing or insufficient weather-stripping. This can result in significant energy loss and moisture intrusion. Recommend installation of standard weather-stripping.

Recommended DIY Project

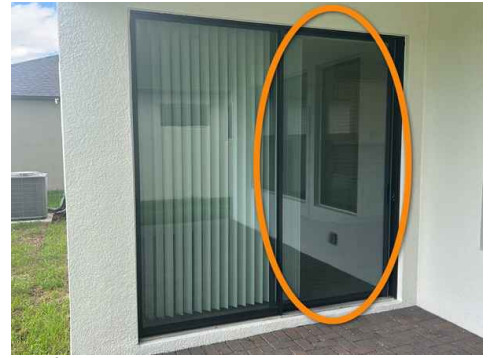
Back

2.7.5 G. Doors (Interior and Exterior)

SCREEN DOOR IS MISSING

There are tracks for a screen door, but the screen door is missing. Recommend a qualified professional install based on preference.

Contact a qualified door repair/installation contractor.

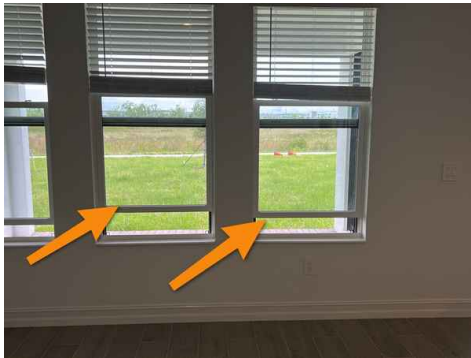
Living Room

2.8.1 H. Windows

One or more windows are difficult to open. This could be caused by a number of reasons, including structural deficiencies that apply force to the frame, windows have broken springs, or windows that are off their track(s). Recommend windows be restored to functional use by an window repair and installation contractor.

Contact a qualified window repair/installation contractor.

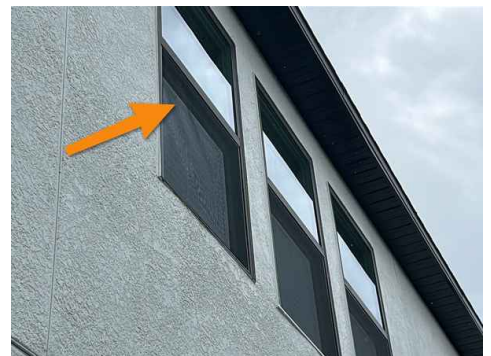
Left

WINDOW SCREEN IS DAMAGED

One or more windows has a damaged screen. Recommend replacement depending on preference.

Contact a qualified window repair/installation contractor.

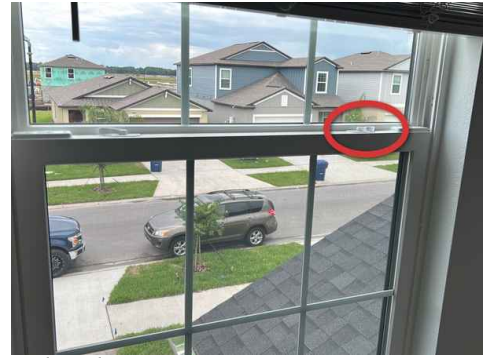
3rd Bedroom

2.8.3 H. Windows

WINDOW LATCH IS DAMAGED

Window latch is damaged and is unable to close properly. This could allow for unforeseen access to the property and is a safety concern. Recommend having window latch replaced or fixed.

Contact a qualified window repair/installation contractor.

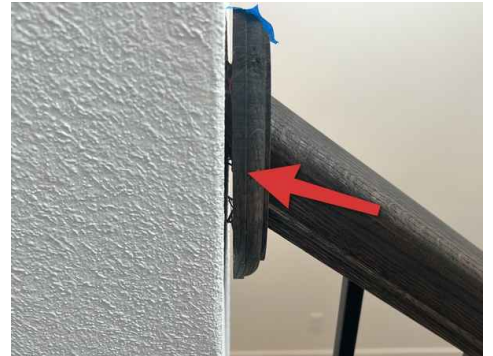
Staircase

2.9.1 I. Stairways (Interior and Exterior)

LOOSE HANDRAIL STRUCTURE

The stairway and/or balcony handrail is loose and unsupported. This is considered a safety issue and should be strengthened or replaced with a sufficient handrail structure, handrail, and baluster system.

Contact a qualified professional.

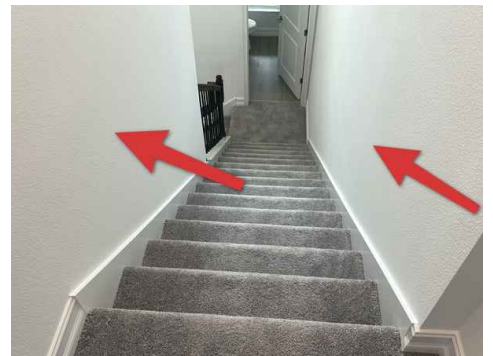
2.9.2 I. Stairways (Interior and Exterior)

HANDRAIL MISSING

Staircase had no handrails. This is a safety hazard. Recommend a qualified handyman install a handrail.

Contact a qualified general contractor.

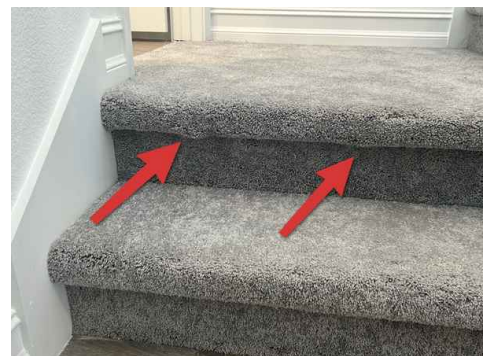
Staircase

2.9.3 I. Stairways (Interior and Exterior)

Stair steps are not uniform and are misshapen. This is a safety issue for a trip hazard. Recommend a qualified professional repair.

Contact a qualified general contractor.

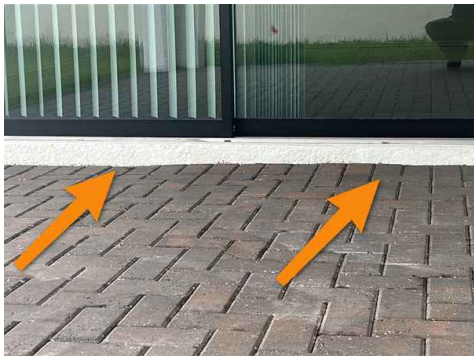
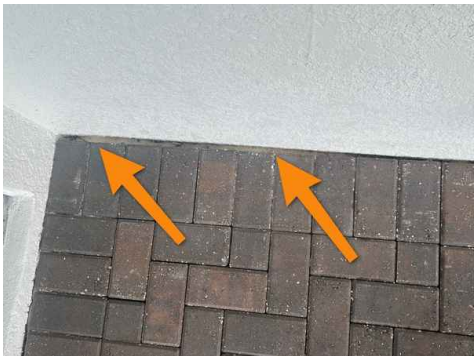
2.11.1 K. Porches, Balconies, Decks, and Carports

Pavers are uneven and/ or have gaps. Proper installation of pavers are flush to the wall with an even slope for proper drainage. Recommend a qualified professional repair areas.

Contact a qualified general contractor.

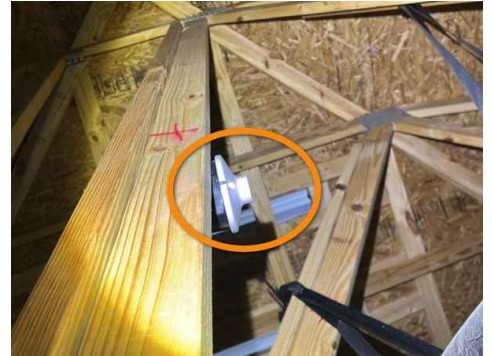
Attic

FIXTURE - BULB IS MISSING

One or more lighting fixtures failed to illuminate. Recommend installing the proper light bulb for functional use.

Contact a qualified electrical contractor.

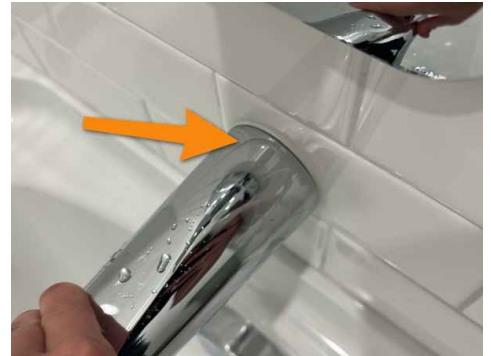
2nd Floor Hall Bathroom

5.1.2 A. Plumbing Supply, Distribution Systems, and Fixtures

Contact a qualified plumbing contractor.

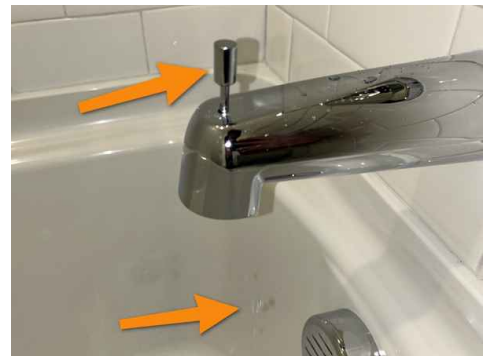
2nd Floor Hall Bathroom

5.1.3 A. Plumbing Supply, Distribution Systems, and Fixtures

Contact a qualified plumbing contractor.

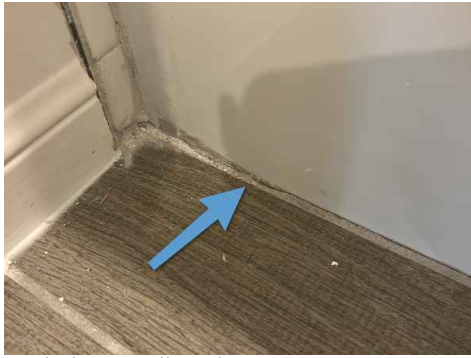
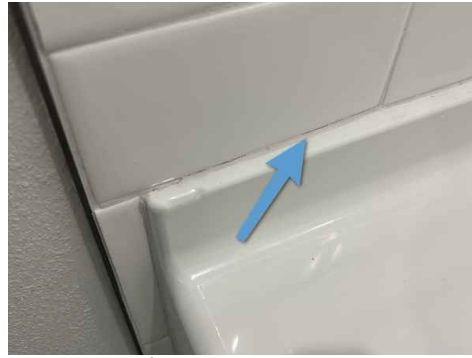
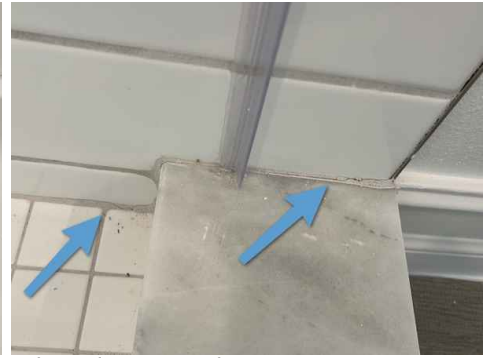
5.1.4 A. Plumbing Supply, Distribution Systems, and Fixtures

Recommended DIY Project

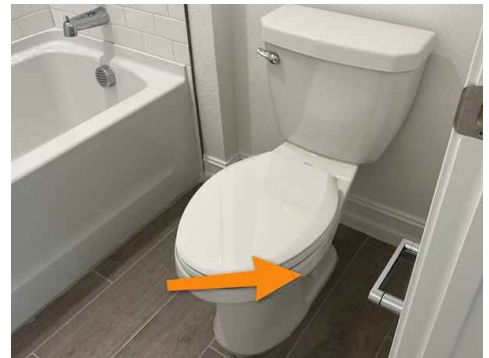
2nd Floor Hall Bathroom

5.1.5 A. Plumbing Supply, Distribution Systems, and Fixtures

Contact a qualified plumbing contractor.

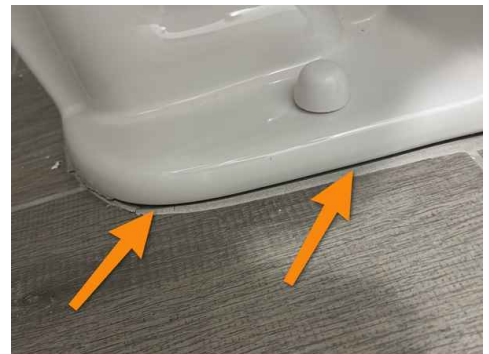
2nd Floor Hall Bathroom

5.1.6 A. Plumbing Supply, Distribution Systems, and Fixtures

Contact a qualified plumbing contractor.

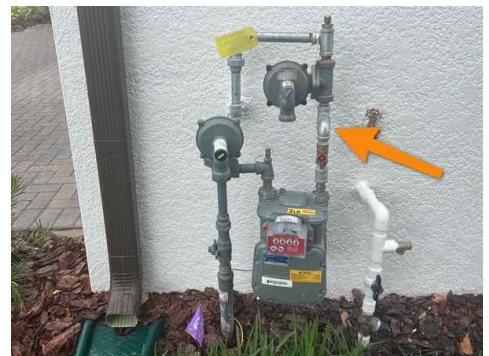
Right

5.5.1 F. Gas Distribution Systems and Gas Appliances

Contact a qualified plumbing contractor.

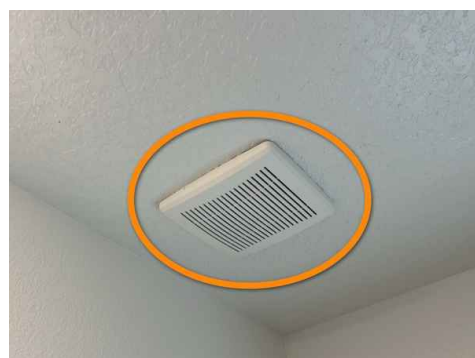
5th Bedroom Bathroom

6.6.1 F. Mechanical Exhaust Vents and Bathroom Heaters
