## SUMMARY

1234 Main St, Tampa, FL 12345  
06/11/2026

Abby Bullock  
Professional Home Inspector  
Merit Property Inspections  
(813)-485-4335  
[info@meritinspects.com](mailto:info@meritinspects.com)

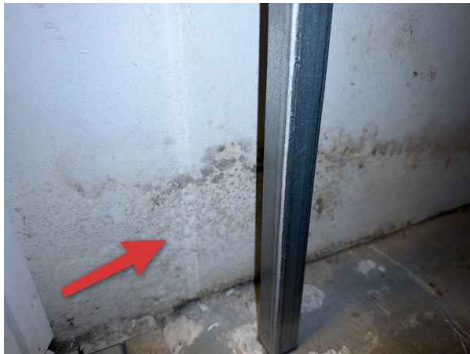
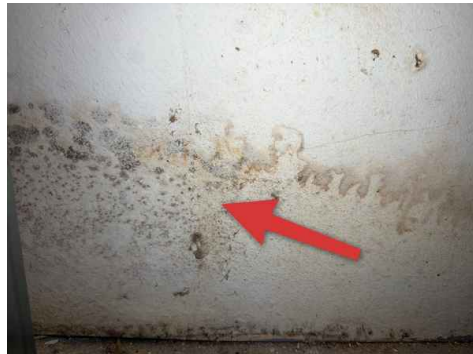
HVAC Closet

**AREA OF ORGANIC GROWTH**

Observed signs of **suspected mold** (discoloration, mold odor, mold spots, etc.) in one or more areas of the wall. Recommend mold inspector identifying source of moisture intrusion and possibly sending samples to a lab for testing.

Contact a qualified mold inspection professional.

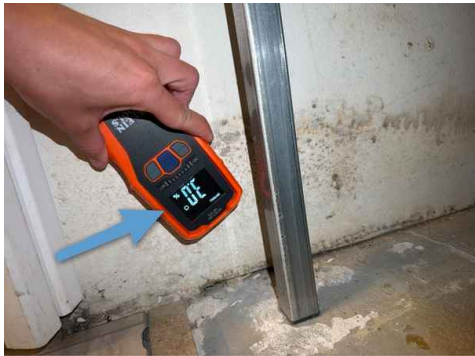
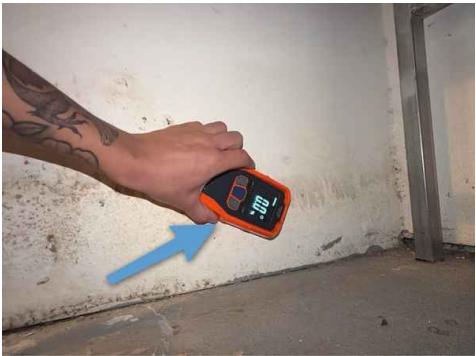
HVAC Closet

**DRY WATER STAIN OBSERVED**

A stain on the wall is present. This stain did not appear damp and could be from a previously resolved water leak. Recommend repainting and monitoring to address as necessary.

Contact a qualified painting contractor.

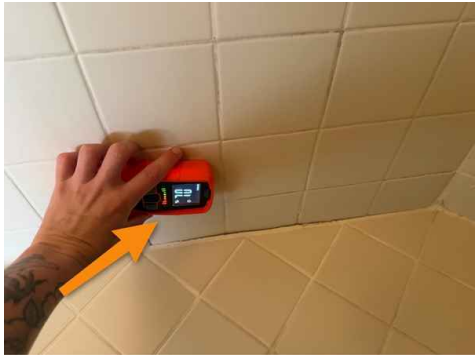
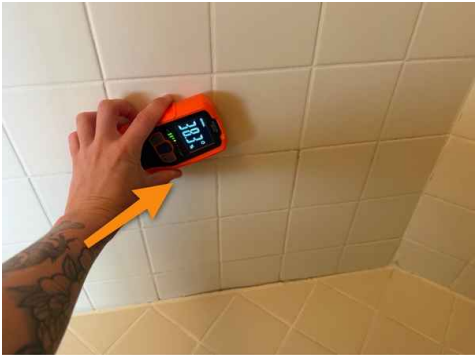
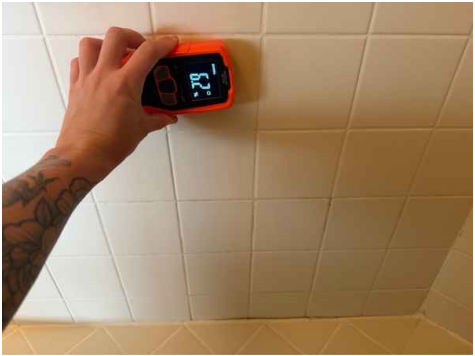
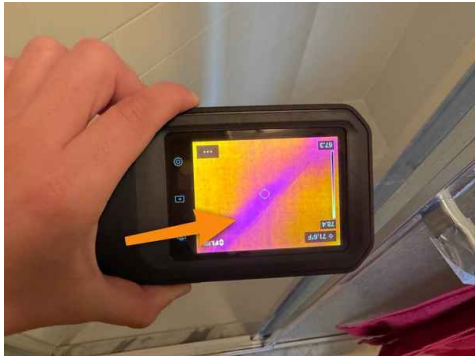
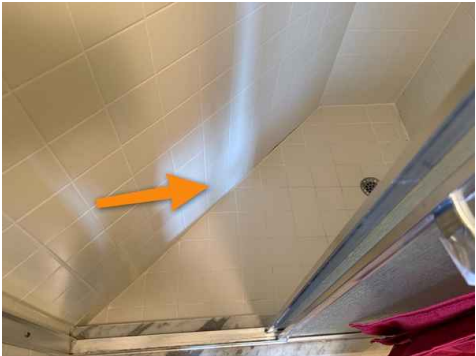
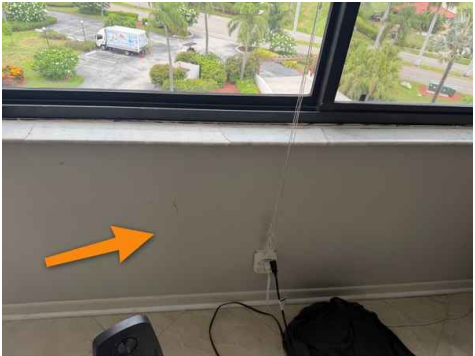
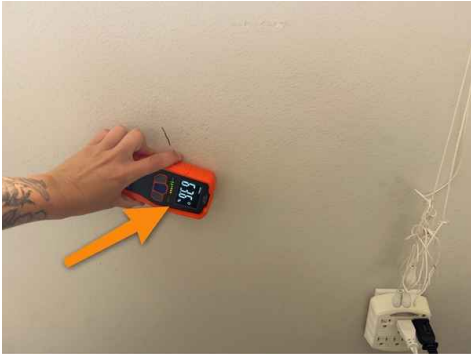
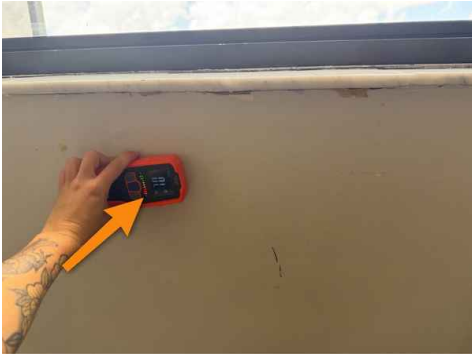
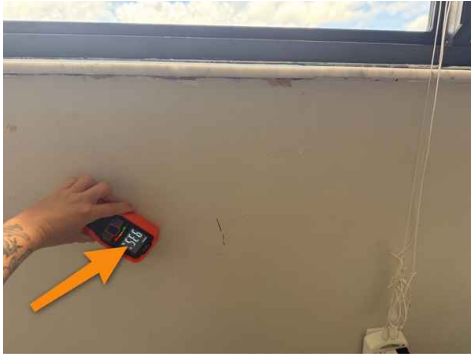
HIGH LEVELS OF MOISTURE PRESENT

**There are high level areas of moisture present on this wall.** This was identified by signs of water intrusion (separation of baseboards, cracks, or moisture staining).

While relative humidity can have some effect on moisture levels, drywall is considered to have an appropriate level of moisture if it has a moisture content of between 5% and 12%.

Moisture readings in this area are higher than normal indicating active or previous water intrusion. Prolonged moisture conditions can contribute to concealed damage and potential microbial growth. The source and full extent of the moisture intrusion could not be determined during this inspection. Recommend a qualified professional identifying the source of moisture intrusion, and a mold remediation be performed if mold is present.

Contact a qualified mold remediation contractor

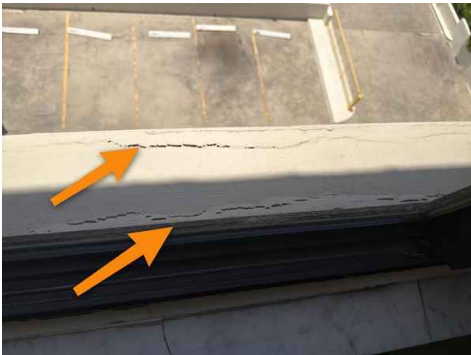
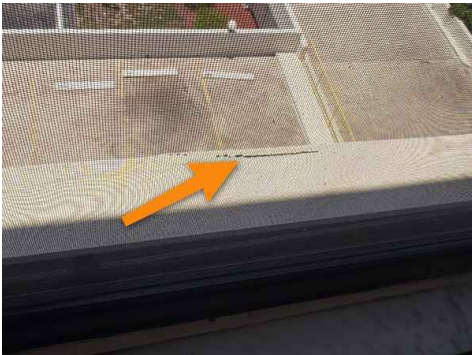
Primary Bedroom

2.5.4 E. Walls (Interior and Exterior)  
**AREAS OF APPARENT WATER INTRUSION**

Significant cracking was observed in the exterior stucco wall covering. Elevated moisture readings were detected on the interior side of the affected wall, indicating possible moisture intrusion through the cracked exterior surface. Prolonged moisture exposure may result in deterioration of building materials and can create conditions conducive to microbial growth. The extent of any concealed damage could not be determined during the inspection. Recommend evaluation and repair by a qualified stucco contractor or building envelope specialist to address the cracking and moisture intrusion.

Recommendation  
Contact a stucco repair contractor

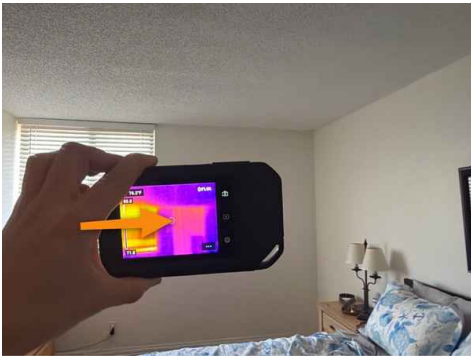
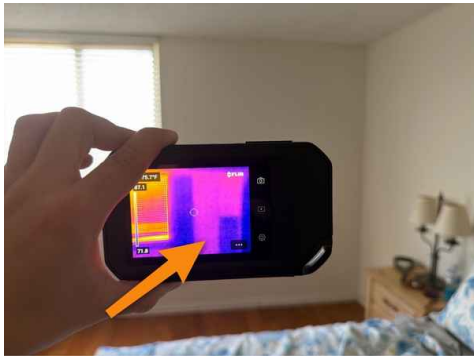
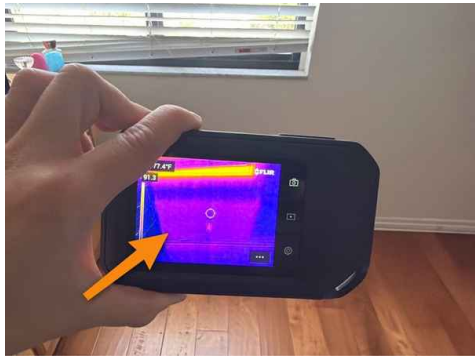
2nd Bedroom

2.5.5 E. Walls (Interior and Exterior)  
**THERMAL - HOT/COLD SPOT SHOWING IN THERMAL SCAN**

There is a hot or cold spot that is showing in the thermal imagery scan that was performed. This is typically caused by a lack of insulation in the walls. This can also be caused by a settling of blown-in or batt insulation in the walls of older structures. Wall areas missing insulation can be more difficult to remedy because of access limitations. Some spots may be permanent inefficiencies because of the cost/benefit in trying to remedy the issue. Recommend further investigation by an insulation contractor or an HVAC specialist.

Recommendation  
Contact a qualified insulation contractor.

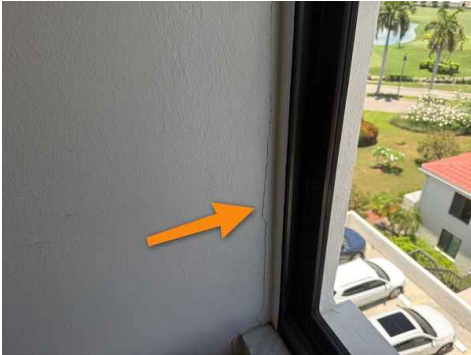
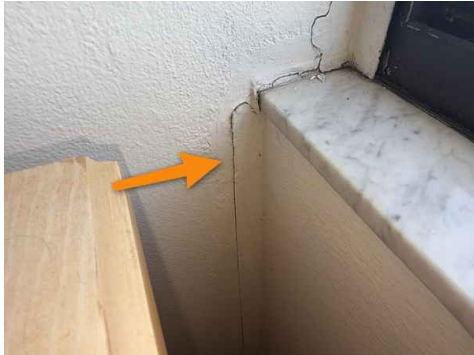
2nd Bedroom

2.5.6 E. Walls (Interior and Exterior)  
**MINOR INTERIOR CRACKS**

Minor cracks were observed in interior wall surfaces. These are commonly associated with normal settling or minor movement. Recommend monitoring for changes and repair as needed.

Recommendation  
Contact a qualified drywall contractor.

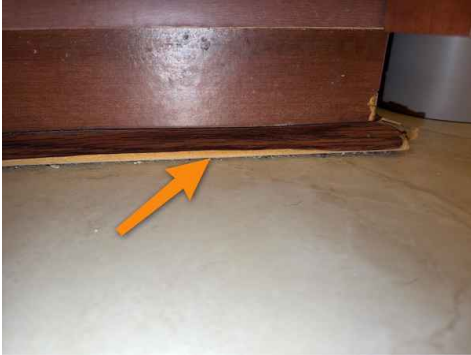
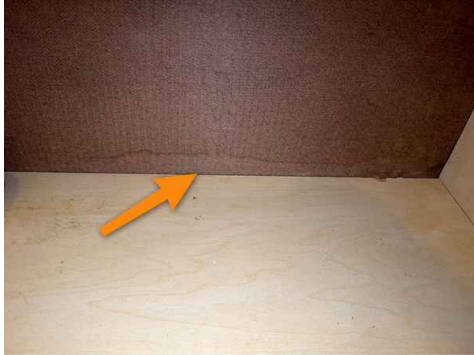
Hall Bathroom

2.5.7 E. Walls (Interior and Exterior)  
**CABINET- EVIDENCE OF WATER DAMAGE**

Evidence of water damage and staining was observed within the cabinet. The condition indicates moisture exposure and may be associated with leakage from plumbing fixtures or components. No leak observed at time of inspection. Recommend monitoring and repairing damaged materials as needed.

Recommendation  
Contact a qualified cabinet contractor.

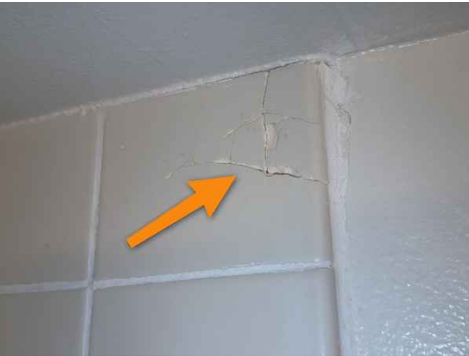
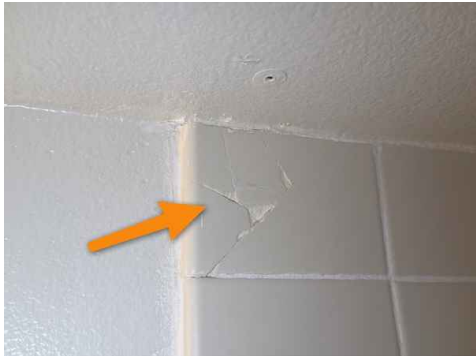
Hall Bathroom

DAMAGED SHOWER WALL TILE

Damage was observed to the shower wall tile near the ceiling. Damaged tile surfaces may allow moisture to penetrate behind the finished wall covering, potentially leading to deterioration of underlying materials. Recommend repair or replacement of the affected tile by a qualified contractor to help prevent moisture intrusion.

Recommendation  
Contact a qualified tile contractor

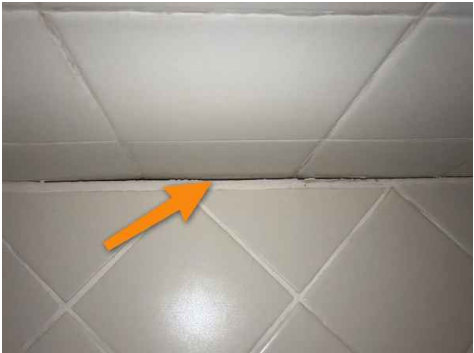
Primary Bathroom

SEPARATION AND GAP AT SHOWER WALL TO FLOOR SEAM

Separation and gaps were observed at the shower wall seam. This condition may allow water to penetrate behind the finished surfaces, resulting in moisture intrusion and wicking into adjacent wall materials. Prolonged moisture exposure can contribute to deterioration of building materials and create conditions conducive to microbial growth. The extent of any concealed damage could not be determined during the inspection. Recommend further evaluation of any moisture-related damage by a qualified professional and repairs as needed.

Recommendation  
Contact a qualified tile contractor

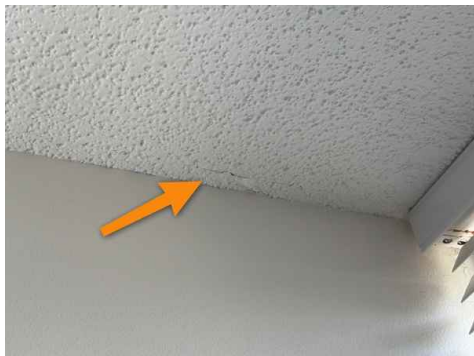
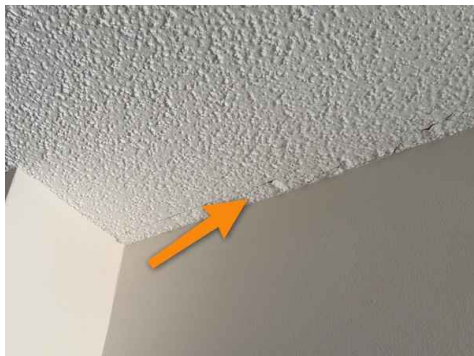
2nd Bedroom

CEILING - SHEETROCK CRACKS MINOR

Minor sheetrock cracking was observed on the ceiling. This is common in structures this age and is often determined to be cosmetic, most often the separation of drywall tape joints. Recommend patching, repainting, monitoring these locations for further cracking.

Recommendation  
Contact a qualified painting contractor.

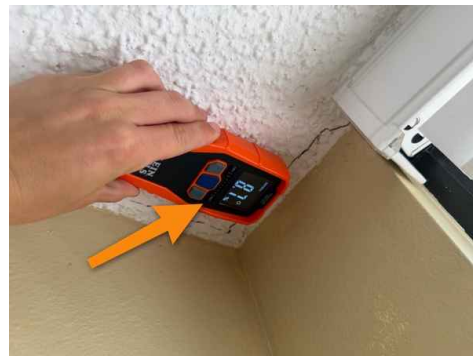
Dining- no elevated levels of moisture

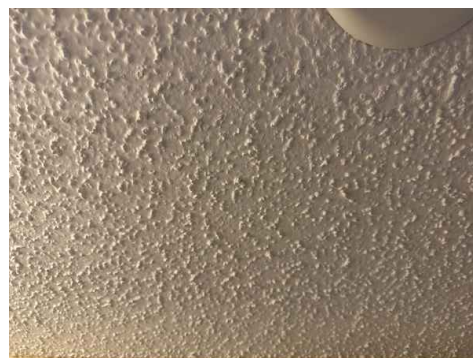
Across structure

##### CEILING - POPCORN TEXTURE

Areas of the structure have popcorn textured ceilings. This texture most likely contains asbestos. Asbestos was the material of choice for popcorn ceilings until the substance was banned as a health hazard in 1978. Manufacturers switched to paper fiber that year, but suppliers continued to sell existing stores of asbestos-laced material. That means that popcorn ceilings installed as late as the mid-'80s could contain asbestos.

The ceiling will not endanger your health as long as it remains completely undisturbed or properly encapsulated with paint. Popcorn ceiling can be tested for asbestos by carefully scraping a small sample into a plastic bag and having it tested at an EPA-accredited lab.

Contact a qualified drywall contractor.

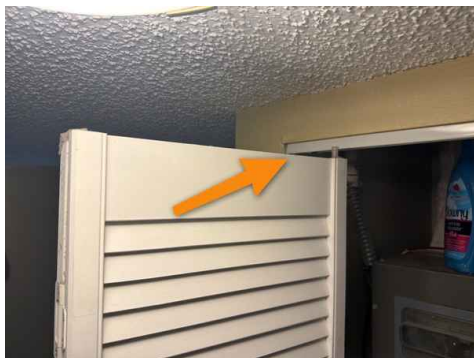
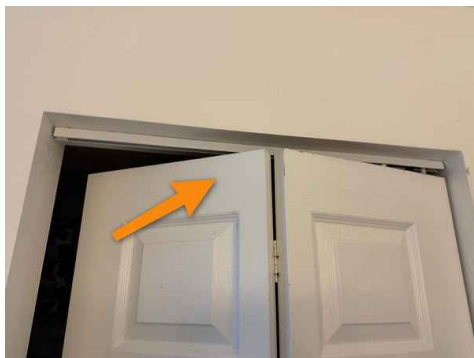
##### DOOR RAIL ISSUE

The door is not sliding on its tracks / rails correctly or is off the tracks completely. Recommend a contractor evaluate and reinstall correctly.

Contact a qualified door repair/installation contractor.

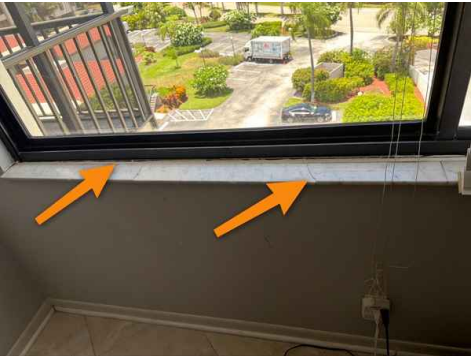
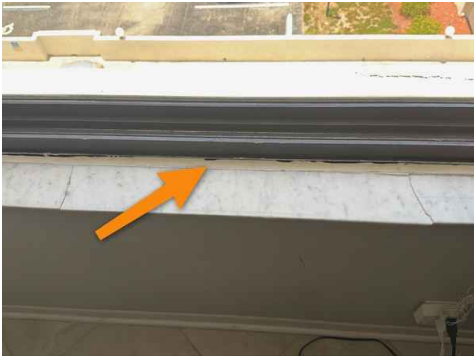
Primary Bedroom

##### WINDOW SILL CRACKING / SEPARATION

Cracking and separation were observed at the window sill and adjacent finishes. The condition appears consistent with movement of the building materials and/or differential movement between the window assembly and surrounding wall surfaces. These openings may permit moisture intrusion and can worsen over time. Recommend repair of the affected areas by a qualified contractor and monitoring.

Recommendation  
Contact a qualified general contractor.

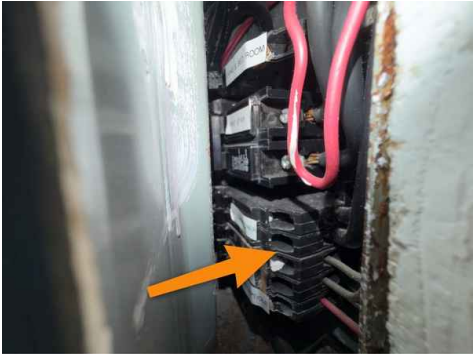
Hall

3.1.1 A. Service Entrance and Panels  
**PANEL MISSING AFCI BREAKERS**

AFCI (Arc-Fault Circuit Interrupter) protection was not installed at applicable branch circuits. Modern safety standards recommend AFCI protection to reduce the risk of electrical fires caused by arc faults. Homes constructed prior to adoption of the 2008 NEC AFCI requirements may not be required to have this protection and are generally considered grandfathered under the standards in place at the time of construction. Upgrades can improve safety and should be discussed with a qualified electrician.

Recommendation  
Contact a qualified electrical contractor.

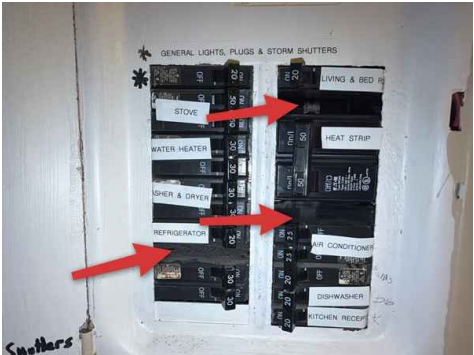
Hall

3.1.2 A. Service Entrance and Panels  
**MISSING BREAKER FILLER PLATES**

Breaker filler plates are missing from the breaker panel. Without filler plates, fingers can fit through the slit creating a safety hazard. Recommend installing the filler plates or contacting an electrician who can install them.

Recommendation  
Contact a qualified electrical contractor.

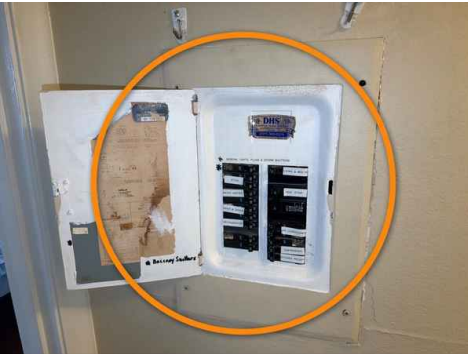
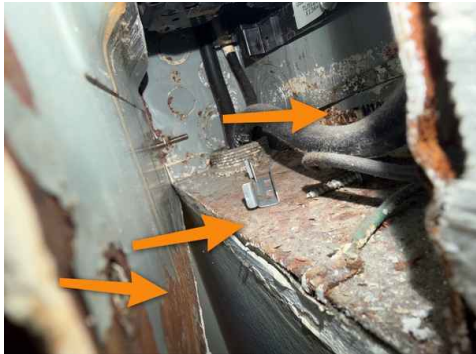
Hall

3.1.3 A. Service Entrance and Panels  
**PANEL APPEARS TO BE NEARING END OF SERVICE LIFESPAN**

The electrical panel appears to be nearing the end of its typical service lifespan based on observed age and condition. Corrosion observed. While functional at the time of inspection, older electrical panels may become less reliable over time and could benefit from further evaluation, maintenance, or replacement by a qualified electrician.

Recommendation  
Contact a qualified electrical contractor.

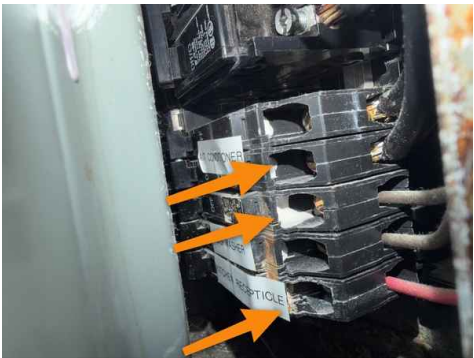
Hall

3.1.4 A. Service Entrance and Panels  
**MINERAL DEPOSITS OBSERVED IN ELECTRICAL PANEL**

White mineral deposits were observed near the circuit breakers, suggesting possible past or ongoing moisture intrusion. Recommend evaluation by a qualified licensed electrician and correction as needed.

Recommendation  
Contact a qualified electrical contractor.

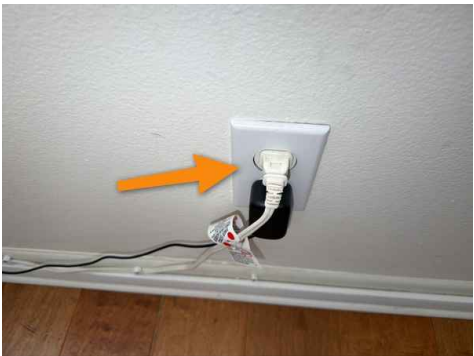
Bedroom

3.2.1 B. Branch Circuits, Connected Devices, and Fixtures  
**OUTLET - LOOSE AND NOT SECURE**

An outlet is loose and not securely fastened to the gang-box and/or the structure behind the sheetrock. Loose outlets will become worse over time as contact points start to wear down and wires bend back and forth. Loose outlets can eventually lead to broken wires, dead circuits, flickering lights, or other electrical problems (including electrical fire). Recommend an electrical contractor tighten the outlet so it does not move.

Recommendation  
Contact a qualified electrical contractor.

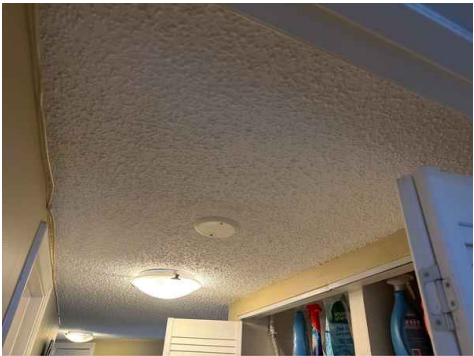
Bedroom Hall

3.3.1 C. Low Voltage & Other  
**SMOKE ALARM - MISSING**

Smoke alarm/detector is missing. It is recommended that smoke alarms be installed inside each bedroom, outside each sleeping area and on every level of the structure. On levels without bedrooms, it is recommended that alarms be installed in the living room (or den or family room) or near the stairway to the upper level, or in both locations. Recommend installation of fire alarm.

Recommendation  
Recommended DIY Project

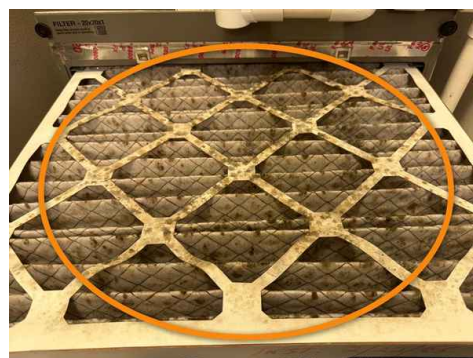
Hall Closet

#### 4.3.1 C. Duct Systems, Chases, and Vents **FILTER REQUIRES REPLACEMENT**

The HVAC filter appears to be beyond its expected lifespan. Recommend replacement. Do it yourself or hire an HVAC/Handyman Contractor.

Recommendation  
Contact a handyman or DIY project

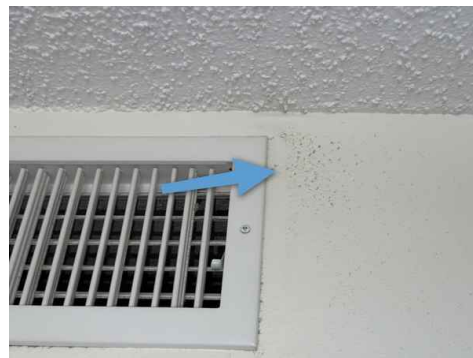
Bedroom

#### 4.3.2 C. Duct Systems, Chases, and Vents **DUCT CLEANING IS RECOMMENDED**

Inspector has discovered evidence that the HVAC duct system should be cleaned. This includes either a visual investigation of the plenums through access ports (if available) or supply vents that are dirty, dusty, and/or clogged with debris.

Recommendation  
Contact a qualified HVAC professional.

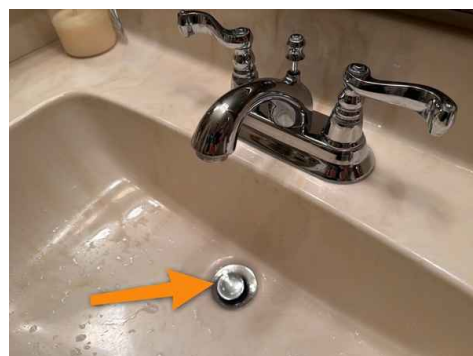
Hall Bathroom

##### **FAUCET DRAIN PULL ISSUE**

The faucet drain pull is not functioning properly and is jammed. Recommend plumbing contractor to resolve issue.

Recommendation  
Contact a qualified plumbing contractor.

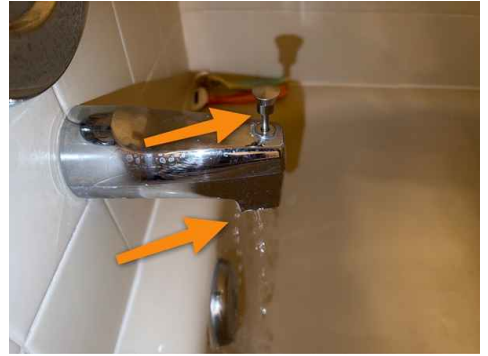
Hall Bathroom

#### TUB SPOUT DIVERTER IS NOT EFFECTIVE

The tub spout divert is not fully diverting water to the shower. A leaking and/or broken shower diverter wastes water and creates a lower-pressure shower experience. Recommend consulting a plumbing contractor.

Contact a qualified plumbing contractor.

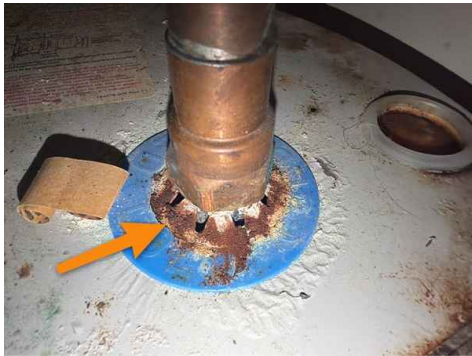
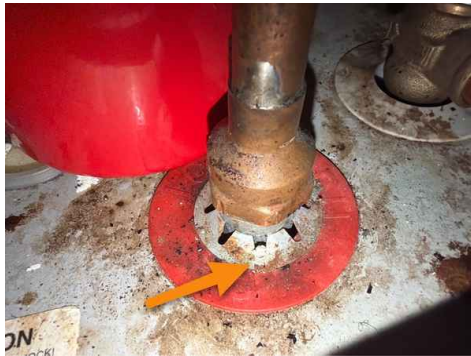
Entry Hall Closet

#### CORROSION AT PIPE CONNECTORS

Corrosion and mineral deposits were observed at the water heater plumbing connection. This condition is typically associated with past or ongoing moisture exposure and may indicate leakage at the connection. Continued deterioration can lead to water damage and premature failure of the affected components. Recommend evaluation and repair by a qualified plumbing contractor, with replacement of deteriorated components as necessary.

Contact a qualified plumbing contractor.

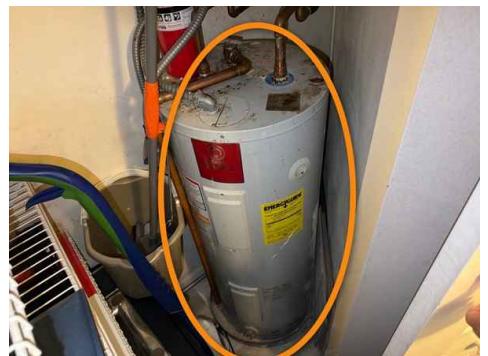
Entry Hall Closet

#### WATER HEATER PAST EXPECTED SERVICE LIFESPAN

The water heater has reached the end of its expected useful life based on age. Typical residential water heaters have a service life of approximately 8 to 12 years, and this unit appears to be at or beyond that range. The current age warrants consideration of replacement in the near term and/or budgeting for replacement.

Contact a qualified plumbing contractor.

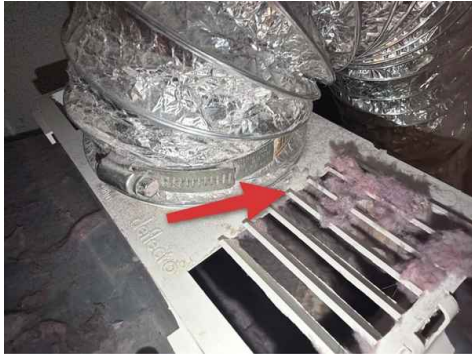
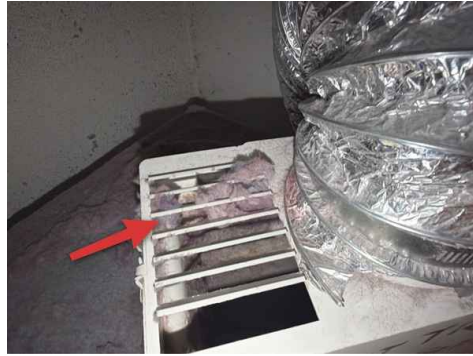
Laundry Closet

#### VENT IS DIRTY

The dryer vent is dirty and may be partially clogged. Consider cleaning the vent prior to use to prevent the buildup of debris and possible fire hazard.

Contact a qualified plumbing contractor.
