**SUMMARY**

1234 Main St , Tampa, FL 33607

Buyer Name
05/14/2025Abby Bullock
Professional Home Inspector
Merit Property Inspections
+8134854335
info@meritinspects.com

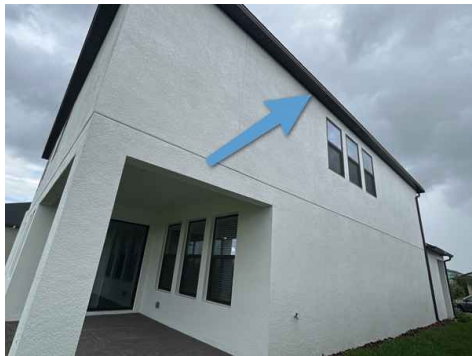
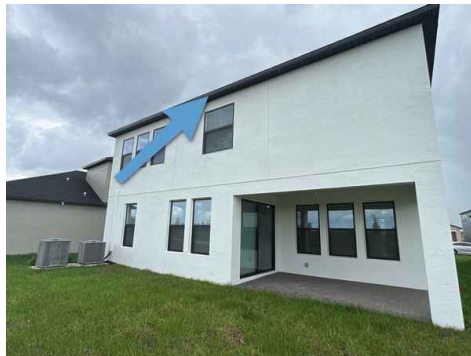
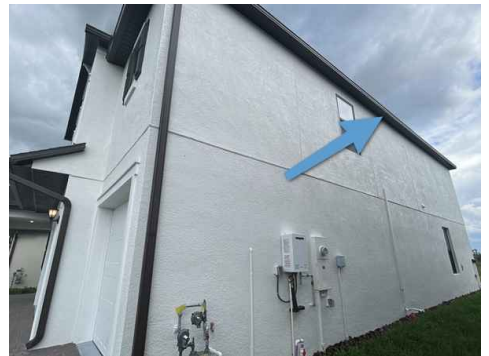
2.2.1 B. Grading and Drainage

GUTTERS NOT PRESENT (MOST OF STRUCTURE)

Gutters are used to direct rain water away from the foundation of the building which can help protect the foundation, reduce erosion, and prevent leaks/flooding from forming. The structure is missing gutters on a portion of the rooflines. Recommend installation as necessary.

Contact a qualified gutter contractor

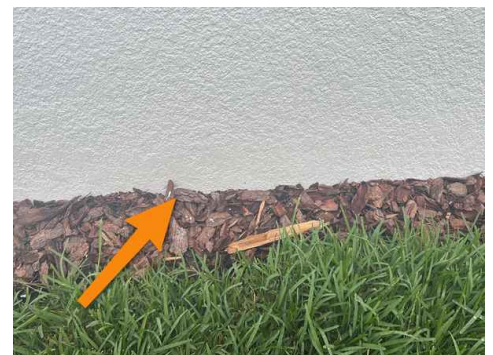
2.2.2 B. Grading and Drainage

LOW CLEARANCE TO GRADE

The clearance from the finished floor elevation (i.e. top of slab) to the exterior grade (i.e. ground) should be 6-inches or greater. This will prevent pooling surface water runoff from storm events from entering the structure. Recommend regrading the build-up of material to expose the foundation and create a greater clearance.

Additionally the soil and vegetation should not be in contact with the siding or any wood.

Across structure

Contact a qualified landscaping contractor

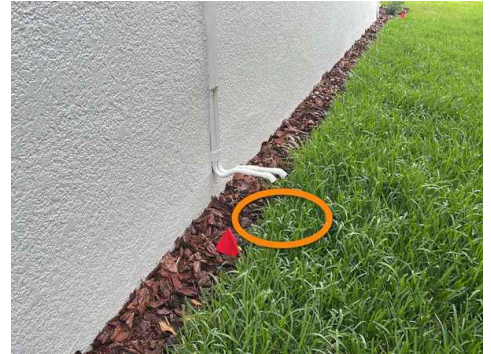
2.2.3 B. Grading and Drainage

AREA WHERE WATER WILL STAND

Area where water can occur, which could indicate poor drainage and/or grading. Recommend monitor and/or installing a splash block to disperse water.

Right

Contact a qualified landscaping contractor

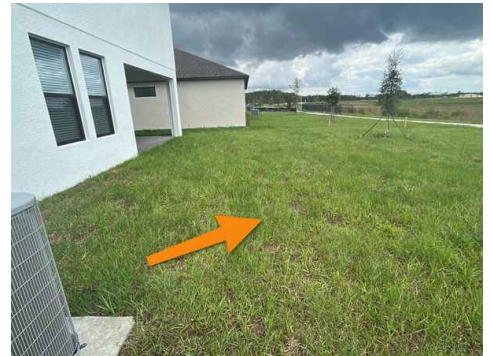
2.2.4 B. Grading and Drainage

NEGATIVE GRADING SLOPE

Grading is sloping towards the structure in some areas. The slope away from the structure should be at least 0.5 inch per foot for 10 feet. This drainage slope could lead to water intrusion and foundation issues. Recommend qualified landscaper or foundation contractor regrade so water flows away from structure.

Back

Contact a qualified landscaping contractor

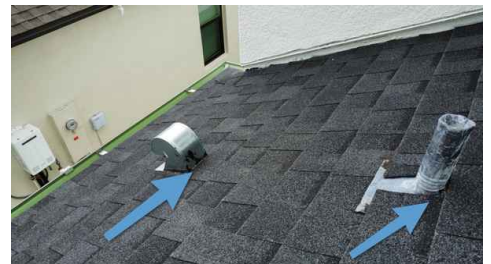
2.3.1 C. Roof Covering Materials

RE-CAULKING NEEDED

Areas of the roof need re-caulking to prevent water intrusion. Recommend hiring a contractor to re-caulk with approved roofing caulk and/or silicon sealant as necessary.

Contact a qualified roofing professional.

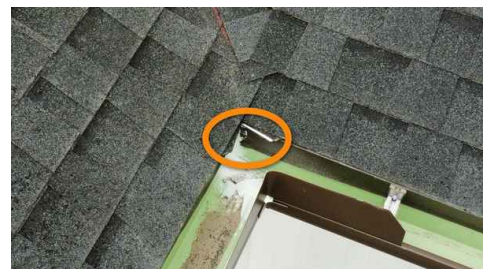
2.3.2 C. Roof Covering Materials

DAMAGED COVERING

Roof coverings exhibited general damage that could affect performance. Recommend a qualified roofer evaluate and repair.

Front

Contact a qualified roofing professional.

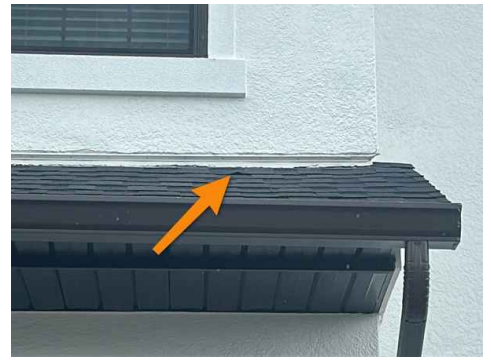
2.3.3 C. Roof Covering Materials

LIFTED SHINGLES

Areas of the roof show lifted shingles. This is typically caused by high gusts of wind. Lifted shingles will not seal with the lower shingles and allow for water intrusion. Recommend a roofing contractor to replace.

Front

Contact a qualified roofing professional.

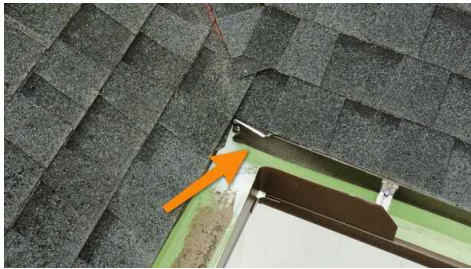
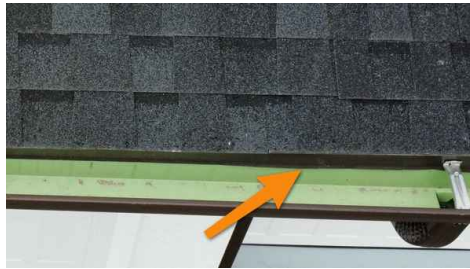
2.3.4 C. Roof Covering Materials

LIFTED DRIP EDGE FLASHING

Areas of the roof show lifted flashing areas. Lifted flashing areas will not seal with the fascia or siding and can allow for water intrusion. Recommend a roofing contractor to replace.

Contact a qualified roofing professional.

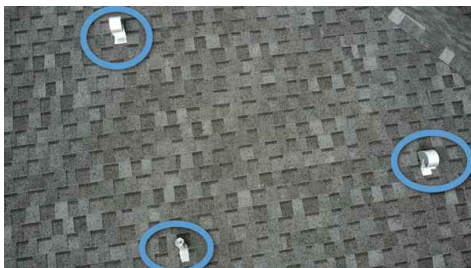
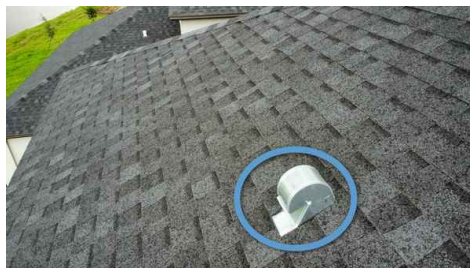
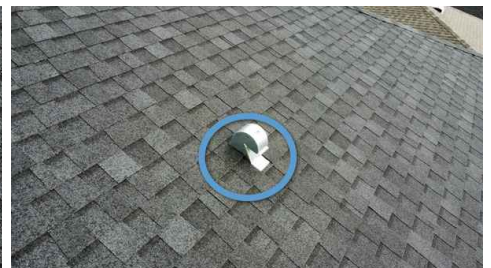
2.3.5 C. Roof Covering Materials

VENTS UNPAINTED OR SHOULD BE REPAINTED

Roof vents are unpainted or should be repainted with a rust preventative paint (typically matching the roof color or black). Unpainted vents are more likely to cause discoloration of the roof by runoff as vents rust and rubber deteriorates.

Contact a qualified roofing professional.

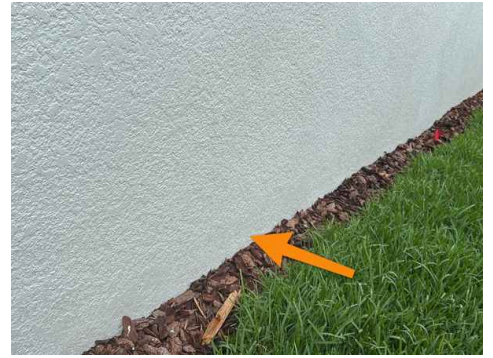
2.5.1 E. Walls (Interior and Exterior)

NO STUCCO WEEP SCREED

No weep screed material was observed at the base of the wall stucco finish. The weep screed is a special piece of metal flashing that runs along the bottom of walls that wicks moisture out of holes that are located at the bottom of the flashing. It hangs below the lower sill plate to ensure that the water wicks past any material that could become damaged by excessive amounts of water. Recommend a stucco repair contractor to evaluate a resolution. We also recommend a mold inspection be performed to determine if mold is present and sending air quality (or tape) samples to a lab for testing.

Across structure

Contact a stucco repair contractor

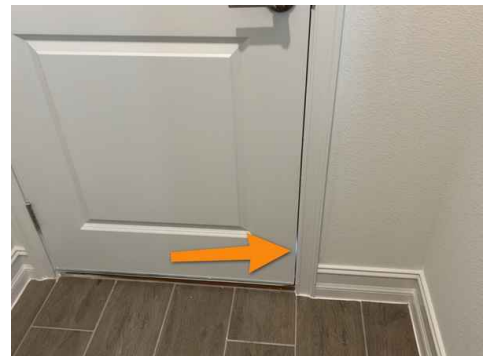
2.7.1 G. Doors (Interior and Exterior)

DOOR HAS NOTICEABLE GAP

One or more gaps could result in energy loss. Recommend handyman or door contractor evaluate.

Garage

Contact a qualified door repair/installation contractor.

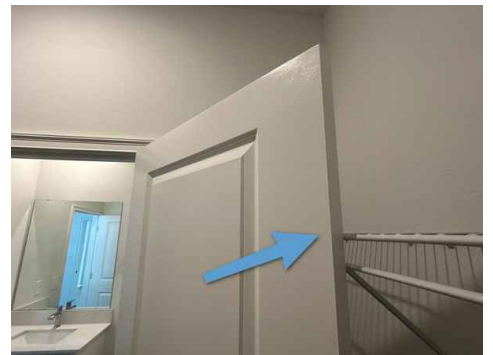
2.7.2 G. Doors (Interior and Exterior)

DOOR HAS NO DOORSTOP

Door has no doorstop. Without a doorstop, the doorknob can be lodged into the sheetrock and create a hole. Recommend installation of a doorstop.

5th Bedroom Closet

Recommended DIY Project

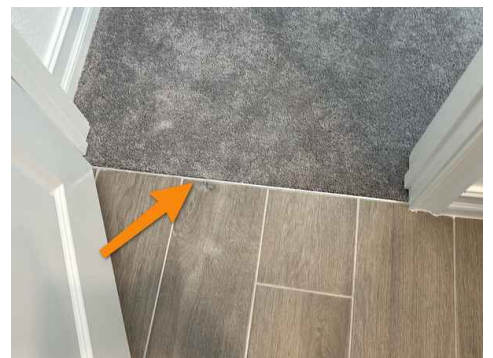
2.7.3 G. Doors (Interior and Exterior)

DOOR THRESHOLD MISSING (ACROSS STRUCTURE)

The door threshold is missing. The door threshold provides for an even transition from the exterior to the interior; it also allows for the door to seal properly and transition to the interior flooring. The door threshold should be firm, fully supported, and even across the bottom of the door.

Staircase Bathroom

Contact a qualified door repair/installation contractor.

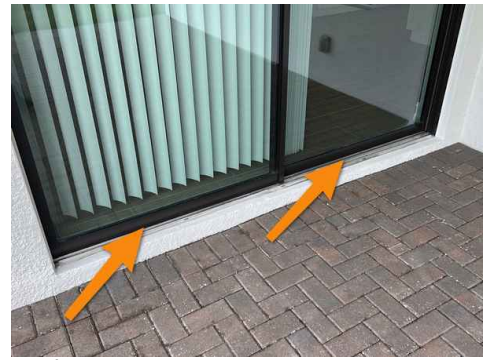
2.7.4 G. Doors (Interior and Exterior)

DOOR WEATHER-STRIPPING MISSING OR INSUFFICIENT

Door has missing or insufficient weather-stripping. This can result in significant energy loss and moisture intrusion. Recommend installation of standard weather-stripping.

Back

Recommended DIY Project

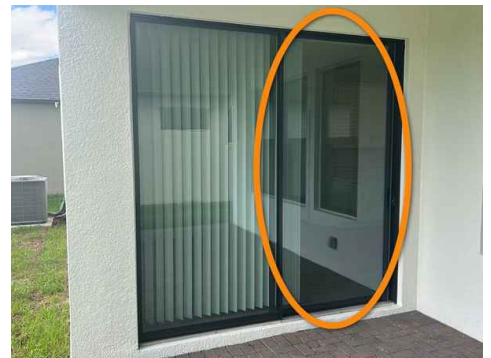
2.7.5 G. Doors (Interior and Exterior)

SCREEN DOOR IS MISSING

There are tracks for a screen door, but the screen door is missing. Recommend a qualified professional install based on preference.

Back

Contact a qualified door repair/installation contractor.

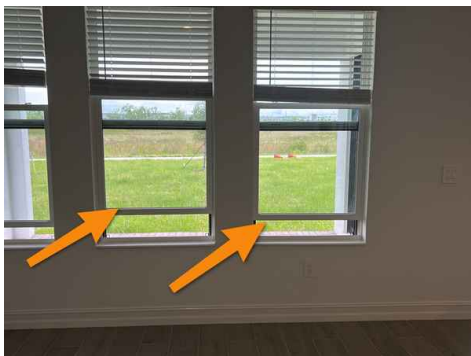
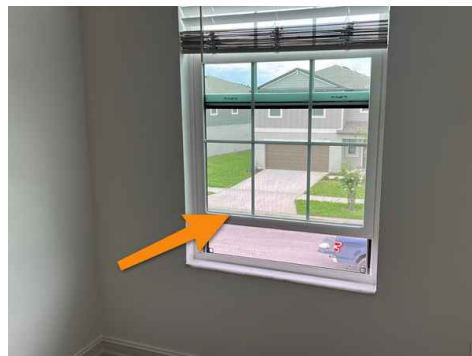
2.8.1 H. Windows

WINDOW DIFFICULT TO OPEN

One or more windows are difficult to open. This could be caused by a number of reasons, including structural deficiencies that apply force to the frame, windows have broken springs, or windows that are off their track(s). Recommend windows be restored to functional use by an window repair and installation contractor.

Contact a qualified window repair/installation contractor.

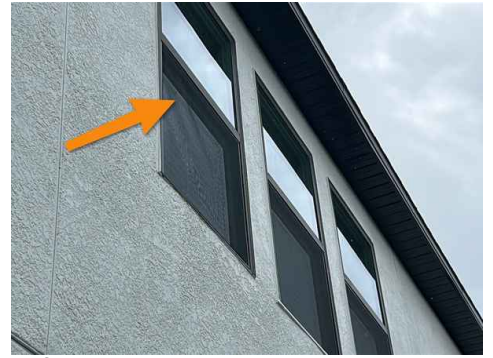
2.8.2 H. Windows

WINDOW SCREEN IS DAMAGED

One or more windows has a damaged screen. Recommend replacement depending on preference.

Left

Contact a qualified window repair/installation contractor.

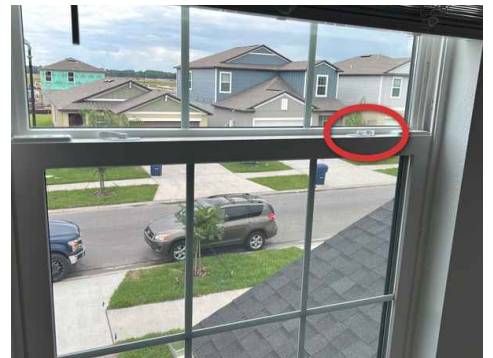
2.8.3 H. Windows

WINDOW LATCH IS DAMAGED

Window latch is damaged and is unable to close properly. This could allow for unforeseen access to the property and is a safety concern. Recommend having window latch replaced or fixed.

3rd Bedroom

Contact a qualified window repair/installation contractor.

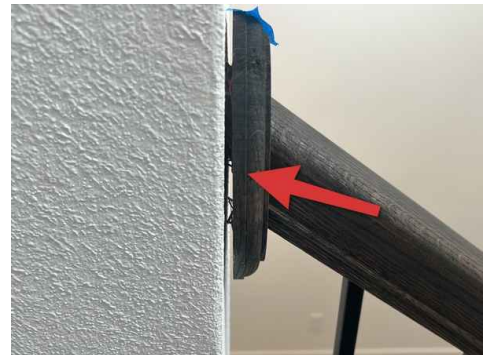
2.9.1 I. Stairways (Interior and Exterior)

LOOSE HANDRAIL STRUCTURE

The stairway and/or balcony handrail is loose and unsupported. This is considered a safety issue and should be strengthened or replaced with a sufficient handrail structure, handrail, and baluster system.

Staircase

Contact a qualified professional.

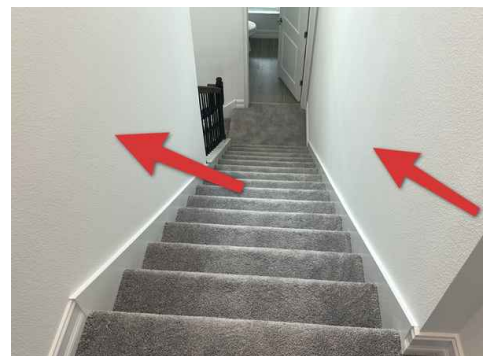
2.9.2 I. Stairways (Interior and Exterior)

HANDRAIL MISSING

Staircase had no handrails. This is a safety hazard. Recommend a qualified handyman install a handrail.

Staircase

Contact a qualified general contractor.

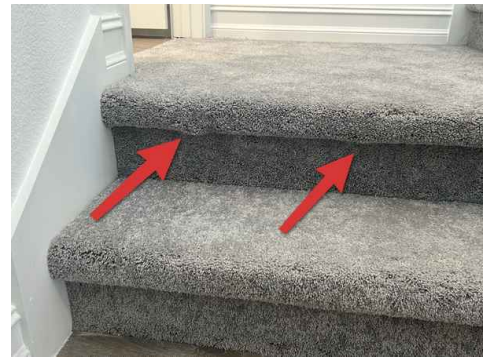
2.9.3 I. Stairways (Interior and Exterior)

STAIR STEPS NOT UNIFORM

Stair steps are not uniform and are misshapen. This is a safety issue for a trip hazard. Recommend a qualified professional repair.

Staircase

Contact a qualified general contractor.

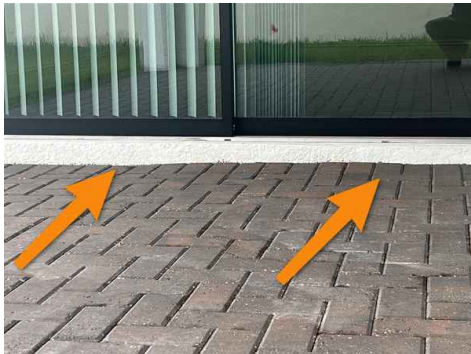
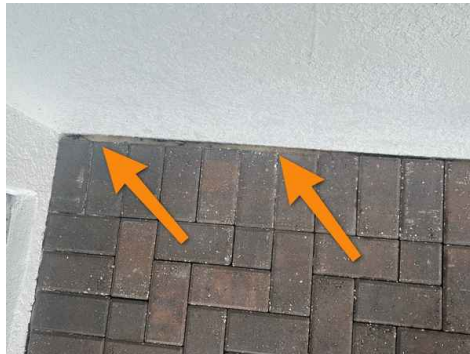
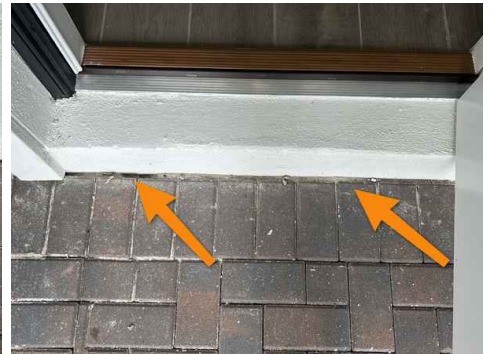
2.11.1 K. Porches, Balconies, Decks, and Carports

UNEVEN/ GAPS IN PAVERS

Pavers are uneven and/ or have gaps. Proper installation of pavers are flush to the wall with an even slope for proper drainage. Recommend a qualified professional repair areas.

Contact a qualified general contractor.

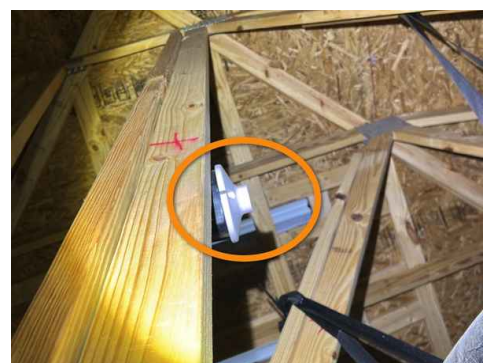
3.2.1 B. Branch Circuits, Connected Devices, and Fixtures

FIXTURE - BULB IS MISSING

One or more lighting fixtures failed to illuminate. Recommend installing the proper light bulb for functional use.

Attic

Contact a qualified electrical contractor.

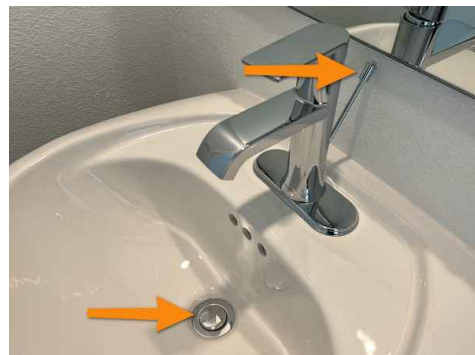
5.1.1 A. Plumbing Supply, Distribution Systems, and Fixtures

FAUCET DRAIN PULL ISSUE

The faucet drain pull is not functioning properly and doesn't hold water. Recommend plumbing contractor to resolve issue.

Staircase Bathroom

Contact a qualified plumbing contractor.

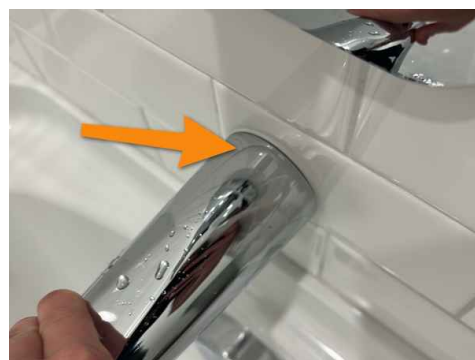
5.1.2 A. Plumbing Supply, Distribution Systems, and Fixtures

LOOSE FIXTURE

Plumbing fixture is loose. Recommend hiring a plumber to tighten fixture.

2nd Floor Hall Bathroom

Contact a qualified plumbing contractor.

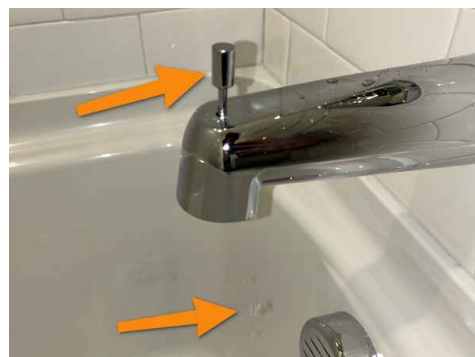
5.1.3 A. Plumbing Supply, Distribution Systems, and Fixtures

TUB SPOUT DIVERTER IS NOT EFFECTIVE

The tub spout divert is not fully diverting water to the shower. A leaking and/or broken shower diverter wastes water and creates a lower-pressure shower experience. Repairing a shower diverter can be a DIY project, or you may want to consult a plumbing contractor.

2nd Floor Hall Bathroom

Contact a qualified plumbing contractor.

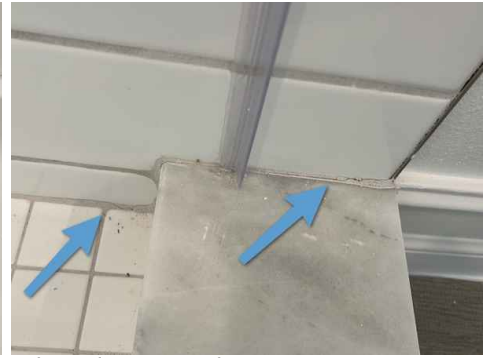
5.1.4 A. Plumbing Supply, Distribution Systems, and Fixtures

TUB/SHOWER RE-CAULKING NECESSARY

The tub and/or shower requires re-caulking. Re-caulking is necessary where caulking is missing or mold/mildew stains are present and have permanently set (i.e. they are no longer removable). Re-caulking can be completed DIY, or most general contractors and plumbers can re-caulk a bathroom. Confirm the use of silicon-based sealants that will prevent the penetration of water into the seams and cracks.

Recommended DIY Project

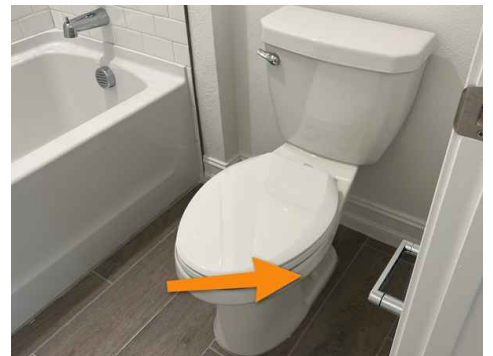
5.1.5 A. Plumbing Supply, Distribution Systems, and Fixtures

TOILET IS LOOSE

The toilet is loose and not stable. This could be at the connection with the ground or at the bowl connection with the tank.

2nd Floor Hall Bathroom

Recommend tightening the toilet bolts or hiring a qualified plumbing contractor to tighten and further investigate.

Contact a qualified plumbing contractor.

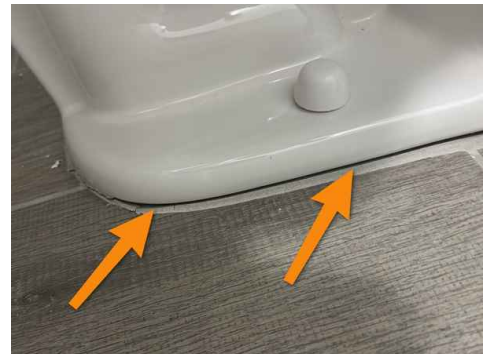
5.1.6 A. Plumbing Supply, Distribution Systems, and Fixtures

TOILET NEEDS RE-CAULKING

The toilet caulking is missing and/or the caulking has deteriorated and is considered damaged. Recommend a plumber re-caulk the toilet.

2nd Floor Hall Bathroom

Contact a qualified plumbing contractor.

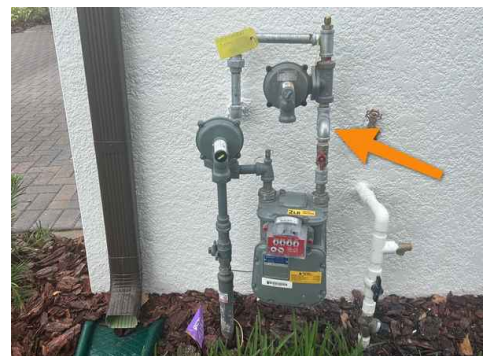
5.5.1 F. Gas Distribution Systems and Gas Appliances

EVIDENCE OF GALVANIZED PIPING

Property has evidence that galvanized pipe was used for gas line. Galvanized water pipe contains a zinc coating that helps keep the pipe from corroding from contact with water. However, over time, pieces of the coating will flake off and clog gas regulators and burner units. Additionally, the use of both types of pipe can cause accelerated corrosion where they touch. Recommend replacement of the areas that are galvanized with the correct black pipe material.

Right

Contact a qualified plumbing contractor.

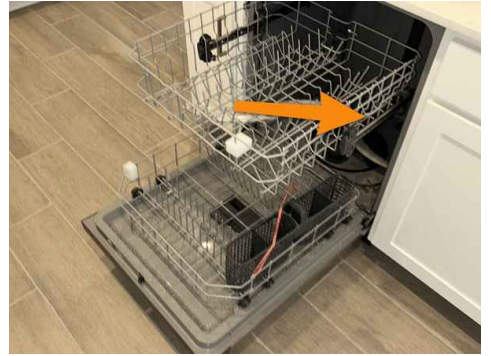
6.1.1 A. Dishwashers

DISHWASHER DRAWER ISSUE

The top dishwasher drawer gets stuck when it is being pulled out. Recommend a qualified professional repair the drawer to functional use.

Kitchen

Contact a qualified appliance repair professional.

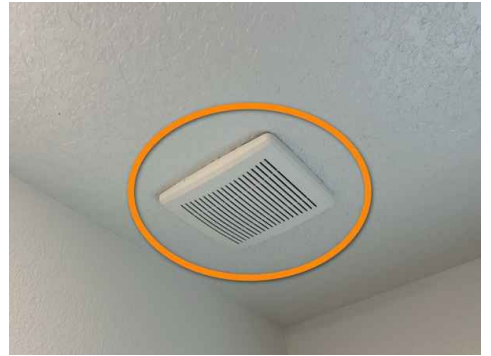
6.6.1 F. Mechanical Exhaust Vents and Bathroom Heaters

VENT FAN INOPERABLE

The vent fan is inoperable and will not power on. Recommend further investigation to determine the cause of the problem.

5th Bedroom Bathroom

Contact a qualified electrical contractor.
