**SUMMARY**

1234 Main St , Tampa, FL 33607

Abby Bullock
Professional Home Inspector
Merit Property Inspections
(813)485-4335
info@meritinspects.com

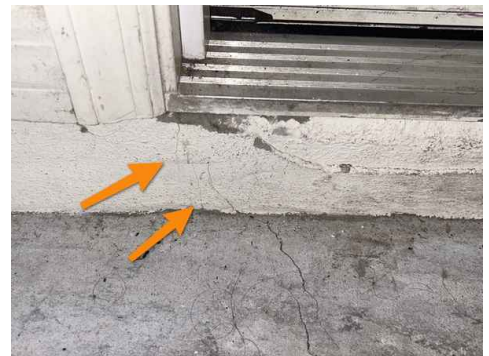
Garage

SLAB - FOUNDATION CRACKS - MINOR

Minor cracking was noted at the foundation. This is common as concrete ages and shrinkage surface cracks are normal. Recommend patching the minor cracks to prevent moisture/pest intrusion. Also recommend monitoring for more serious shifting/displacement.

Recommendation
Recommend monitoring.

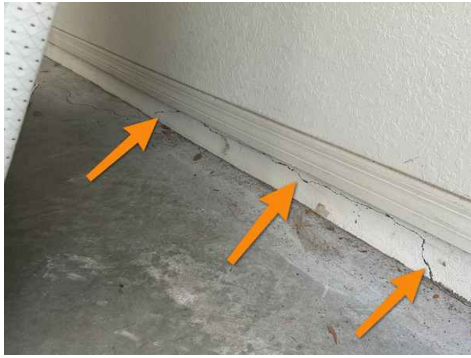
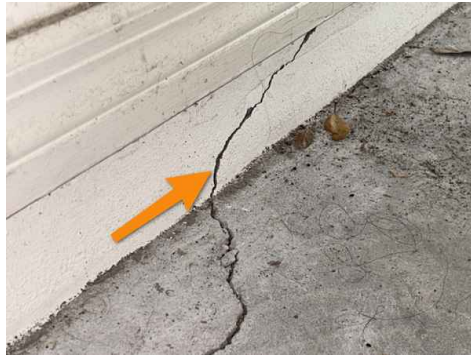
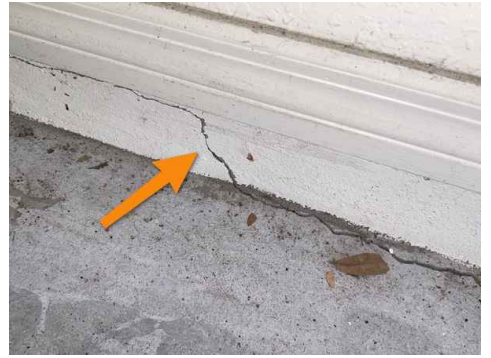
2.1.2 A. Foundations

SLAB - FOUNDATION CRACKS - MAJOR

Severe cracking noted at the foundation. This is typically consistent with soil movement and could lead to serious damage to structural components, foundation and/or slabs. It is possible that this crack has already contributed to structural deficiencies.

Recommend a foundation contractor evaluate and provide a cost/report on course of action and remedy.

Recommendation
Contact a foundation contractor.

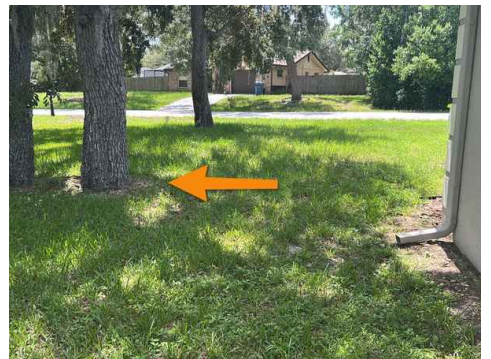
2.1.3 A. Foundations

TREES NEAR STRUCTURE

Trees growing near the structure may effect future performance of the foundation. Evaluate, remove, monitor, and/or address as necessary.

Recommended DIY Project

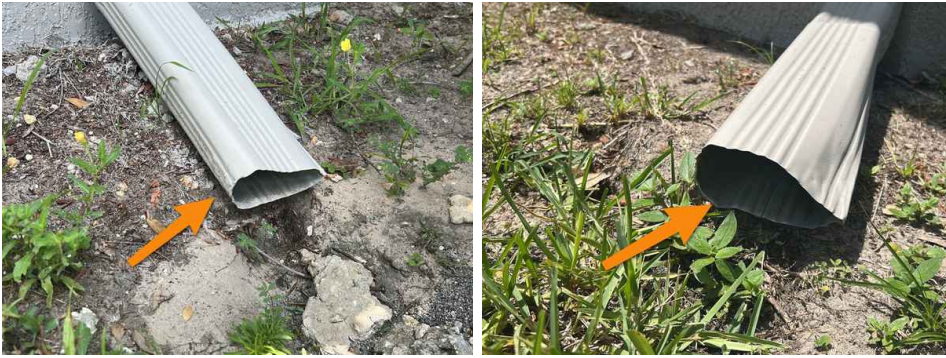
2.2.2 B. Grading and Drainage

GUTTER IS CRUSHED

A downspout gutter is crushed. This can cause flow restrictions and debris buildup in the gutter system that could lead to an overflow. Recommend replacing the crushed portion of the gutter as necessary.

Contact a handyman or DIY project

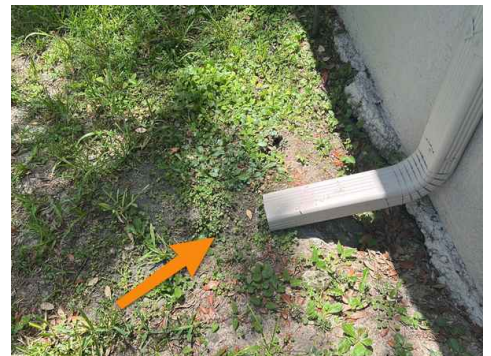
2.2.3 B. Grading and Drainage

GUTTER MISSING SPLASHBLOCK

Some or all of the gutter downspouts are missing splash blocks. Splash blocks help disperse the water away from the foundation and prevent the erosion of soils. Recommend installing splash blocks at all necessary locations.

Contact a handyman or DIY project

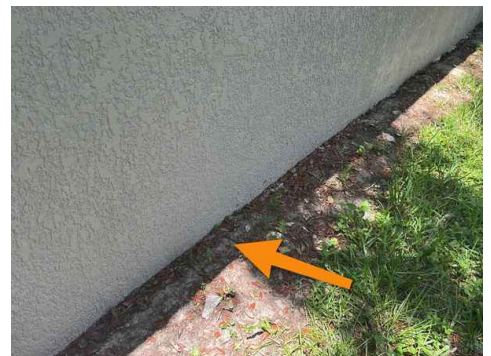
2.2.4 B. Grading and Drainage

LOW CLEARANCE TO GRADE

The clearance from the finished floor elevation (i.e. top of slab) to the exterior grade (i.e. ground) should be 6-inches or greater. This will prevent pooling surface water runoff from storm events from entering the structure. Recommend re-grading the build-up of material to expose the foundation and create a greater clearance.

Additionally, soil and vegetation should not be in contact with the siding or any wood.

Contact a qualified landscaping contractor

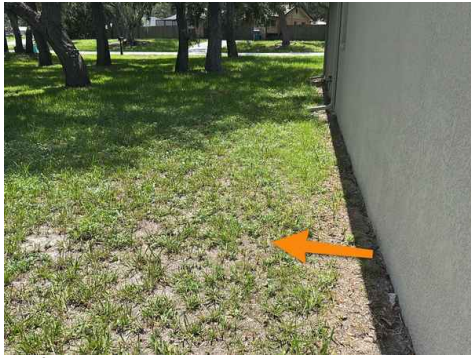
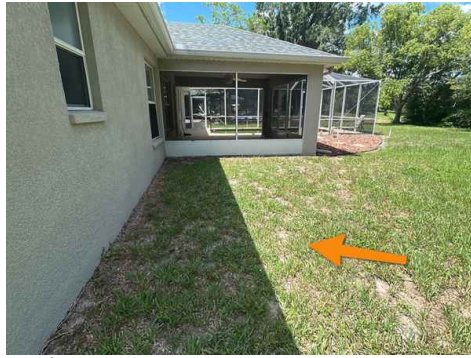
2.2.5 B. Grading and Drainage

NO GRADING (FLAT) SLOPE

The grading around the structure is relatively level (flat). This may not allow for property water drainage away from the foundation. Ideally, the structure should be the highest point on the property to promote good drainage and water run off away from the structure. Evaluate and address as necessary.

Contact a qualified landscaping contractor

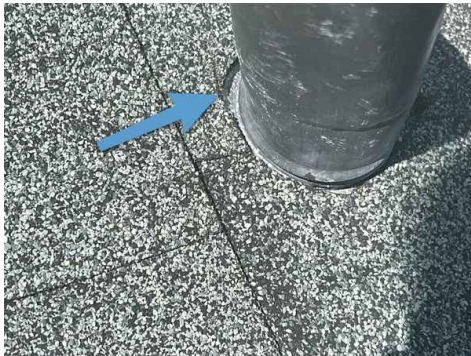
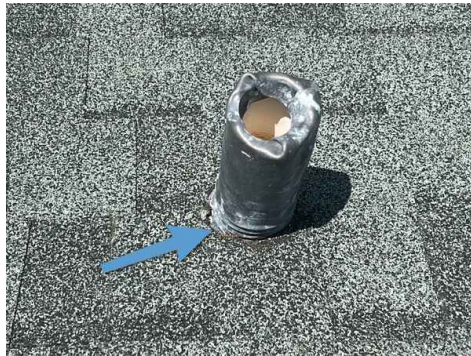
2.3.1 C. Roof Covering Materials

RE-CAULKING NEEDED

Roof leaks typically occur at penetration points such as roof vents. Re-caulking at these penetration points will help prevent water intrusion. Recommend hiring a contractor to re-caulk with approved roofing caulk and/or silicon sealant as necessary.

Contact a qualified roofing professional.

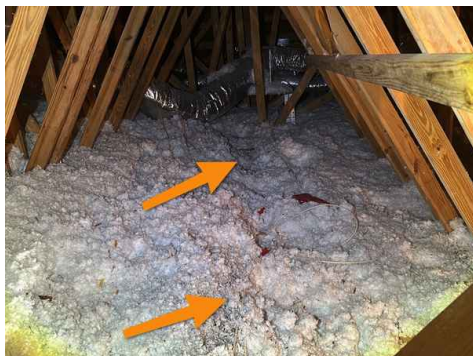
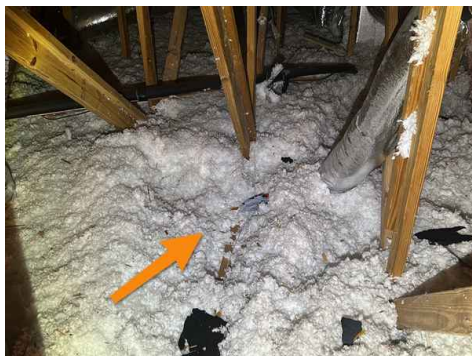
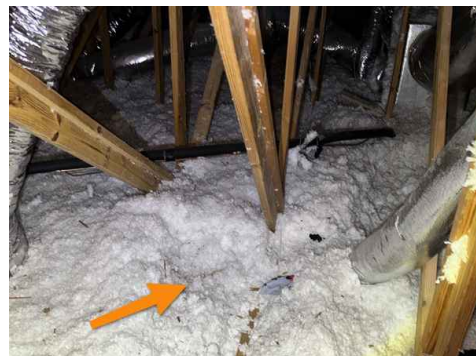
2.4.1 D. Roof Structures and Attics

INSULATION IS UNEVENLY DISTRIBUTED

Insulation in the attic unevenly distributed and not smooth / even across the attic surface. This is common in older structures where attic insulation has been moved for repairs and installations.

Insulation that is not smooth and even across the attic surface will be less efficient and will be unable to create a thermal barrier as intended. Recommend a insulation contractor smooth the insulation and/or install new insulation in areas of the attic, as necessary.

Contact a qualified insulation contractor.

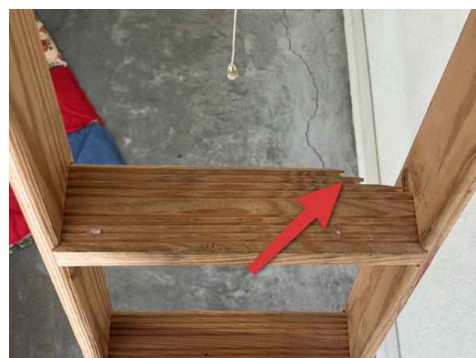
2.4.2 D. Roof Structures and Attics

ATTIC LADDER DAMAGED

The attic ladder is damaged- Unsafe. Recommend repair of the ladder.

Contact a qualified general contractor.

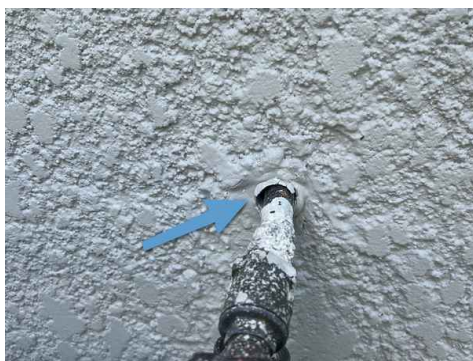
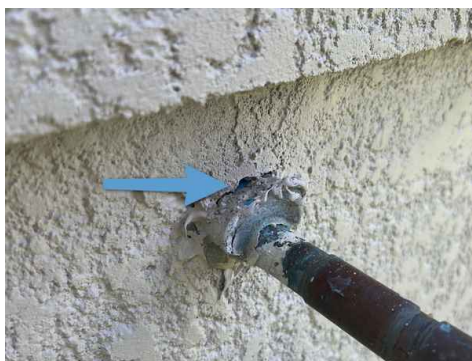
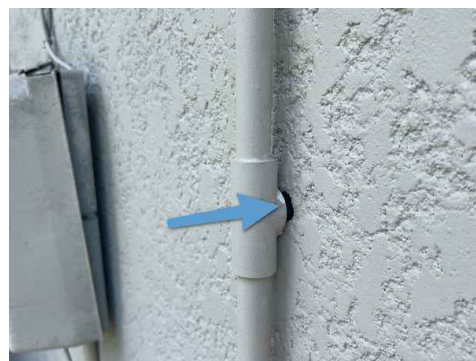
2.5.1 E. Walls (Interior and Exterior)

CAULKING DETERIORATED AND/OR MISSING

Caulking is necessary to seal gaps less than 1/2-inch. Caulking that is missing can provide for water penetration and allow insect access into the structure.

Contact a qualified general contractor.

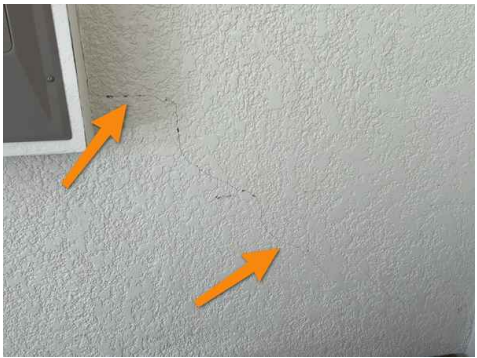
2.5.2 E. Walls (Interior and Exterior)

CRACKS MAJOR

Major cracking observed in wall structure that is likely due to structural foundation issues and is considered evidence of a structural deficiency. Recommend a qualified foundation contractor evaluate and advise on course of action.

Recommendation
Contact a foundation contractor.

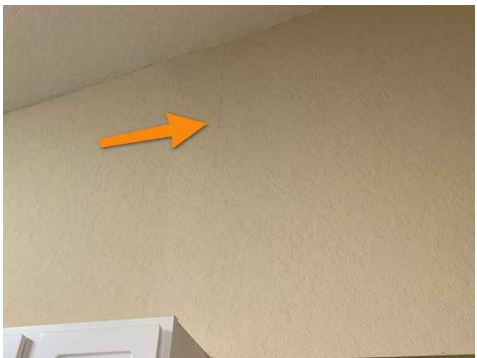
2.5.3 E. Walls (Interior and Exterior)
CRACKS MINOR

Minor cracking was observed in wall structure. This is common in structure this age and is often determined to be cosmetic. That said, cracking is a first sign of foundation failure and cracks can grow over time; recommend monitoring.

Recommendation
Recommended DIY Project

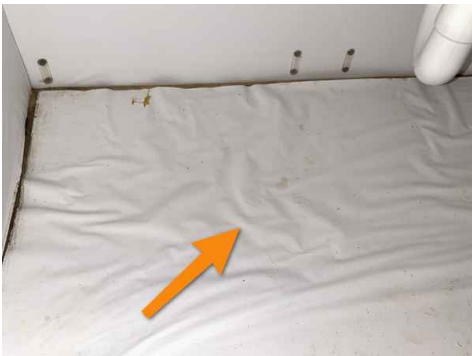
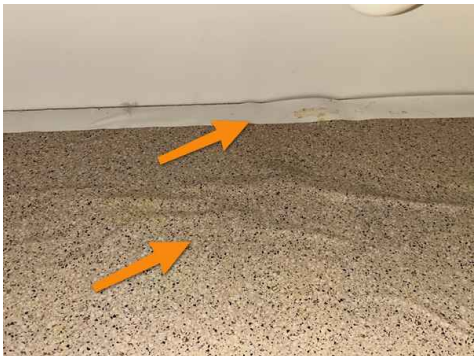
2.5.4 E. Walls (Interior and Exterior)
CABINET - ROTTING CABINETRY

One or more areas of the cabinet show signs of rotting wood. This is caused by continual water inundation or active leaking of the plumbing fixtures from above. Recommend replacement of the cabinetry and further evaluation for active moisture issues and signs of mold.

Recommendation
Contact a qualified cabinet contractor.

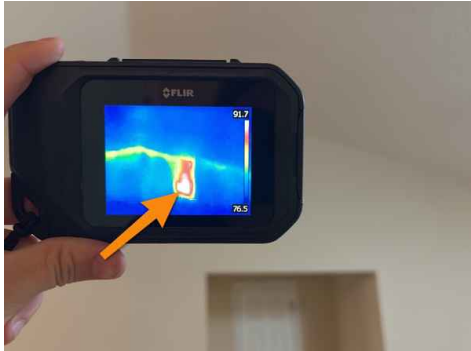
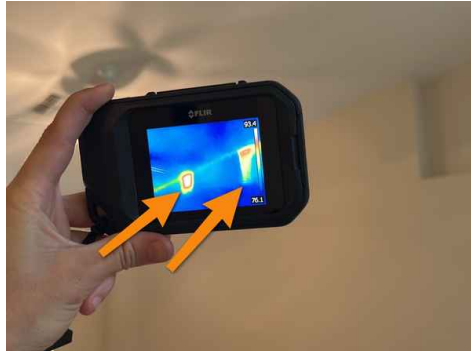
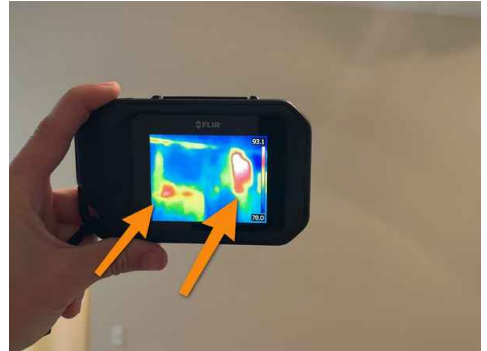
2.5.5 E. Walls (Interior and Exterior)
THERMAL - HOT/COLD SPOT SHOWING IN THERMAL SCAN

There is a hot or cold spot that is showing in the thermal imagery scan that was performed. This is typically caused by a lack of insulation in the walls. This can also be caused by a settling of blown-in or batt insulation in the walls of older structures. Many of the localized areas in ceilings can be remedied by investigating the insulation areas missing in attic spaces. Wall areas missing insulation can be more difficult to remedy because of access limitations. Some spots may be permanent inefficiencies because of the cost/benefit in trying to remedy the issue. Recommend further investigation by an insulation contractor or an HVAC specialist.

Contact a qualified insulation contractor.

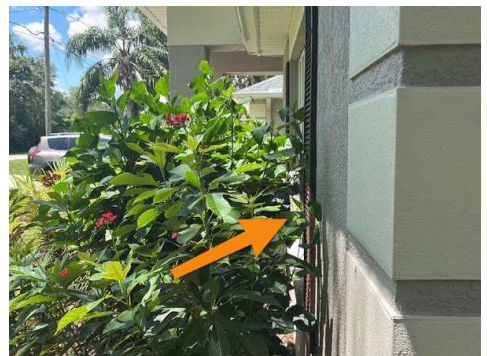
2.5.6 E. Walls (Interior and Exterior)

VEGETATION RUBBING AGAINST SIDING

Vegetation is rubbing against siding. This may promote moisture and pest intrusion. Recommend a qualified professional trim back vegetation.

Contact a qualified landscaping contractor

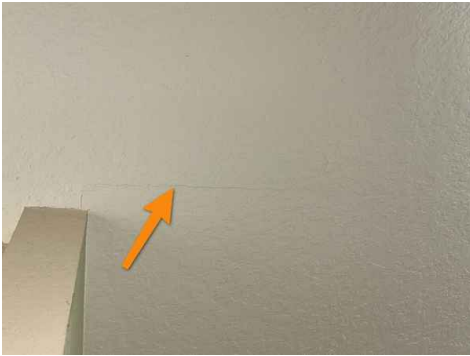
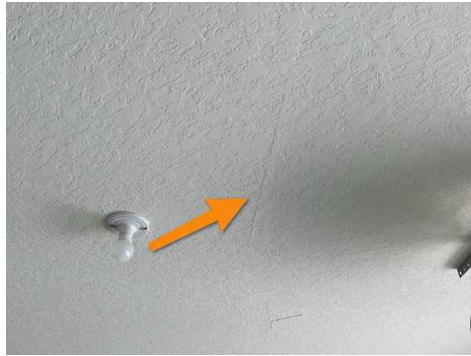
2.6.1 F. Ceilings and Floors

CEILING - SHEETROCK CRACKS MINOR

Minor sheetrock cracking was observed on the ceiling. This is common in structures this age and is often determined to be cosmetic, most often the separation of drywall tape joints. Recommend patching, repainting, monitoring these locations for further cracking.

Contact a qualified painting contractor.

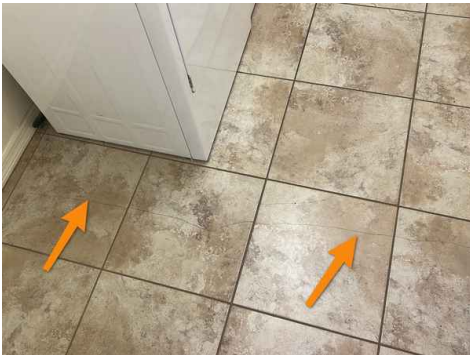
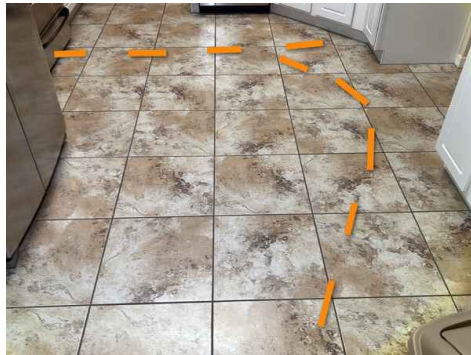
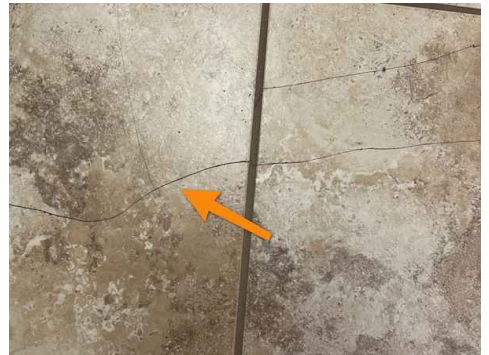
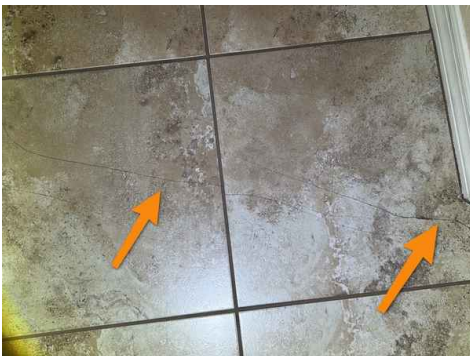
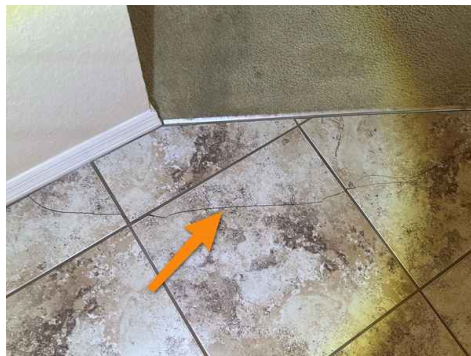
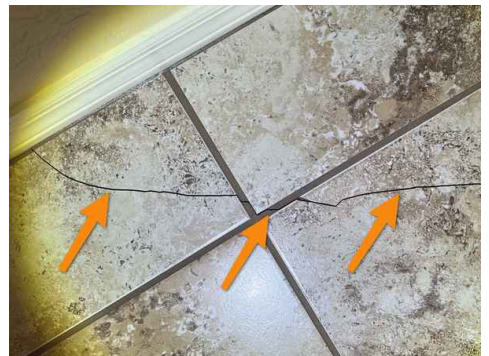
2.6.2 F. Ceilings and Floors

FLOORING - TILES LOOSE / CRACKED OR MISSING

Loose tiles that are popped or missing and/or cracking was observed. This is possibly due to structural foundation issues and is considered evidence of a structural deficiency if on the interior of the structure. Recommend a qualified foundation repair company / contractor evaluate and advise on course of action prior to repair of the flooring.

Kitchen overview of cracks

Contact a qualified flooring contractor

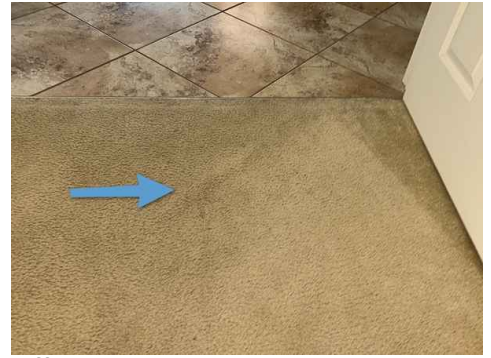
2.6.3 F. Ceilings and Floors

FLOORING - CARPET WRINKLING PRESENT

Carpet wrinkling was present at the time of inspection. Although carpet wrinkling (both in the carpet itself or underlying carpet pad) is generally considered a cosmetic defect, this can indicate structural defects. Additionally carpet wrinkling is considered a safety tripping hazard to pedestrians. Recommend hiring a carpet installer to re-stretch the carpet and determine the problem.

Contact a qualified flooring contractor

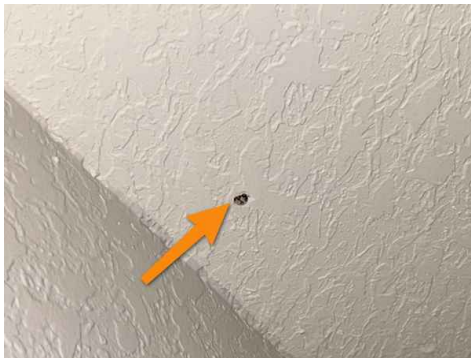
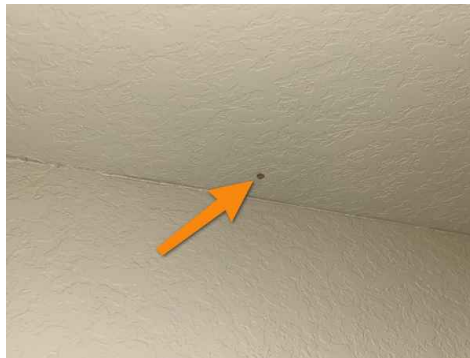
2.6.4 F. Ceilings and Floors

CEILING- EXPOSED NAIL HEADS ON SHEETROCK (NAIL POP)

The sheetrock has nail heads showing (sometimes called "nail pops") where nails have penetrated the mud covering becoming exposed. This is common in homes of this age and is primarily considered a cosmetic deficiency. Often the mud to cover the nail was not thick enough and has "popped off" the sheetrock as the home has aged. It is unlikely that the cause is a structural deficiency. Recommend repaint or hire a general contractor to resolve, as necessary. Monitor area for future nail pops.

Contact a qualified drywall contractor.

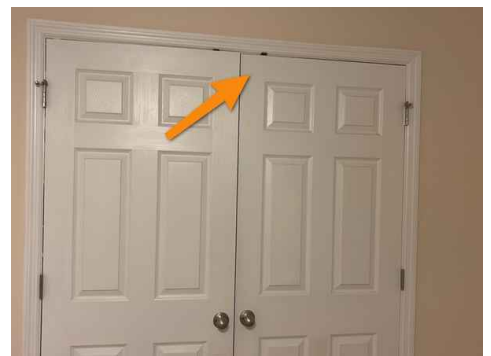
2.7.1 G. Doors (Interior and Exterior)

DOOR RUBS / STICKS AND IS MISALIGNED

Door sticks, rubs the frame, and is tough or impossible to open and/or close. The door is not aligning with the frame. Recommend hiring a door repair and installation contractor to realign the door or sanding down offending sides.

Contact a qualified door repair/installation contractor.

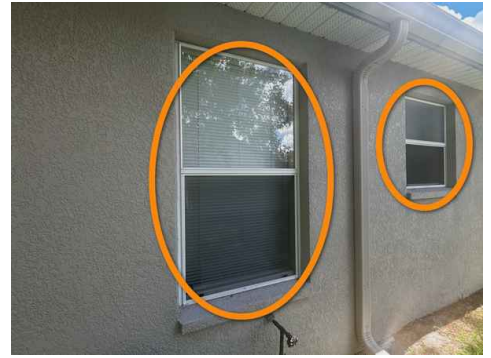
2.9.1 H. Windows

SINGLE PANE WINDOWS (ENTIRE PROPERTY)

All (or almost all) windows in the structure appear to be single pane. Single pane windows are less efficient and will lead to higher utility bills. Not all window photos are documented in the section, and photos here should be used as an example. Recommend budgeting for replacement of windows, as necessary, in the future for the entire property to undergo a window replacement.

Contact a qualified window repair/installation contractor.

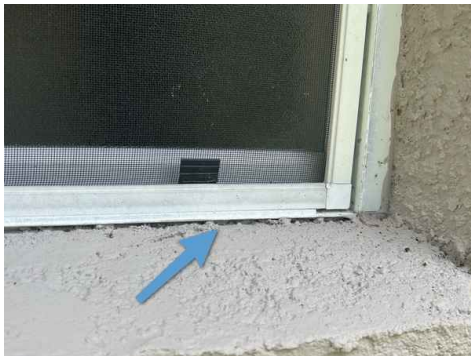
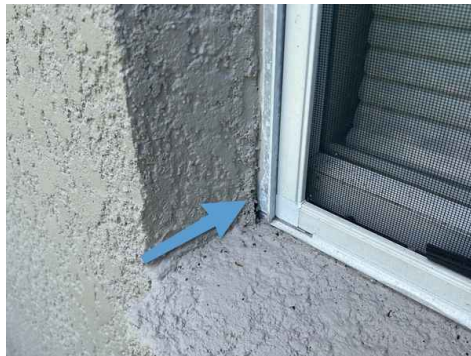
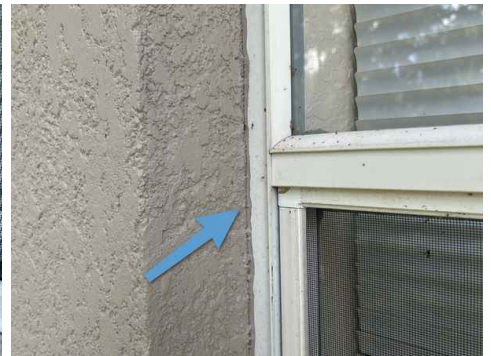
2.9.2 H. Windows

WINDOWS SHOULD BE RECAULKED (ENTIRE PROPERTY)

The entire property has windows that have aged, cracked, and/or missing caulking that should be replaced. Inspector notes noticeable gaps around most/all windows of the property. This can lead to water penetration and insect intrusion. Windows should be recaulked with a silicone based sealant.

Contact a qualified window repair/installation contractor.

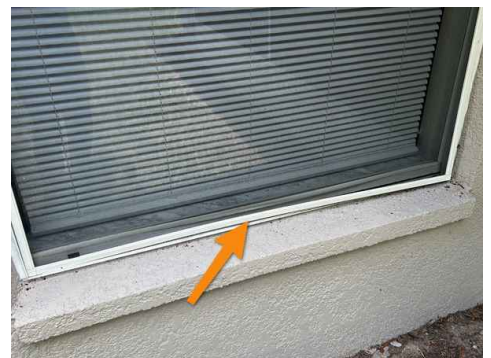
2.9.3 H. Windows

WINDOW SCREEN IS DAMAGED

Window has a damaged screen. Recommend replacement depending on preference.

Contact a qualified window repair/installation contractor.

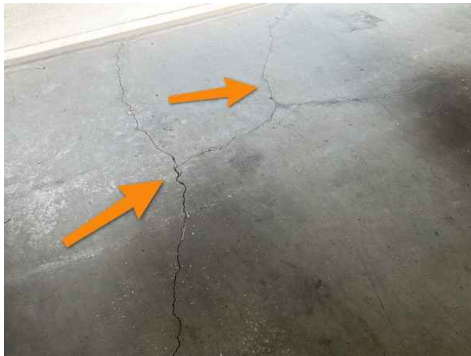
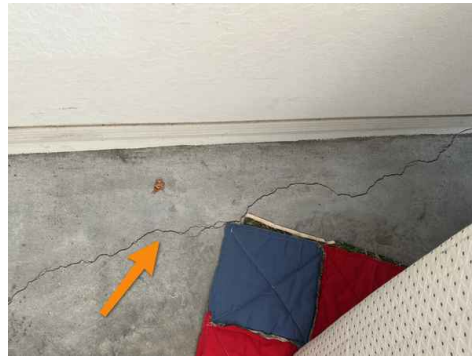
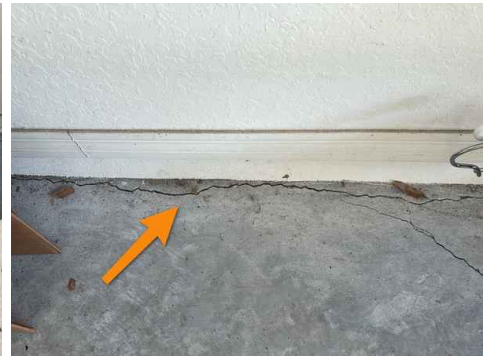
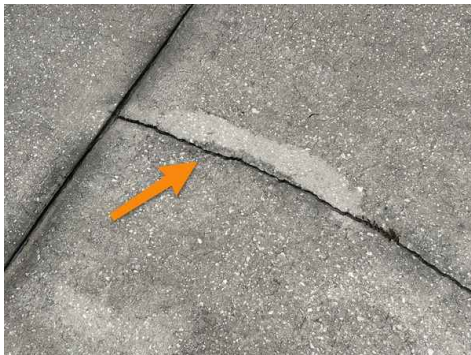
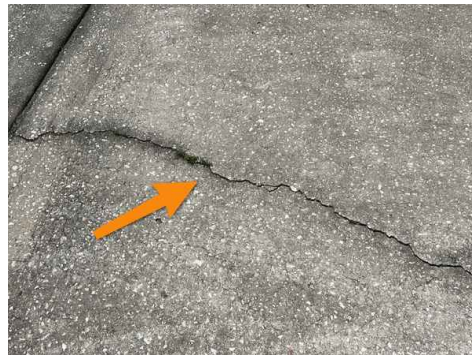
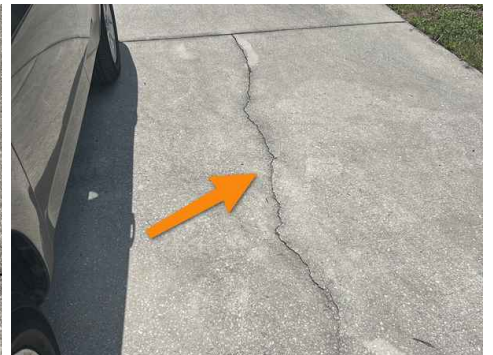
2.11.1 K. Porches, Balconies, Decks, and Carports

OLD CONCRETE - PORCH CRACKS, SEPARATION, OR HEAVING

The porch show signs of aged cracking, separation, heaving, and/or deterioration. This is common in areas of the state that have clay-based soils. Compromised concrete will continue to exhibit decay, failure, collapse, and uplift if not remediated. Recommend caulking larger cracks and applying a concrete sealer. Cracking can also be a safety tripping hazard for pedestrians.

Recommend monitoring.

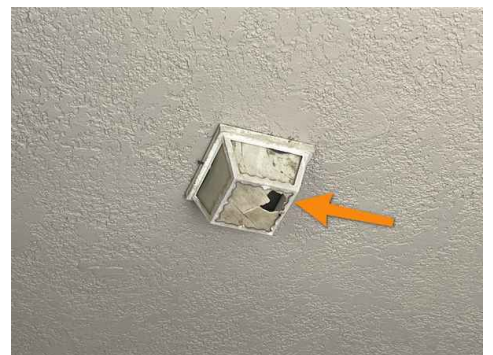
3.2.1 B. Branch Circuits, Connected Devices, and Fixtures

FIXTURE - DAMAGED BULB COVER

Lighting fixture bulb cover is damaged. This is considered a primarily cosmetic deficiency, but can provide some protection for the bulb. Recommend replacement of the bulb cover as necessary.

Contact a qualified electrical contractor.

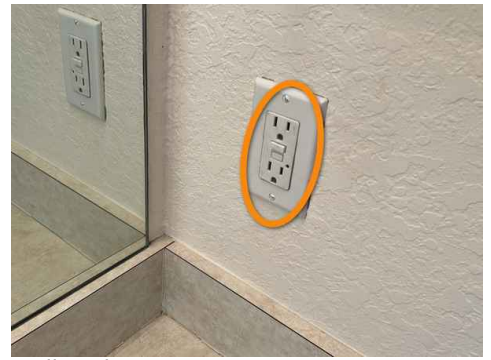
3.2.2 B. Branch Circuits, Connected Devices, and Fixtures

OUTLET - GFCI NOT FUNCTIONING

GFCI outlet was not functioning properly. This is because it was not tripping or not resetting. Recommend licensed electrician investigating the cause and replacing receptacles that are malfunctioning in all locations necessary.

Contact a qualified electrical contractor.

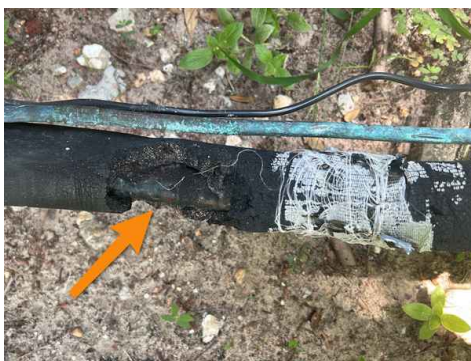
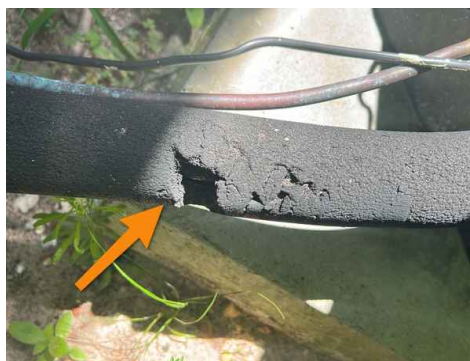
4.2.1 B. Cooling Equipment

CONDENSER - FREON INSULATION MISSING OR DAMAGED

Missing or damaged insulation on the refrigerant line can cause energy loss and condensation. Recommend contacting an HVAC professional to replace the missing or damaged insulation.

Contact a qualified HVAC professional.

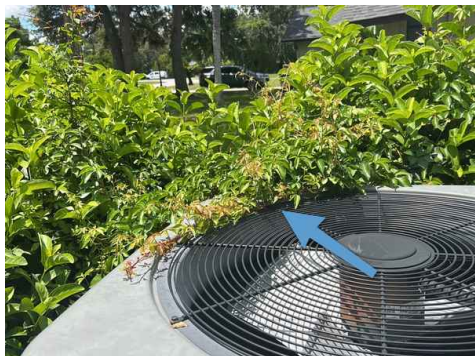
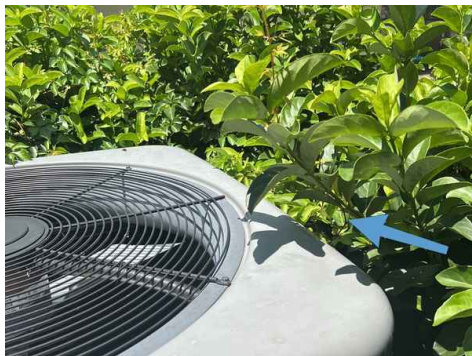
4.2.2 B. Cooling Equipment

CONDENSER - VEGETATION IS TOO CLOSE

A tree and/or vegetative growth is too close to the condenser unit. The condenser utilizes the air-space around it to release heat from the structure. Growth around the condenser will lower the efficiency and/or could cause the unit to overheat. Recommend removing or trimming the growth away from the condenser by at least 3-feet on the sides and 10-feet above the unit.

Contact a qualified landscaping contractor

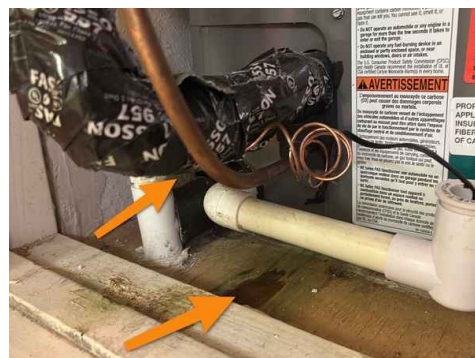
4.2.3 B. Cooling Equipment

EVAPORATOR- FREON LEAK

Freon leak at evaporator. Recommend a qualified professional repair.

Contact a qualified HVAC professional.

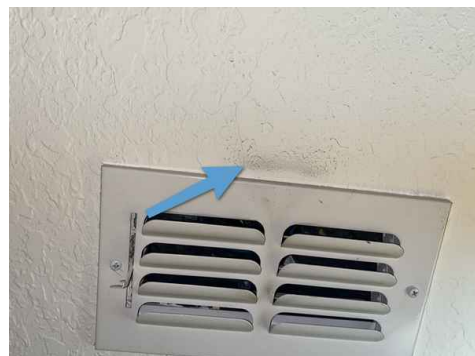
4.3.1 C. Duct Systems, Chases, and Vents

DUCT CLEANING IS RECOMMENDED

Inspector has discovered evidence that the HVAC duct system should be cleaned. This includes either a visual investigation of the plenums through access ports (if available) or supply vents that are dirty, dusty, and/or clogged with debris.

Contact a qualified HVAC professional.

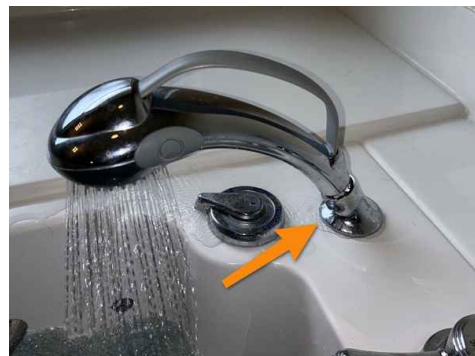
5.1.1 A. Plumbing Supply, Distribution Systems, and Fixtures

FIXTURE DRIPPING

A fixture is dripping. Recommend qualified handyman or plumber evaluate and repair.

Contact a qualified plumbing contractor.

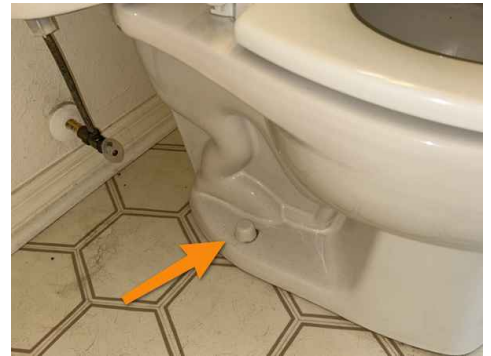
5.1.2 A. Plumbing Supply, Distribution Systems, and Fixtures

TOILET IS LOOSE

The toilet is loose at the bolts and is not stable. This may lead to leaks, and it is generally unsafe. Recommend tightening the toilet bolts or hiring a qualified plumbing contractor to tighten and further investigate.

Contact a qualified plumbing contractor.

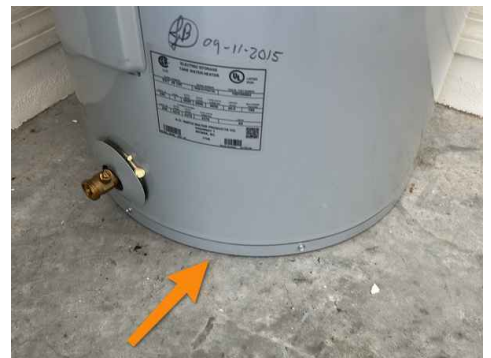
5.3.1 C. Water Heating Equipment

WATER HEATER SITTING ON THE GROUND

The water heater is not elevated off the ground. Water heaters that are sitting on the ground with rust-out faster than elevated water heaters.

Contact a qualified plumbing contractor.

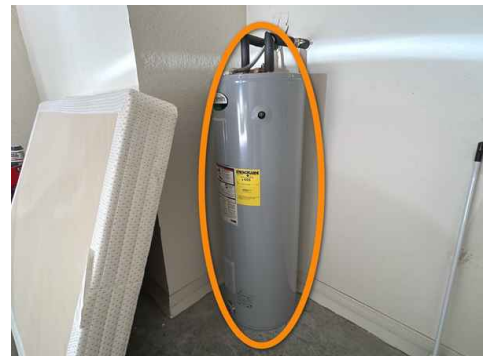
5.3.2 C. Water Heating Equipment

WATER HEATER NEAR OR PAST EXPECTED SERVICE LIFESPAN

Typical water heater lifespan is 10-12 years. Water heater is near or past its expected service lifespan. Recommend a qualified professional replace.

Contact a qualified plumbing contractor.

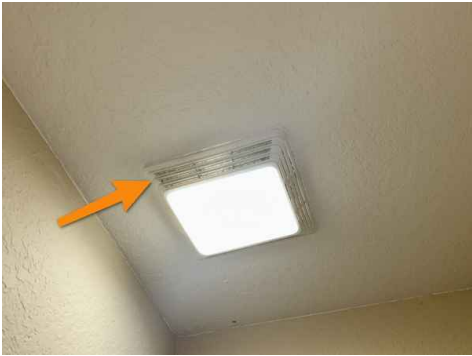
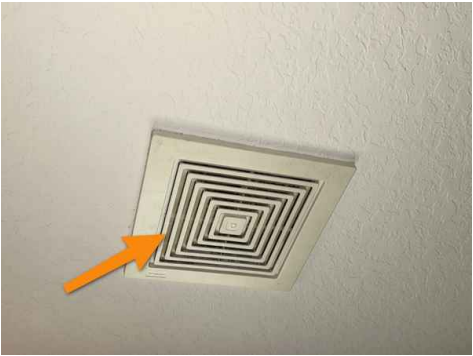
6.6.1 F. Mechanical Exhaust Vents and Bathroom Heaters

VENT FAN IS NOISY

The vent fan is unusually noisy when powered on. Recommend further investigation to determine the cause of the problem.

Contact a qualified electrical contractor.
