SUMMARY

1234 Main St 123, Tampa, FL 33607

Abby Bullock
Professional Home Inspector
Merit Property Inspections
+8134854335
info@meritinspects.com

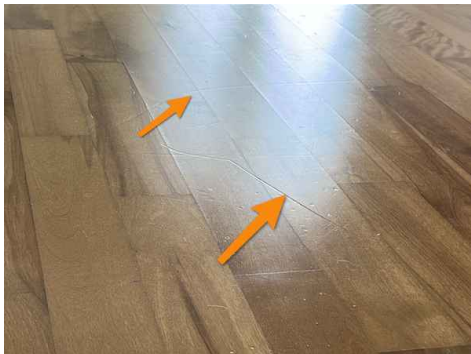
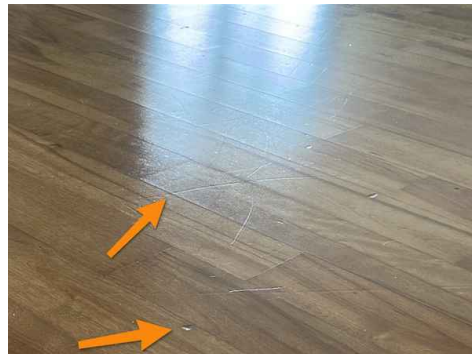
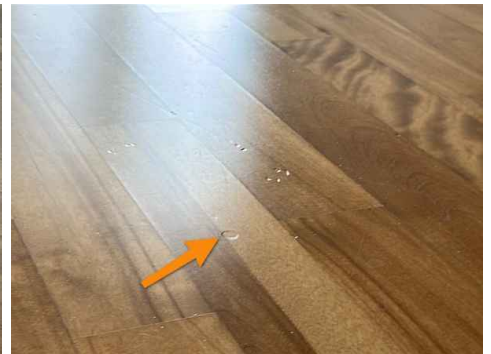
Primary Bedroom

FLOORING - DAMAGED

The flooring had general moderate damage visible at the time of the inspection. Damaged flooring may be primarily cosmetic and should be resolved as necessary. Recommend evaluation by a qualified flooring contractor.

Contact a qualified flooring contractor

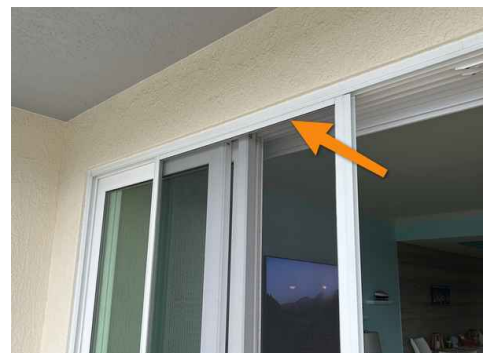
Balcony

SCREEN DOOR RUBS / STICKS

Screen door sticks, rubs the frame, and is tough to open and/or close. The door is not aligning with the frame. Recommend hiring a door repair and installation contractor to realign the door.

Contact a qualified door repair/installation contractor.

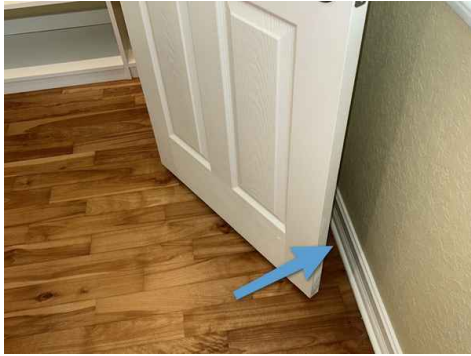
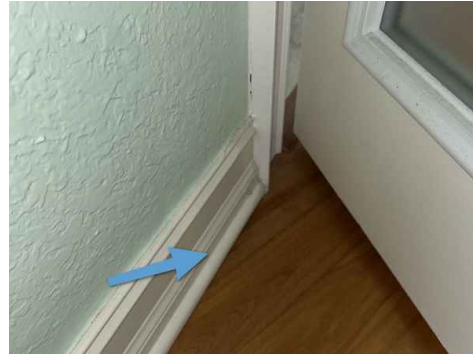
2nd Bedroom Closet

DOOR HAS NO DOORSTOP

Door has no doorstop. Without a doorstop, the doorknob can be lodged into the sheetrock and create a hole. Recommend installation of a doorstop.

Recommended DIY Project

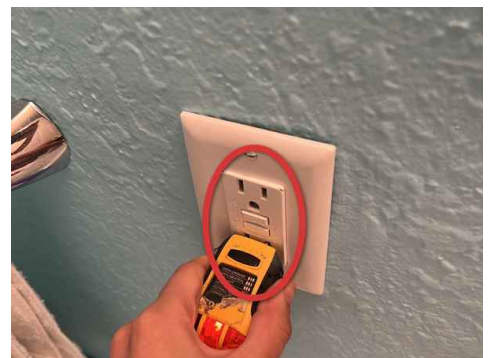
Shared Bathroom

OUTLET - LOOSE AND NOT SECURE

An outlet is loose and not securely fastened to the gang-box and/or the structure behind the sheetrock. Loose outlets will become worse over time as contact points start to wear down and wires bend back and forth. Loose outlets can eventually lead to broken wires, dead circuits, flickering lights, or other electrical problems (including electrical fire). Recommend an electrical contractor tighten the outlet so it does not move.

Contact a qualified electrical contractor.

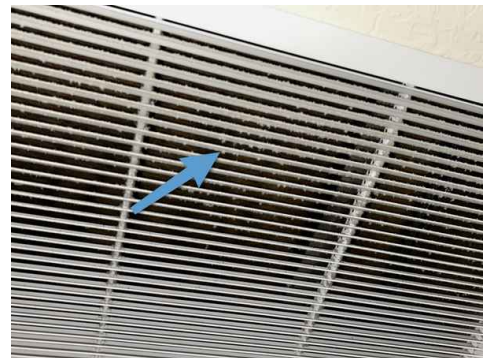
Entry Hall

DUCT CLEANING IS RECOMMENDED

Inspector has discovered evidence that the HVAC duct system should be cleaned. This includes either a visual investigation of the plenums through access ports (if available) or supply vents that are dirty, dusty, and/or clogged with debris.

Contact a qualified HVAC professional.

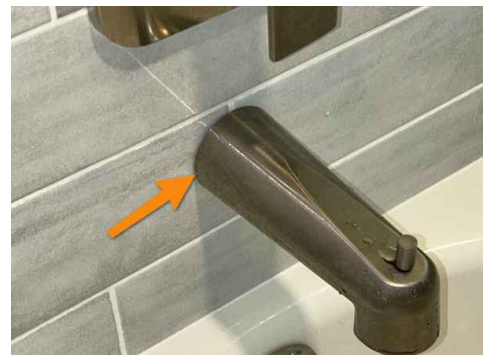
Shared Bathroom

LOOSE FIXTURE

Plumbing fixture is loose. Recommend hiring a plumber to tighten fixture.

Contact a qualified plumbing contractor.

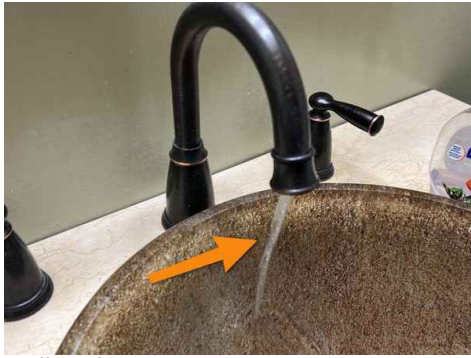
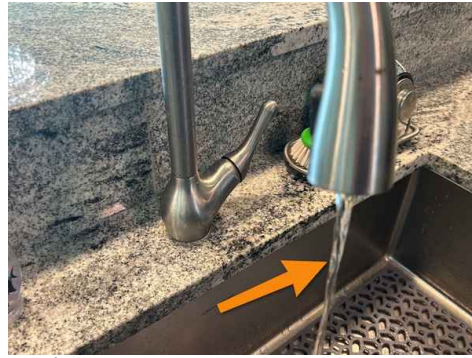
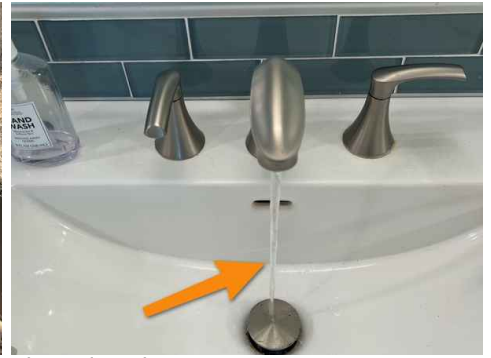
Hall Bathroom

LOW PRESSURE AND/OR FLOW TO FAUCET(S)

Low water pressure / flow to one or more faucets. This may be due to a clogged water supply pipe, a clogged inline filter, or a broken fixture. Recommend further investigation by a plumbing contractor.

Contact a qualified plumbing contractor.

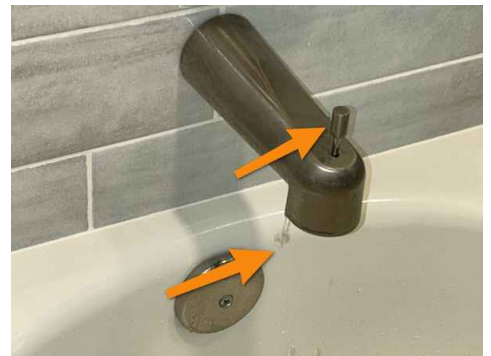
Shared Bathroom

TUB SPOUT DIVERTER IS NOT EFFECTIVE

The tub spout divert is not fully diverting water to the shower. A leaking and/or broken shower diverter wastes water and creates a lower-pressure shower experience. Repairing a shower diverter can be a DIY project, or you may want to consult a plumbing contractor.

Contact a qualified plumbing contractor.

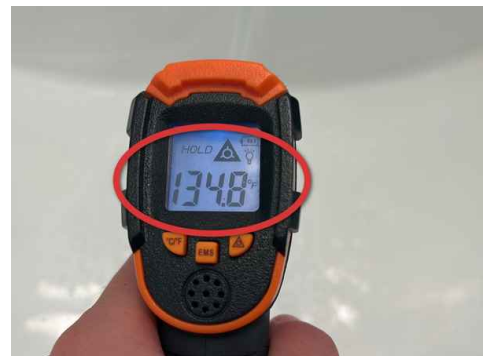
HOT - WATER HEATER TOO HOT

The water heater temperature is too hot. Generally accepted safe and comfortable water temperature is one-hundred twenty (120) degrees Fahrenheit from a hot water faucet.

A temperature above one-hundred thirty (130) degrees Fahrenheit is general considered to be unsafe. Recommend a plumbing contractor evaluate why the water heater is producing water that is considered too hot.

134°F

Contact a qualified plumbing contractor.

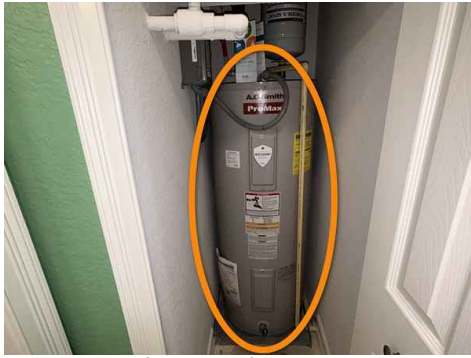
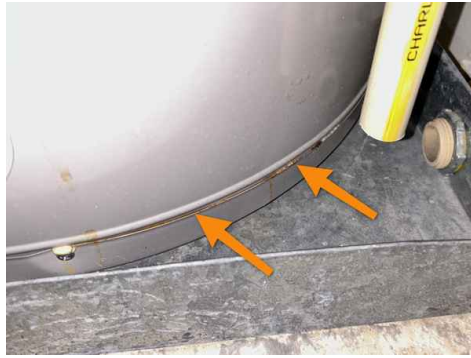
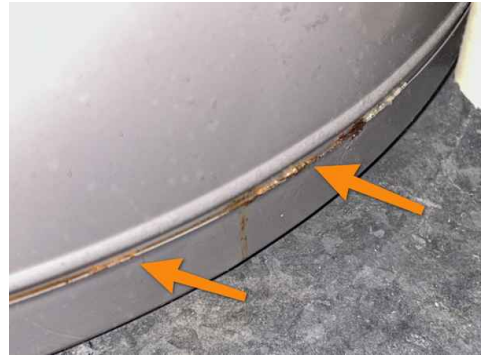
Primary Bathroom Closet

WATER HEATER NEAR OR PAST EXPECTED SERVICE LIFESPAN

The water heater has reached the end of its expected useful life based on both age and visible condition. Typical residential water heaters have a service life of approximately 8 to 12 years, and this unit appears to be at or beyond that range. Visual signs consistent with advanced age and wear were observed, including corrosion at the tank seams and fittings, rust discoloration on the exterior casing, sediment buildup at the base, and signs of moisture accumulation or prior leakage in the surrounding area. These indicators suggest the unit may be at increased risk of failure and is no longer functioning at optimal efficiency. The current condition warrants consideration of replacement in the near term and/or budgeting for replacement.

Contact a qualified plumbing contractor.

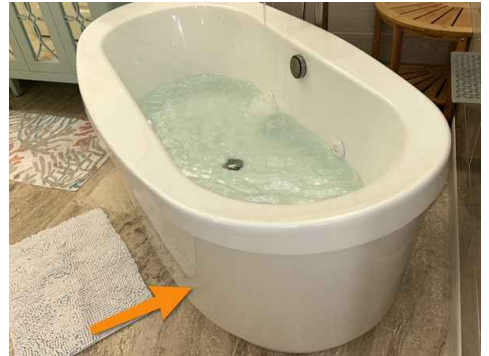
Primary Bathroom

5.4.1 D. Hydro-Massage Therapy Equipment **NO ACCESS TO PUMP**

The hydrotub mechanical components (pump and possibly blower) and plumbing fixtures are inaccessible. A hydrotub is required to have a removable front panel or side entry (through a cabinet) to access components that may need to be repaired or replaced. Recommend adding a way to access the underside of the hydrotub.

Contact a qualified general contractor.

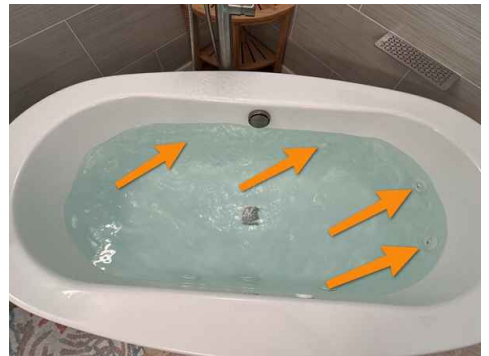
Primary Bathroom

5.4.2 D. Hydro-Massage Therapy Equipment **INSUFFICIENT FLOW FROM JETS**

Insufficient flow from multiple jets. Recommend a qualified professional investigate and repair.

Contact a qualified plumbing contractor.

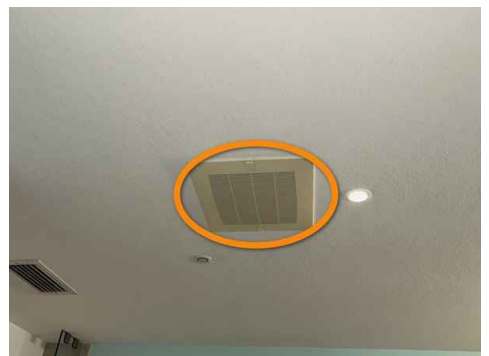
Primary Bathroom

VENT FAN IS NOISY

The vent fan is unusually noisy when powered on. Recommend further investigation to determine the cause of the problem.

Contact a qualified electrical contractor.

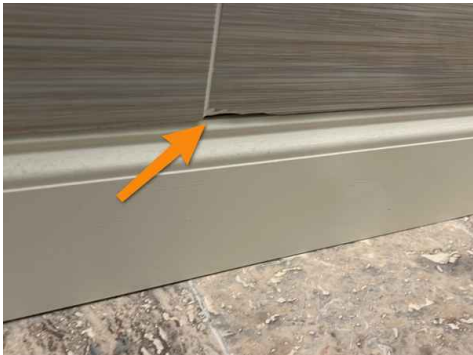
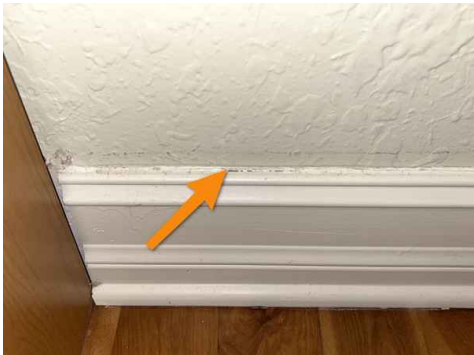
Primary Bathroom

PHOTOS(S) OF COSMETIC IMPERFECTIONS

Inspector is not required to report cosmetic defects in an inspection report. This includes aesthetic imperfections that generally do not affect working condition of the property. The photos in this section are for the purpose of documentation, but are not considered a deficiency.
