# Uniform Mitigation Verification Inspection Form

| Inspection Date: <b>06/20/2025</b> | | | |
| Address: <b>1234 Main St</b> | | Home Phone: | |
| Year of Home: <b>1976</b> | # of Stories: <b>1</b> | Email: | |

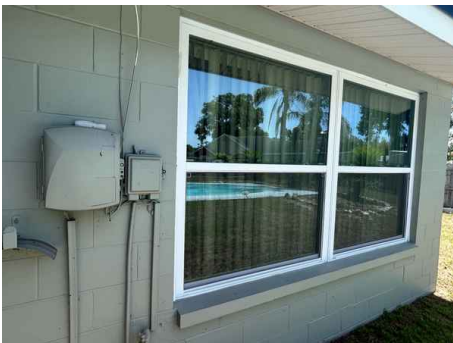
| Opening Protection Level Chart<br>Place an "X" in each row to identify all forms of protection in use for each opening type. Check only one answer below (A thru X), based on the weakest form of protection (lowest row) for any of the Glazed openings and indicate the weakest form of protection (lowest row) for Non-Glazed openings. | | Glazed Openings | | | | Non-Glazed Openings | |
|---|---|---|---|---|---|---|---|
| X | No Windborne Debris Protection | X | | | | | |

No impact protection

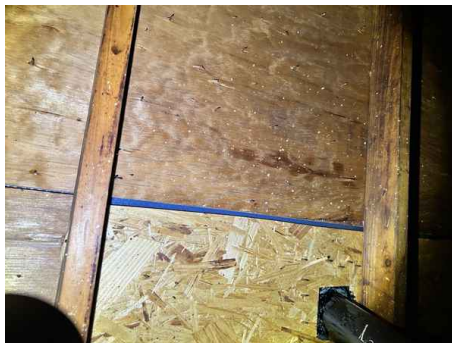
- ☐ A. SWR (also called Sealed Roof Deck) Self-adhering polymer modified-bitumen roofing underlayment applied directly to the sheathing or foam adhesive SWR barrier (not foamed-on insulation) applied as a supplemental means to protect the dwelling from water intrusion in the event of roof covering loss.
- ☒ B. No SWR.
- ☐ C. Unknown or undetermined.

No SWR

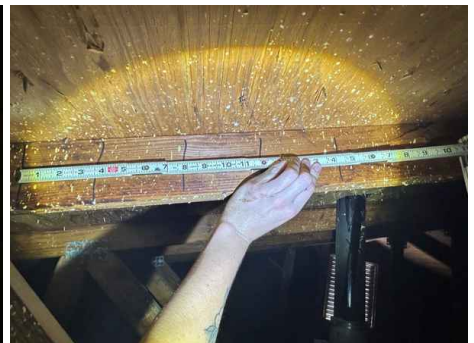
- ☒ C. Plywood/OSB roof sheathing with a minimum thickness of 7/16" inch attached to the roof truss/rafter (spaced a maximum of 24" inches o.c.) by 8d common nails spaced a maximum of 6" inches in the field. -OR- Dimensional lumber/Tongue & Groove decking with a minimum of 2 nails per board (or 1 nail per board if each board is equal to or less than 6 inches in width). -OR- Any system of screws, nails, adhesives, other deck fastening system or truss/rafter

Nail Spacing

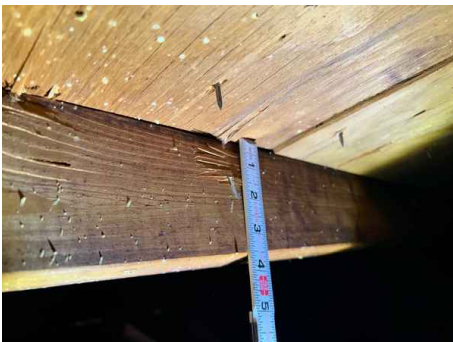
8D Nails

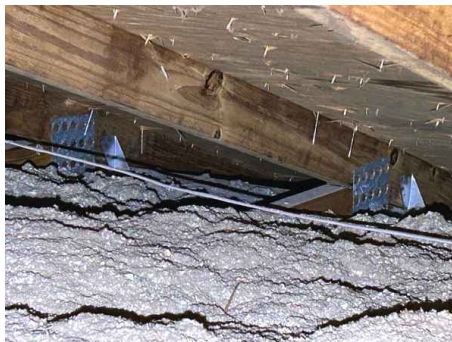
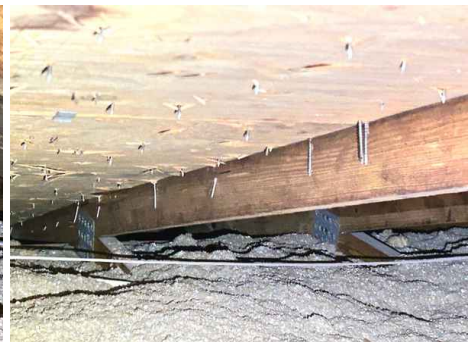
- ☒ Secured to truss/rafter with a minimum of three (3) nails, **and**
- ☒ Attached to the wall top plate of the wall framing, or embedded in the bond beam, with less than a 1/2" gap from the blocking or truss/rafter **and** blocked no more than 1.5" of the truss/rafter, **and** free of visible severe corrosion.
- ☒ B. Clips
  - ☒ Metal connectors that do not wrap over the top of the truss/rafter, **or**
  - ☐ Metal connectors with a minimum of 1 strap that wraps over the top of the truss/rafter and does not meet the nail position requirements of C or D, but is secured with a minimum of 3 nails.
- ☐ C. Single Wraps

Clips
