# MERIT PROPERTY INSPECTIONS

## PROPERTY INSPECTION REPORT COPY

1234 Main St  
Tampa, FL 12345

06/11/2026

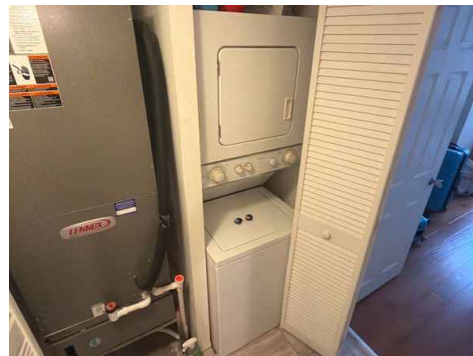
Laundry Closet- Operated

These images are considered informational only.
