## PROPERTY INSPECTION REPORT

1234 Main St  
Tampa, FL 33607

07/09/2025

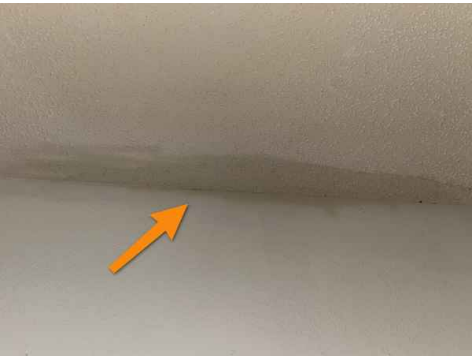
2nd Bedroom Closet- 0%

**CEILING - WATER STAIN OBSERVED**

A stain on the ceiling is present. This stain did not visually appear damp and could be from a previously resolved water leak. No moisture was detected. Recommend repainting, monitoring, and addressing as necessary.

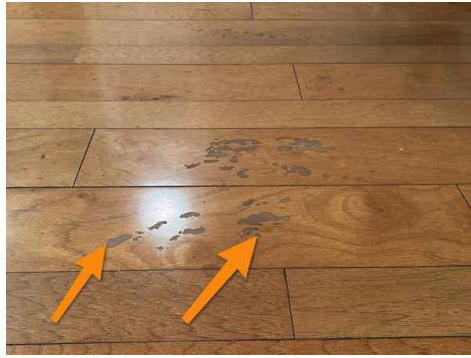
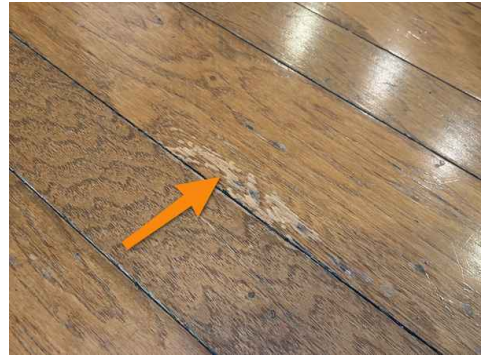
Across structure

**FLOORING - DAMAGED**

The flooring had general moderate damage visible at the time of the inspection. Damaged flooring may be primarily cosmetic and should be resolved as necessary. Recommend evaluation by a qualified flooring contractor.

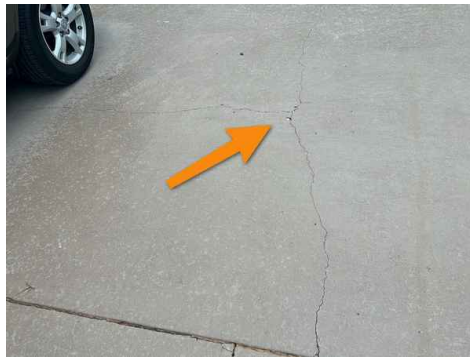
Front

**CRACKS, SEPARATION, OR HEAVING**

The porch show signs of aged cracking, separation, heaving, and/or deterioration. Compromised concrete will continue to exhibit decay, failure, collapse, and uplift if not remediated. Recommend caulking larger cracks and applying a concrete sealer. Cracking can also be a safety tripping hazard for pedestrians.

Recommend monitoring.

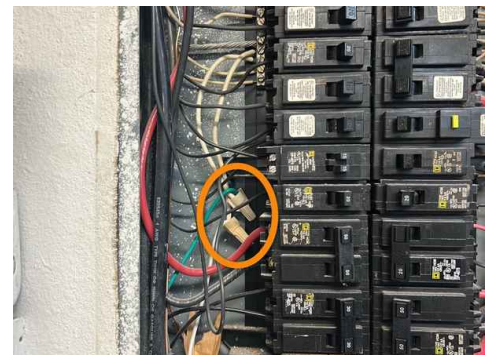
Garage

**Limitations****A. Service Entrance and Panels****PIGTAILED WIRES IN PANEL**

Pigtailed wires inside the box indicate one of two things. First (1), box may be recently replaced and pigtails are necessary to connect the shorter wires to the new breaker locations. Second (2), wires may be aluminum and pig tailing is necessary to connect the aluminum to the copper only breakers. Inspector is unable to determine if the wires are aluminum or copper throughout the home due to the fact that the pigtail and covers all wire tips.

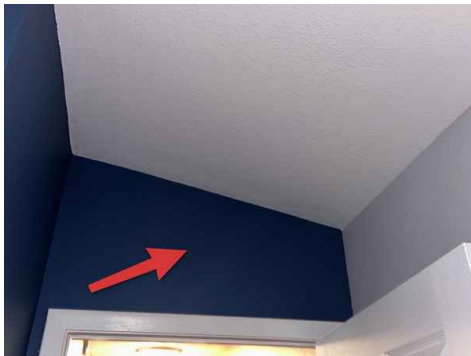
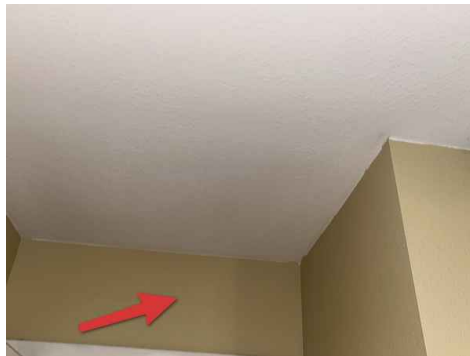
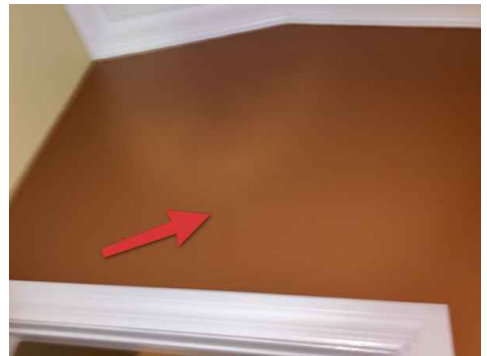
## **SMOKE ALARMS - MISSING (ENTIRE STRUCTURE)**

Smoke alarms/detectors are missing in the structure in multiple locations. It is recommended that smoke alarms be installed inside each bedroom, outside each sleeping area and on every level of the structure. On levels without bedrooms, it is recommended that alarms be installed in the living room (or den or family room) or near the stairway to the upper level, or in both locations. Recommend installation of smoke alarms/detectors in all areas of the structure, throughout the property, in all areas that require them.

Contact a qualified electrical contractor.

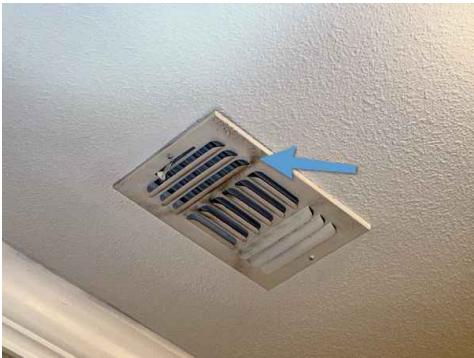
Primary Bathroom

DUCT CLEANING IS RECOMMENDED

Contact a qualified HVAC professional.

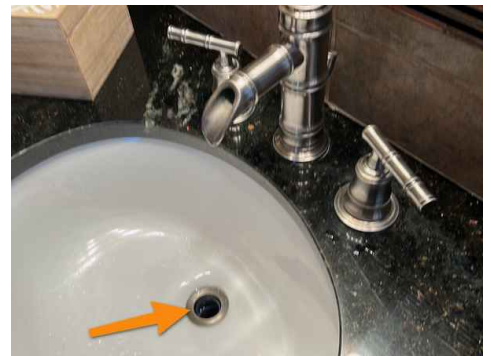
Primary Bathroom

**FAUCET DRAIN PULL MISSING**

The faucet drain pull is missing. Recommend plumbing contractor to resolve issue.

Contact a qualified plumbing contractor.

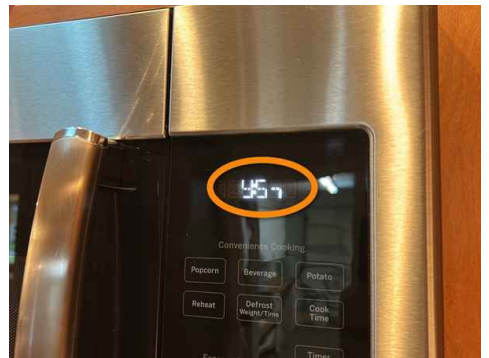
Kitchen

The microwave control panel is not easily read. Control panels age over time and can become harder to see, eventually becoming impossible. Some microwaves have settings to control the panel brightness. Recommend exploring settings or budgeting for a new microwave. Some higher-end microwaves may warrant service by an appliance repair technician.

Contact a qualified appliance repair professional.

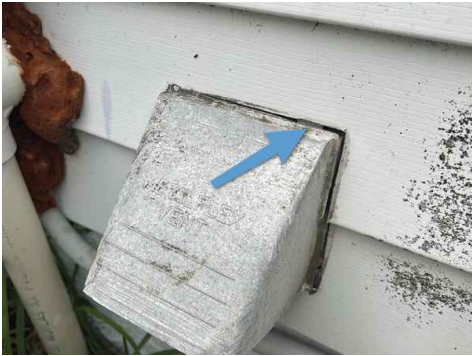
Right

The vent cover is not sealed to the wall, allowing for moisture and insect access. Recommend re-caulking.
