# MERIT PROPERTY INSPECTIONS

## PROPERTY INSPECTION REPORT COPY

1234 Main Street  
St. Petersburg, FL 33716

06/13/2026 9:00AM

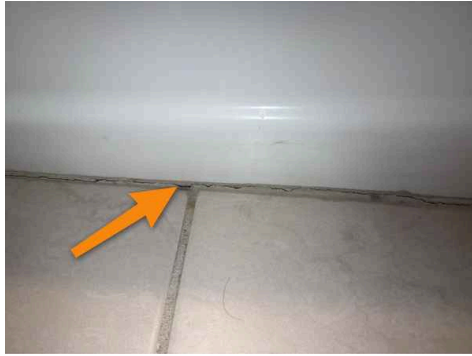
2nd Floor Hall Bathroom

Areas in the structure are showing separation. Separation of trim/cabinets/baseboards are primarily considered cosmetic and can be resolved by sanding, recaulking, and/or re-painting. That said, these finish areas are some of the most sensitive areas of the home and susceptible to small changes in movement of the foundation and framing. These types of separations are the first signs of foundation issues and should be monitored. The best way to monitor for future separation is to fix these problems professionally and monitor the areas for reappearing.

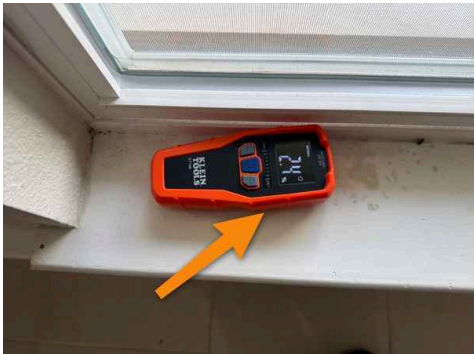
No elevated levels of moisture

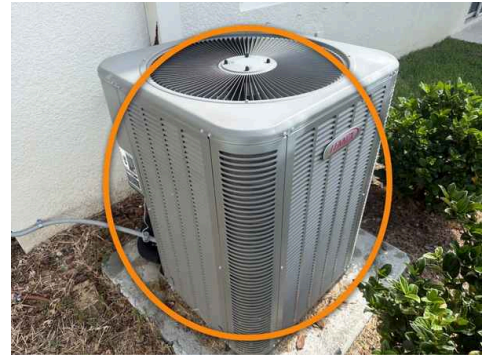
Back

Compressor started and operated but unit was unusually noisy. Recommend licensed HVAC contractor evaluate.

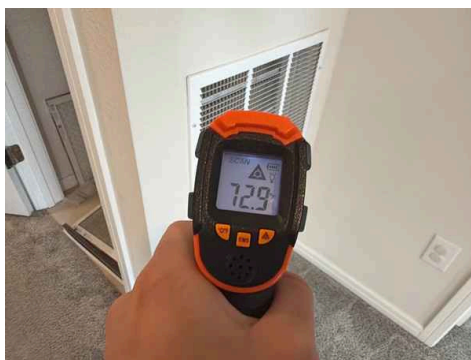
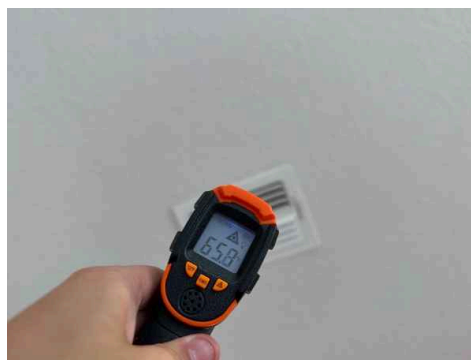
Cooling system was not producing cold enough air at time of inspection. The differential between the return intake and the supply vents was less than the recommended 15°F of minimum difference. A system that is adequately sized and working properly should produce a 15°F to 20°F difference passing through the evaporator coil. Some reasons for a lower differential measurement include:

- Filter needing replacement (clogged filter)
- Inadequate insulation on supply and/or return duct-work
- Low on freon (freon leak)
- Inoperable component of the AC
- Undersized system

Recommend qualified HVAC professional evaluate & ensure functionality.

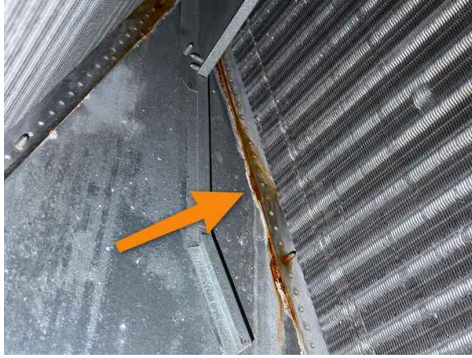
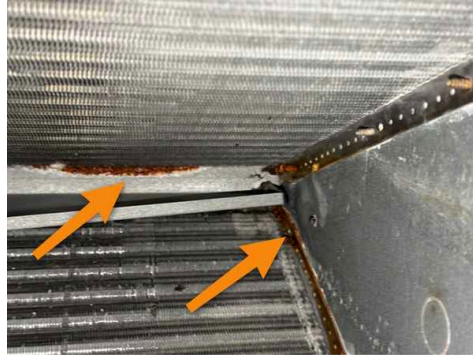
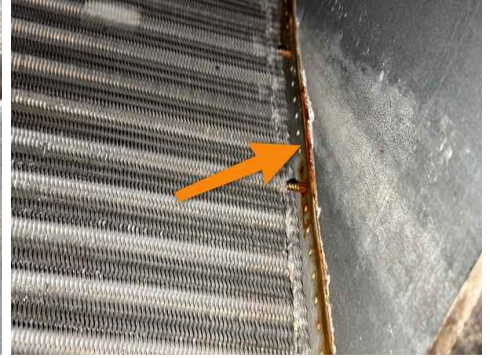
**CORROSION OBSERVED AT EVAPORATOR COILS ASSEMBLY**

Rust and corrosion were observed at the evaporator coil assembly and adjacent metal components. Corrosion is commonly associated with prolonged moisture exposure and may contribute to deterioration of HVAC components over time. Recommend evaluation by a qualified HVAC contractor and repair or replacement as needed.

Contact a qualified HVAC professional.

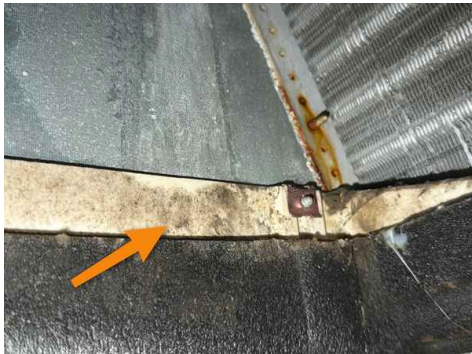
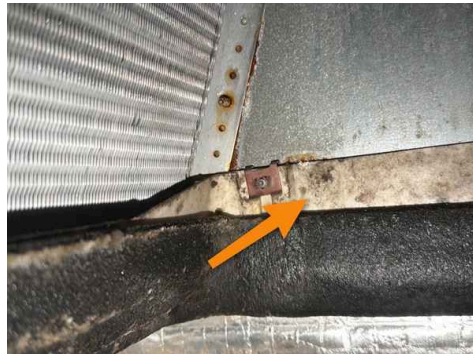
A microbial growth-like substance was observed at the evaporator coil assembly and adjacent components. Such conditions are commonly associated with elevated moisture levels and condensate accumulation within the air handler. The substance was not tested and its exact nature could not be determined during the inspection. Recommend cleaning and further evaluation by a qualified HVAC contractor.

Contact a qualified HVAC professional.

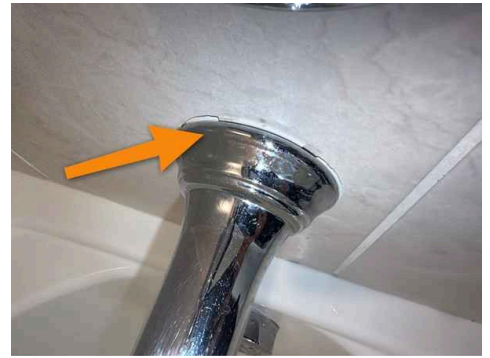
2nd Floor Hall Bathroom

#### LOOSE FIXTURE

Plumbing fixture is loose. This may lead to future leaking. Recommend hiring a plumber to tighten fixture.

Contact a qualified plumbing contractor.

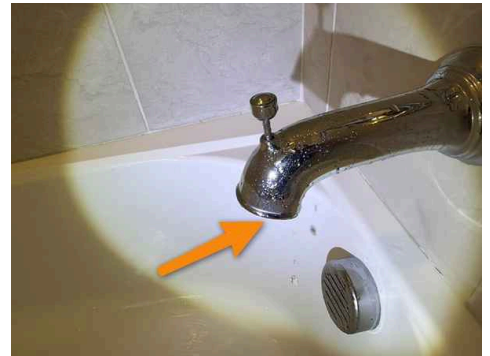
2nd Floor Hall Bathroom

The tub spout divert is not fully diverting water to the shower. A leaking and/or broken shower diverter wastes water and creates a lower-pressure shower experience. Recommend consulting a plumbing contractor.

Contact a qualified plumbing contractor.

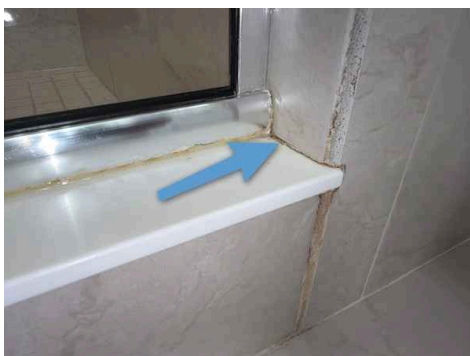
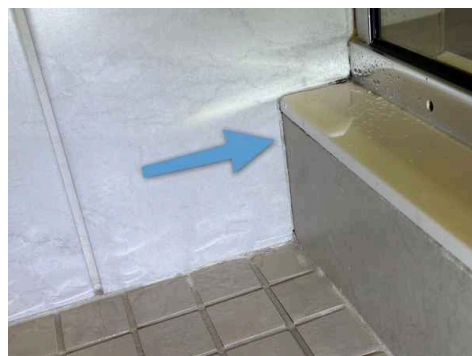
The tub and/or shower requires re-caulking. Re-caulking is necessary where caulking is missing or cracking. Confirm the use of silicon-based sealants that will prevent the penetration of water into the seams and cracks.

Recommended DIY Project

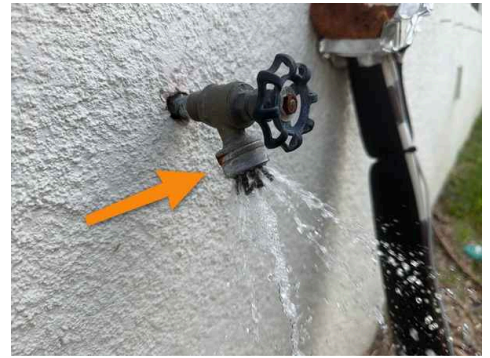
Back

The exterior hose bib is leaking from the vacuum breaker device when in use. This condition can result in water waste and may allow water intrusion into the wall. Recommend repair or replacement of the vacuum breaker or hose bib by a qualified plumber.

Contact a qualified plumbing contractor.

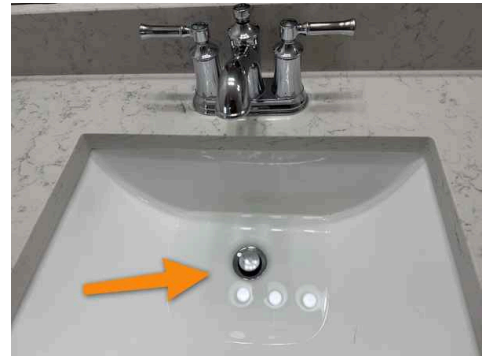
Primary Bathroom Left

Poor/slow drainage was observed at time of inspection. Recommend a qualified plumber evaluate and repair.

Contact a qualified plumbing contractor.

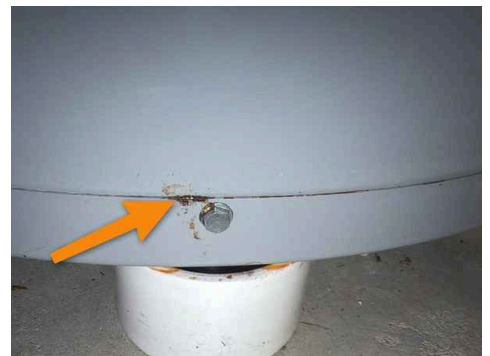
Garage

##### **RUSTING OBSERVED**

Rusting and corrosion were observed at the water heater at the bottom of the tank. This condition may indicate condensation. Recommend monitoring area.

Contact a qualified plumbing contractor.

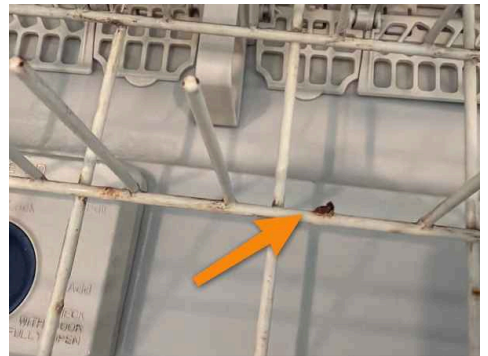
Kitchen

#### **RUSTED DISHWASHER RACK**

Rust and corrosion were observed on the dishwasher rack. Deterioration of the rack coating can expose the underlying metal to moisture, resulting in continued corrosion and potential damage to dishes and cookware. Recommend repair or replacement of the affected rack components as needed.

Contact a qualified appliance repair professional.

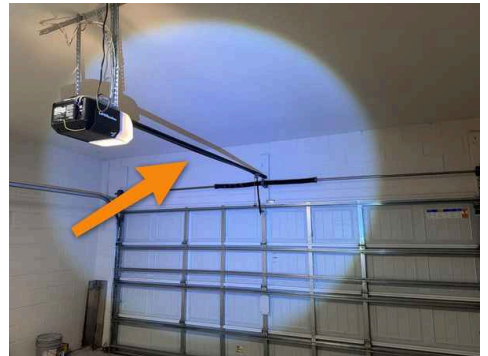
### 6.7.1 G. Garage Door Operators

The garage door was observed to produce excessive noise during operation. This condition may indicate worn or improperly adjusted components such as rollers, hinges, tracks, or the opener mechanism. Continued use without maintenance could lead to premature wear or failure. Recommend evaluation, lubrication, and servicing by a qualified garage door technician to ensure proper and safe operation.

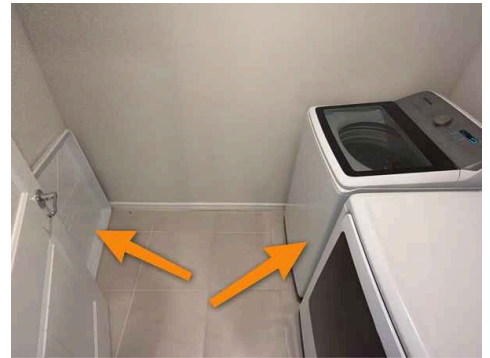
Laundry

## 6.10.1 J. Washers &amp; Dryers

Washing machines that are located upstairs should have overflow drain pans or a floor drain (minimum). Recommend installing a pan routed to the exterior or a drain to prevent possible water damage of the appliance leaks.

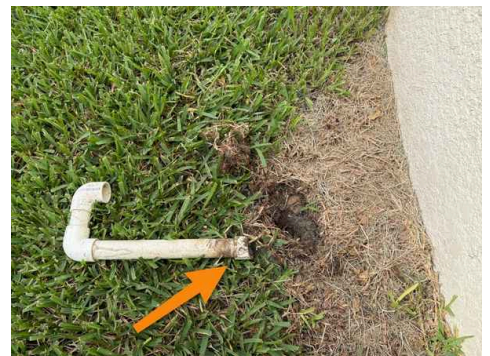
Left

**DAMAGE TO WASHING MACHINE  
OVERFLOW PAN DRAIN**

Damage was observed at the washing machine overflow pan drain connection. The damaged condition may impair the drain pan's ability to properly discharge water in the event of a leak or overflow, increasing the risk of water damage. Recommend repair or replacement of the affected components by a qualified contractor.

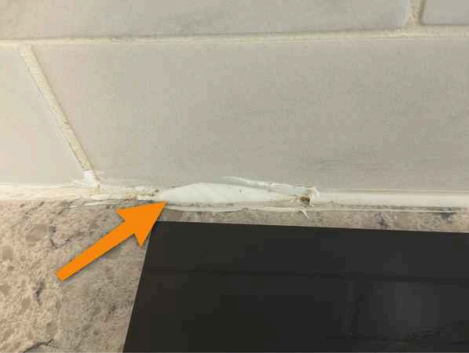
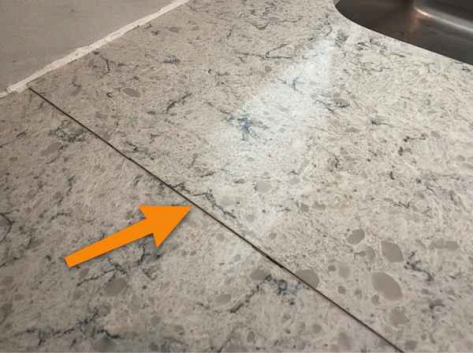
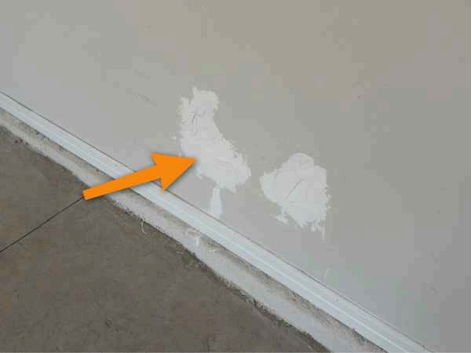
Inspector is not required to report cosmetic defects in an inspection report. This includes aesthetic imperfections that generally do not affect working condition of the property. The photos in this section are for the purpose of documentation, but are not considered a deficiency.

Recommendation  
Contact a qualified professional.
