# MERIT PROPERTY INSPECTIONS

## PROPERTY INSPECTION REPORT COPY

1234 Main Street  
St. Petersburg, FL 33716

06/13/2026 9:00AM

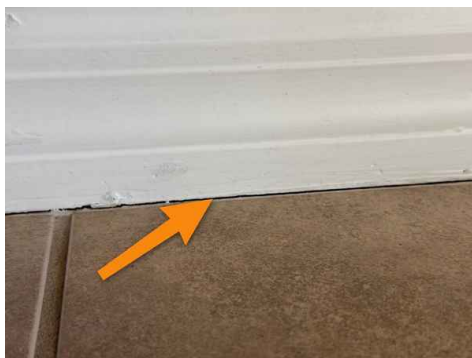
Living

Areas in the structure are showing separation. Separation of trim/baseboards are primarily considered cosmetic and can be resolved by sanding, recaulking, and/or re-painting. That said, these finish areas are some of the most sensitive areas of the home and susceptible to small changes in movement of the foundation and framing. These types of separations are the first signs of foundation issues and should be monitored. The best way to monitor for future separation is to fix these problems professionally and monitor the areas for reappearing.

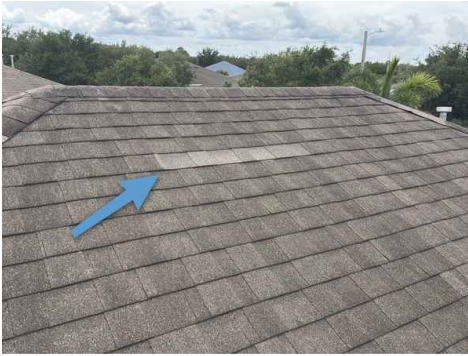
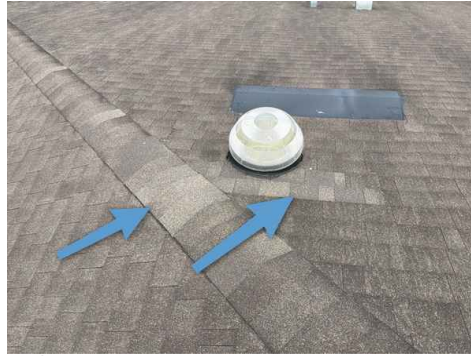
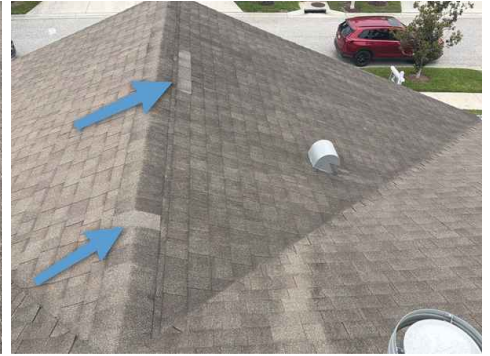
A roof patch was discovered and should be monitored for future leaks.

Recommendation  
Recommend monitoring.

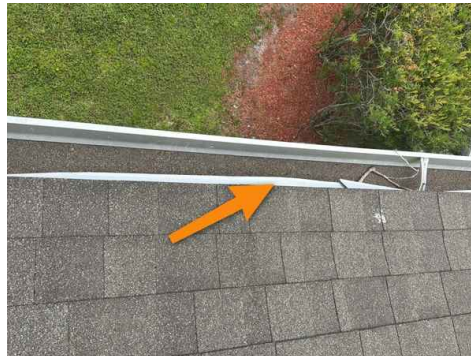
Back

Areas of the roof show lifted or separated flashing areas. These areas will not seal with the lower shingle areas or siding and can allow for water intrusion. Recommend a roofing contractor to replace.

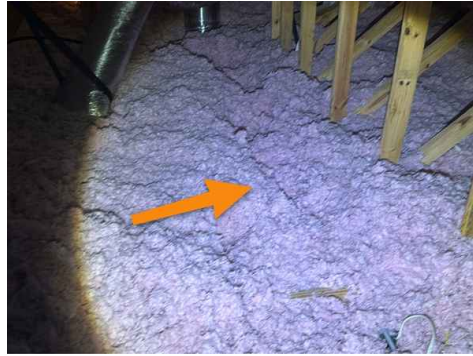
Attic

Insulation in the attic unevenly distributed and not smooth / even across the attic surface. This is common in older structures where attic insulation has been moved for repairs and installations. Insulation that is not smooth and even across the attic surface will be less efficient and will be unable to create a thermal barrier as intended. Recommend a insulation contractor smooth the insulation and/or install new insulation in areas of the attic, as necessary.

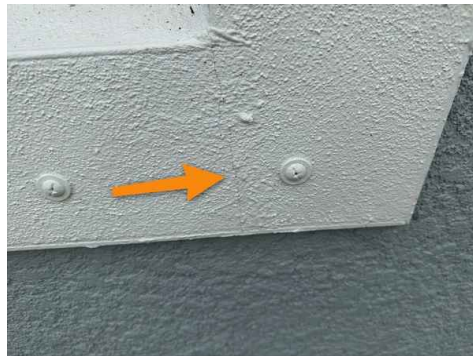
Left

### MINOR STUCCO CRACKS

Cracks were observed in the exterior stucco. **These openings can allow for moisture intrusion** and should be sealed with a compatible elastomeric sealant and repainted as needed. Recommend repair by a qualified stucco contractor to help prevent damage.

Contact a stucco repair contractor

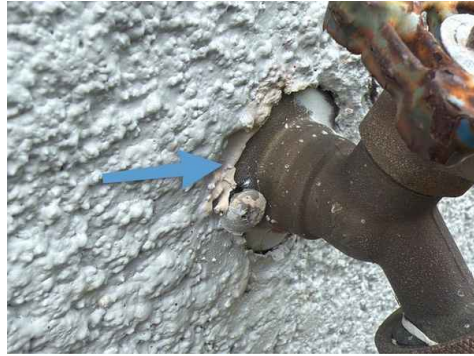
Back

### CAULKING DETERIORATED AND/OR MISSING

Caulking is necessary to seal gaps less than 1/2-inch. Caulking that is missing can provide for water penetration and allow insect access into the structure.

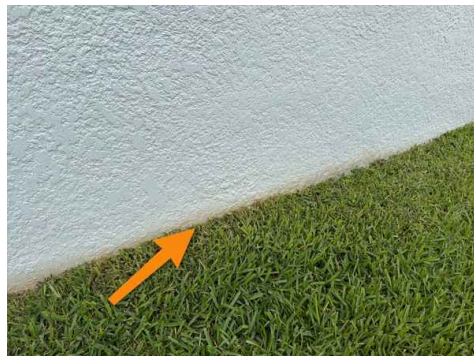
Back Left

Discoloration was observed at the exterior stucco wall covering near grade level. The discoloration is consistent with moisture exposure, organic growth, or accumulation of dirt and debris. While the full extent and cause could not be determined during the inspection, prolonged moisture exposure may contribute to deterioration of exterior finishes over time. Recommend monitoring and further evaluation if conditions worsen or moisture intrusion is suspected.

Contact a stucco repair contractor

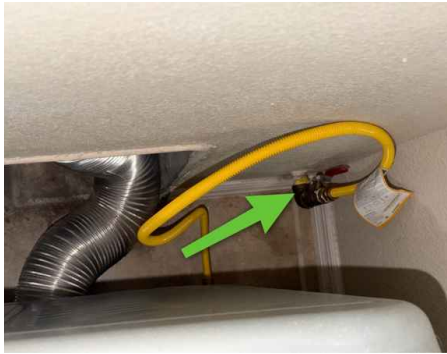
Laundry

## H. Dryer Exhaust Systems: Dryer gas hookup is present

The laundry room shows to have a natural gas dryer has hookup present, even if the current unit is electric or missing.

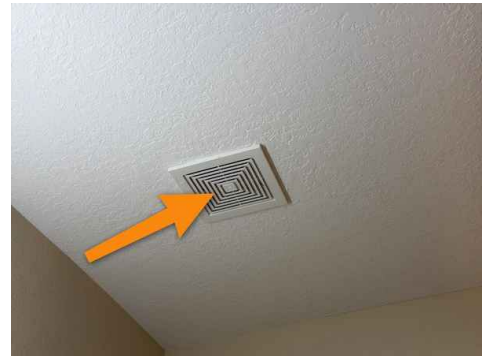
Primary Bathroom

The vent fan is unusually noisy when powered on. Recommend further investigation to determine the cause of the problem.

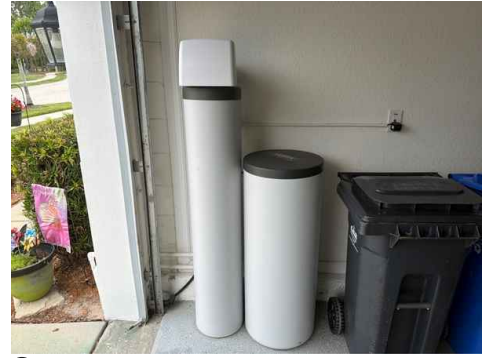
Garage

## WATER SOFTENER SYSTEM - OUT OF SCOPE

The water softener system was inspected for visual leaks. No inspection was made to determine the operation of the water filtration unit nor it's effectiveness. This type of inspection is considered outside the scope of work of this inspection.
