# Executive Summary

# Engineer's Foundation Evaluation

On 3/26/2024 a foundation evaluation was performed at the property located at address 123 Main St, Your City, FL, 12345, which consists of a 3079 square-foot single family attached structure built in 2008 (18 years old) with a slab on grade foundation.

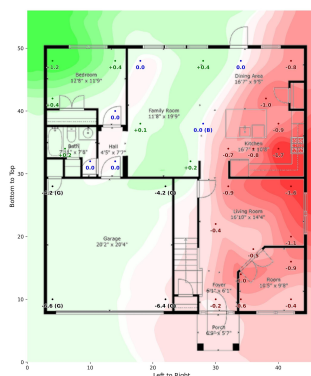
Figure A

This evaluation indicates clear signs of foundation issues. Calculations were not found to be within industry standard limits. Remedial measures are required to bring the foundation to a more level condition. It is recommended that foundation stabilization be completed as soon as possible, if possible within the next year. In addition, visual deficiencies noted should be resolved after foundation improvements have been completed. We also recommend you perform another house elevation plot after repairs have been completed to memorialize the elevation changes. Due to the nature that foundation work is recommended, it is imperative that you read the entire report in detail for a comprehensive explanation of this conclusion.
