MERIT PROPERTY INSPECTIONS

## PROPERTY INSPECTION REPORT

1234 Main St  
Tampa, FL 33607

05/30/2025

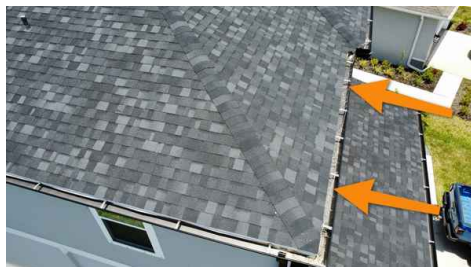
Front

Debris in gutters. Recommend removal for functional use of gutters.

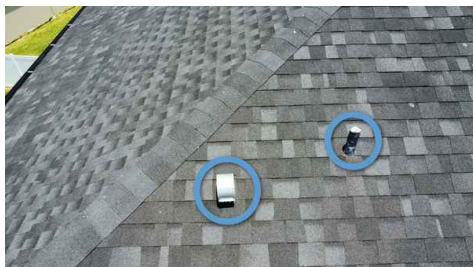
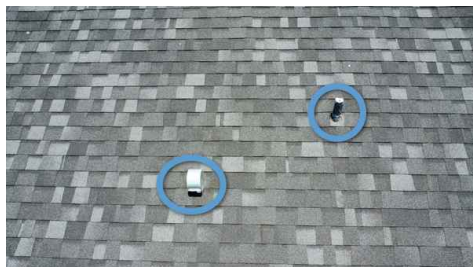
Roof vents are unpainted or should be repainted with a rust preventative paint (typically matching the roof color or black). Unpainted vents are more likely to cause discoloration of the roof by runoff as vents rust and rubber deteriorates.

**Maintenance Item**

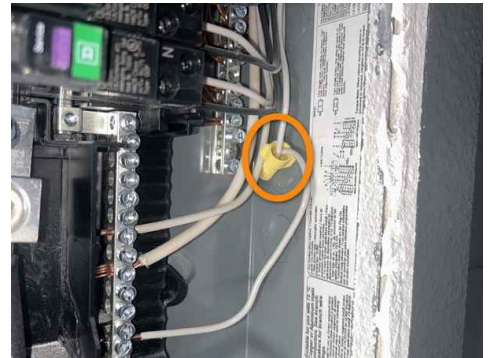
Garage

#### PIGTAILED WIRES IN PANEL

Pigtailed wires inside the box indicate one of two things. First (1), box may be recently replaced and pigtails are necessary to connect the shorter wires to the new breaker locations. Second (2), wires may be aluminum and pig tailing is necessary to connect the aluminum to the copper only breakers. Inspector is unable to determine if the wires are aluminum or copper throughout the home due to the fact that the pigtail and covers all wire tips.

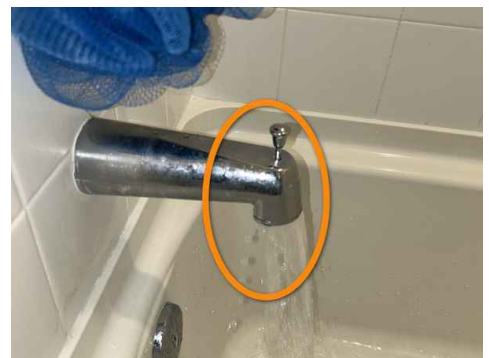
2nd Floor Hall Bathroom

The tub spout divert is not fully diverting water to the shower. A leaking and/or broken shower diverter wastes water and creates a lower-pressure shower experience. Repairing a shower diverter can be a DIY project, or you may want to consult a plumbing contractor.

Contact a qualified plumbing contractor.

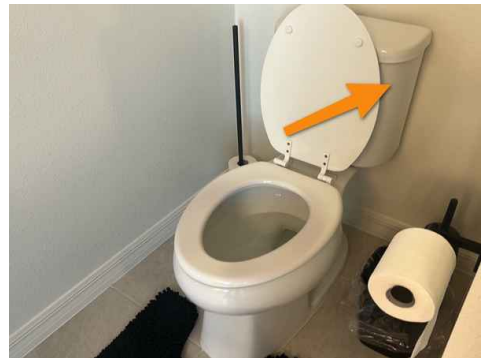
Primary Bathroom

Toilet is running and can be heard continually filling. A running toilet is inefficient and can run up costs on the municipal water bill. Recommend further investigation and possibly a plumber to resolve.

Contact a qualified plumbing contractor.

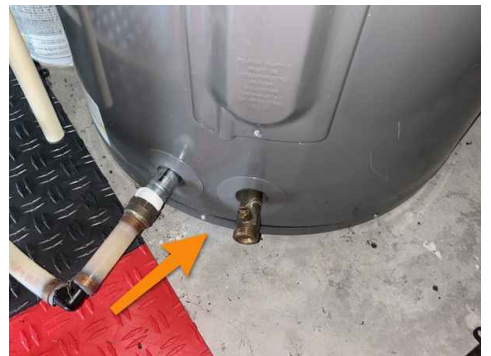
Garage

The water heater is not elevated off the ground. Water heaters that are sitting on the ground with rust-out faster than elevated water heaters.

Contact a qualified plumbing contractor.
