Report V1.0

# Engineer's Foundation Evaluation

123 Main St, Your City, FL, 12345

On 3/29/2024 a foundation evaluation was performed at the property located at address 123 Main St, Your City, FL, 12345, which consists of a 3548 square-foot single family attached structure built in 1990 (35 years old) with a slab on grade foundation.

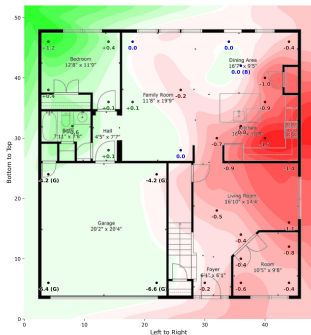
Figure A

**This evaluation indicates clear signs of foundation issues. Calculations were not found to be within industry standard limits. Remedial measures are required to bring the foundation to a more level condition. It is recommended that foundation stabilization be completed as soon as possible, if possible within the next year. In addition, visual deficiencies noted should be resolved after foundation improvements have been completed. We also recommend you perform another house elevation plot after repairs have been completed to memorialize the elevation changes. Due to the nature that foundation work is recommended, it is imperative that you read the entire report in detail for a comprehensive explanation of this conclusion.**
