# MERIT PROPERTY INSPECTIONS

## PROPERTY INSPECTION REPORT COPY

1234 Main St  
Tampa, FL 12345

06/11/2026

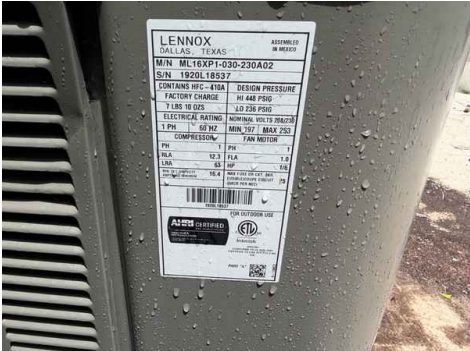
Refrigerant line intact

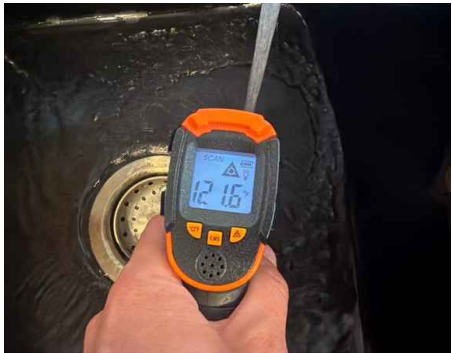
121°F
