MERIT PROPERTY INSPECTIONS

PROPERTY INSPECTION REPORT

1234 Main St
Tampa, FL 33607

05/14/2025

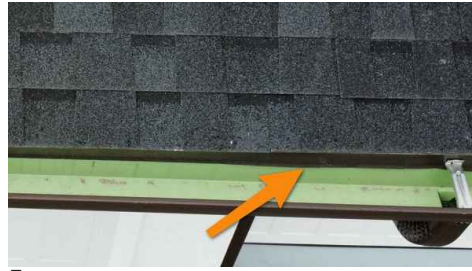
Front

2.3.5 C. Roof Covering Materials

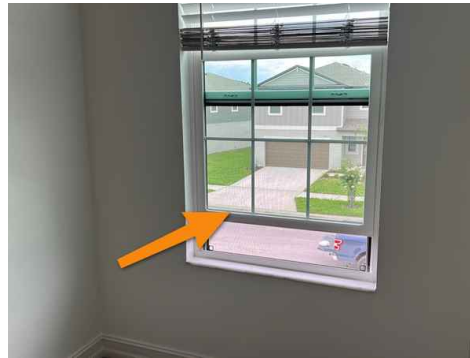
2nd Bedroom

2.8.2 H. Windows

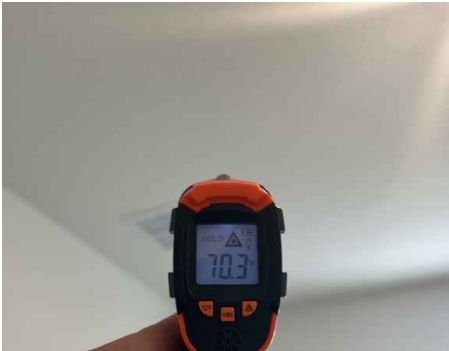
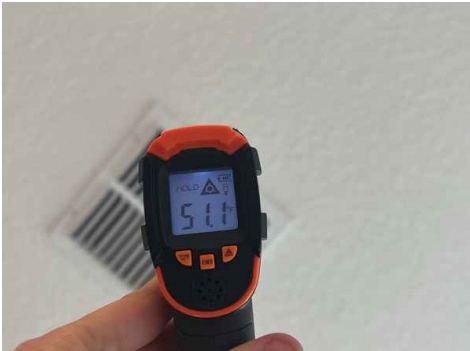
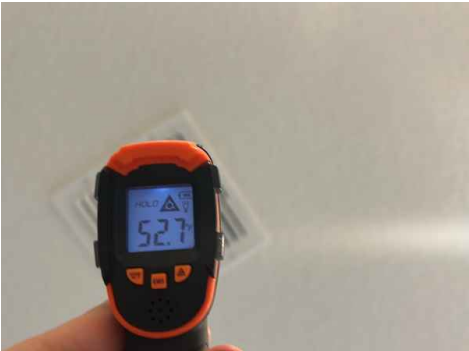
B. Cooling Equipment: 1st unit - measured temperature differential
Operable (15°F to 20°F)

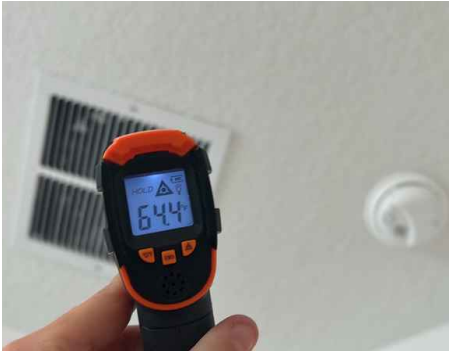
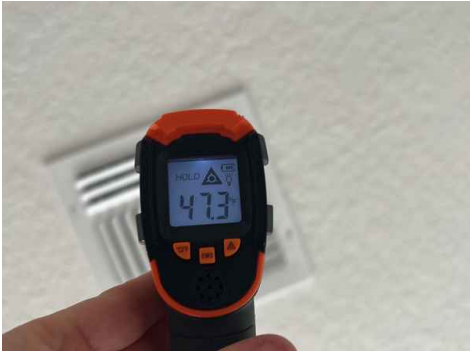
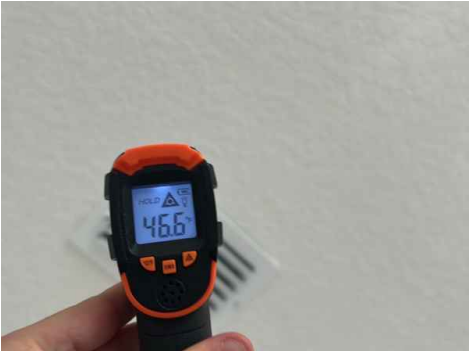
B. Cooling Equipment: 2nd unit - measured temperature differential
Operable (15°F to 20°F)

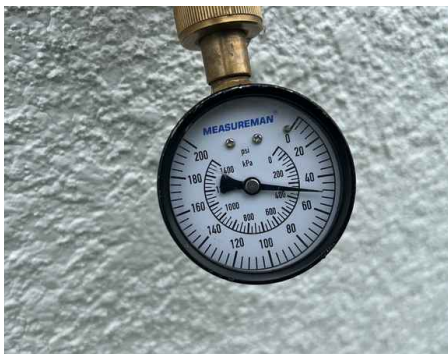
49 PSI

The water distribution pressure should range from 40 psi to 80 psi under typical operation. Photos in this section do not represent a pressure deficiency and are for documentation purposes.

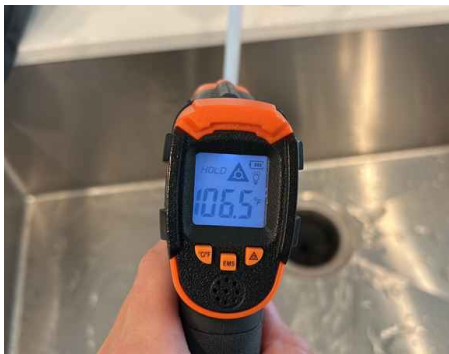
106°F

C. Water Heating Equipment: Water heater temperature

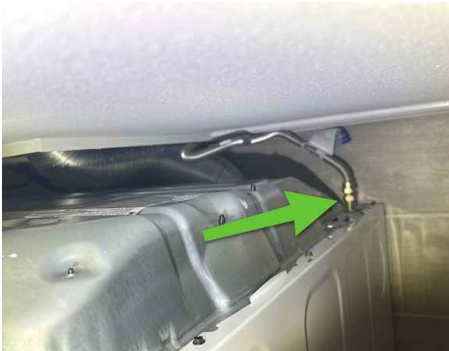
Laundry

H. Dryer Exhaust Systems: Dryer gas hookup is present

The laundry room shows to have a natural gas dryer has hookup present, even if the current unit is electric or missing.

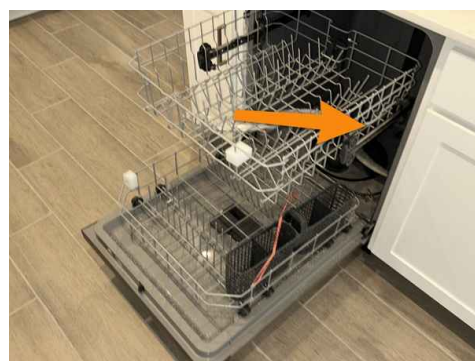
Kitchen

The top dishwasher drawer gets stuck when it is being pulled out. Recommend a qualified professional repair the drawer to functional use.

Contact a qualified appliance repair professional.
